## **Holistic photographic surveys and AI defect identification of the shaft and tunnels at Dinorwig Power Station**

R COOMBS, CC Informatics  
A PRITCHETT, Engie  
J CRAMMAN, CC Informatics

**SYNOPSIS** In 2023, the high pressure shaft and tunnels at the Dinorwig hydro pumped storage scheme were fully drawn down for the first time since operations started on site. This presented owner/operator Engie with an opportunity to collect data about the condition of the concrete in the 10m diameter, 476m deep shaft, and several kilometres of large diameter tunnels feeding the power station.

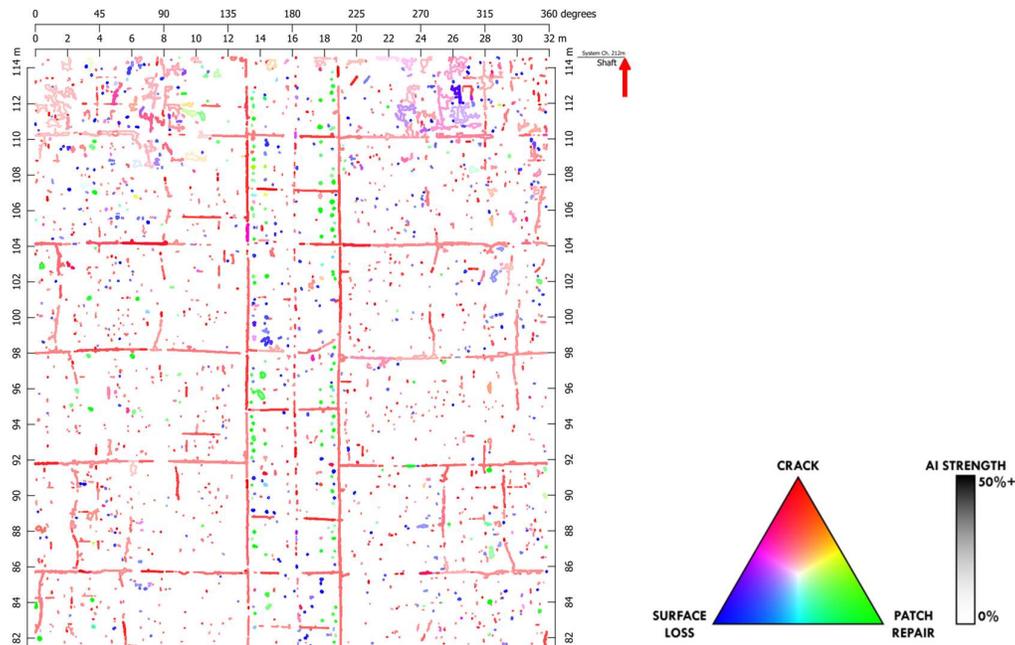
Following a detailed review at individual pixel resolution, the AI data was simplified into vector geometry and summarised on both drawings and tables. This could then be used by engineers to determine the location of surface indications that warranted attention throughout the entire length of the surveyed structure. This was mapped against chainage and orientation within the tunnel portal. An example of the simplified data is shown in Figure 7.

Figure 7. Compositing AI data – tunnel example
