Adapting earthworks design for adverse weather conditions

J MEHTA, Mott MacDonald
W J S SHEEHY, AECOM (formerly Mott MacDonald)
D LOEB, Mott MacDonald
S ZALMAY, Mott MacDonald
J R FOSTER, Mott MacDonald

SYNOPSIS Undertaking earthworks in winter and wet weather is generally avoided due to construction difficulties and potential quality implications. However, with changing climate and programme related challenges, it may not always be possible to avoid this.

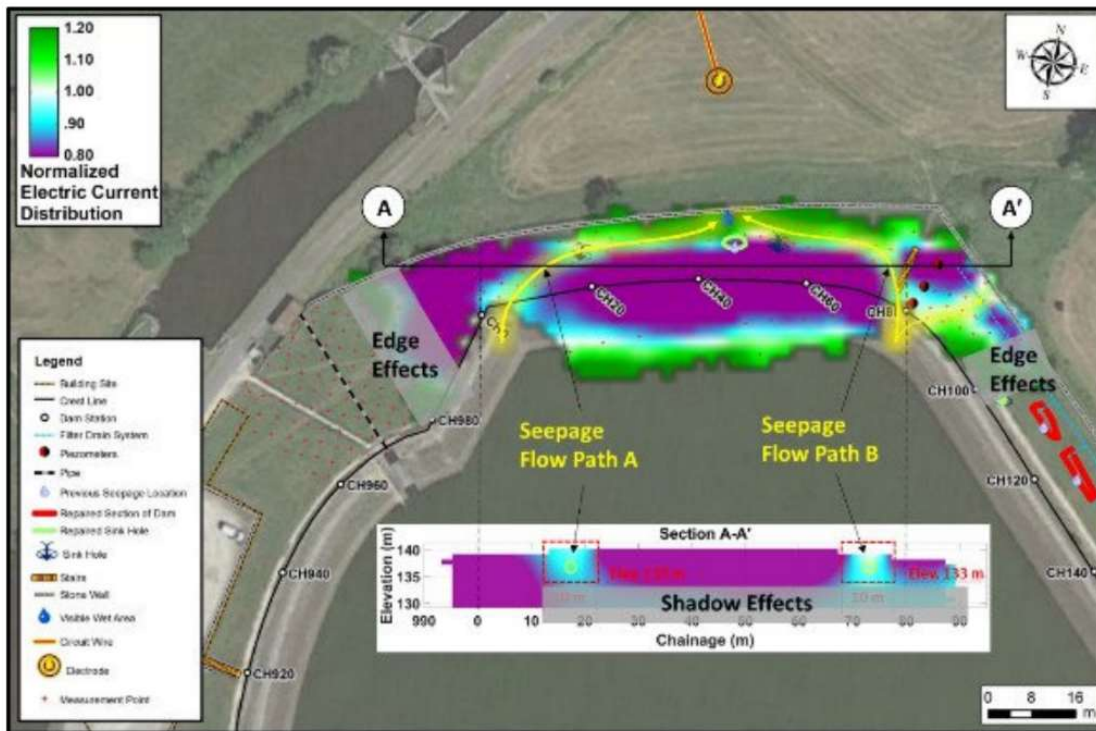
Figure 1. Seepage Paths in the North embankment

In the north embankment, the survey did not record seepage through the embankment but did record seepage through the foundation at two preferential locations, A and B (Figure 1).

- Inferred Seepage Path A: A series of three piezometers were installed at the location of the inferred seepage path into the foundation. All three piezometers recorded a distinct response to variation in reservoir level. The monitoring data related well to the findings of the Willowstick survey.
- Inferred Seepage Path B: Limited piezometric data was available in this location and due to a lack of long-term evidence the relationship could not be confirmed. However, the borehole log recorded the presence of blowing sand at elevation some 3m about the inferred seepage path. The presence of the blowing sands is indicative of high confined water pressure which would tend to support the presence of a seepage path in this area.

- A piezometer located in between the two preferential locations recorded no response with variation in reservoir level - which correlates with the findings of the Willowstick survey.

Due to the presence of the preferential flow paths identified in the foundation during the Willowstick survey, as well as the presence of blowing sands, boreholes were proposed to target the permeable layer in the areas identified so that the groundwater could be alleviated and monitored long term.

Two pressure relief wells were installed in the north embankment to alleviate artesian groundwater in the areas identified by the Willowstick Survey. Challenges were encountered during installation with managing the artesian groundwater and allowing suitable installation of the filter material around the perforated pipe. This was overcome by socketing the casing into a suitably impermeable layer of ground to provide conditions to assist with installation.

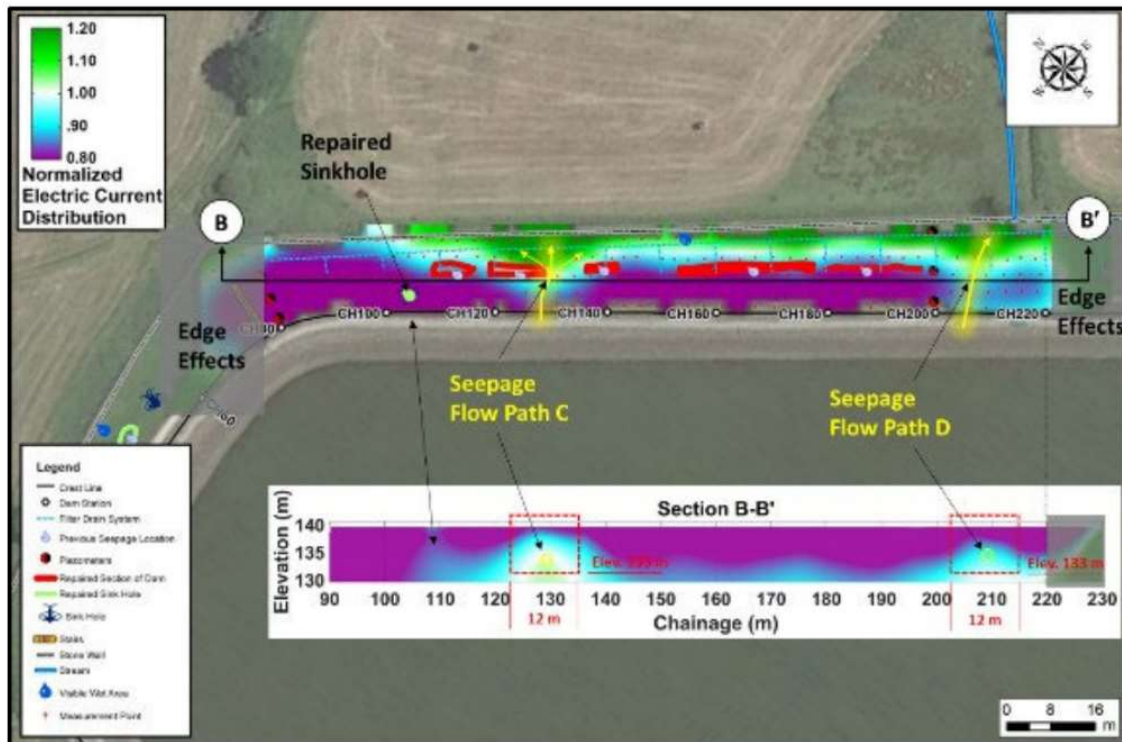
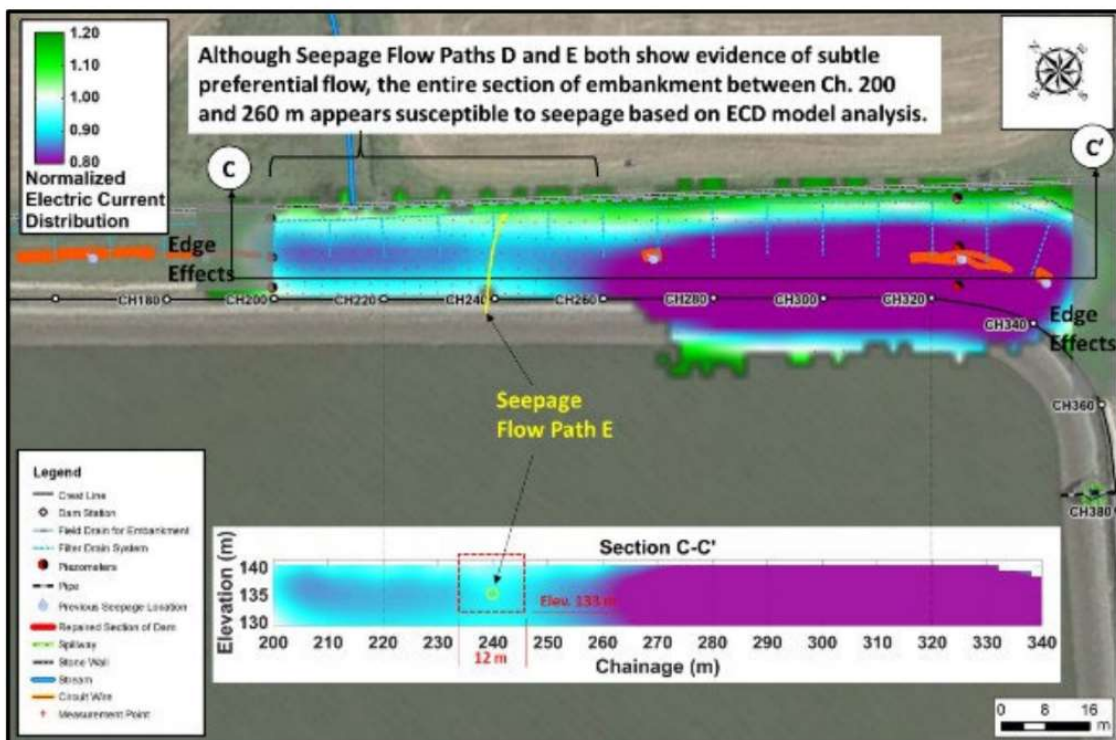
Figure 2. Seepage Paths in the North-East Embankment

In the north-east embankment, the survey identified seepage at three preferential locations, C,D and E (Figure 2).

- Seepage Path C: An inferred seepage path was recorded in the foundation. No piezometers were installed here, although drains are installed along the downstream toe, however the invert of the drainage is above the inferred seepage path. The intensity of the reading at C is akin to that recorded at seepage paths A and B.

- Seepage Path D: An inferred seepage path D is recorded in the foundation and a piezometer was installed in the foundation in this location. A relationship between piezometric level and reservoir level exists here but it is modest – piezometric levels varying by 0.7m for 6m of reservoir head, a ratio of 1 in 8.6 variation in reservoir level. Willowstick records a weaker signal here than at inferred seepage Path C, indicating greater seepage there than at D.

- Seepage Path E: Seepage throughout the embankment is indicated over a 40m length a in the upper embankment. This does not correlate with drainage, piezometer nor Kaplemeyer data. A nominal seepage path was also inferred in the foundation at a discrete point in this area. No piezometer data was available here. The indicated seepage here was very low and was not considered a significant concern.

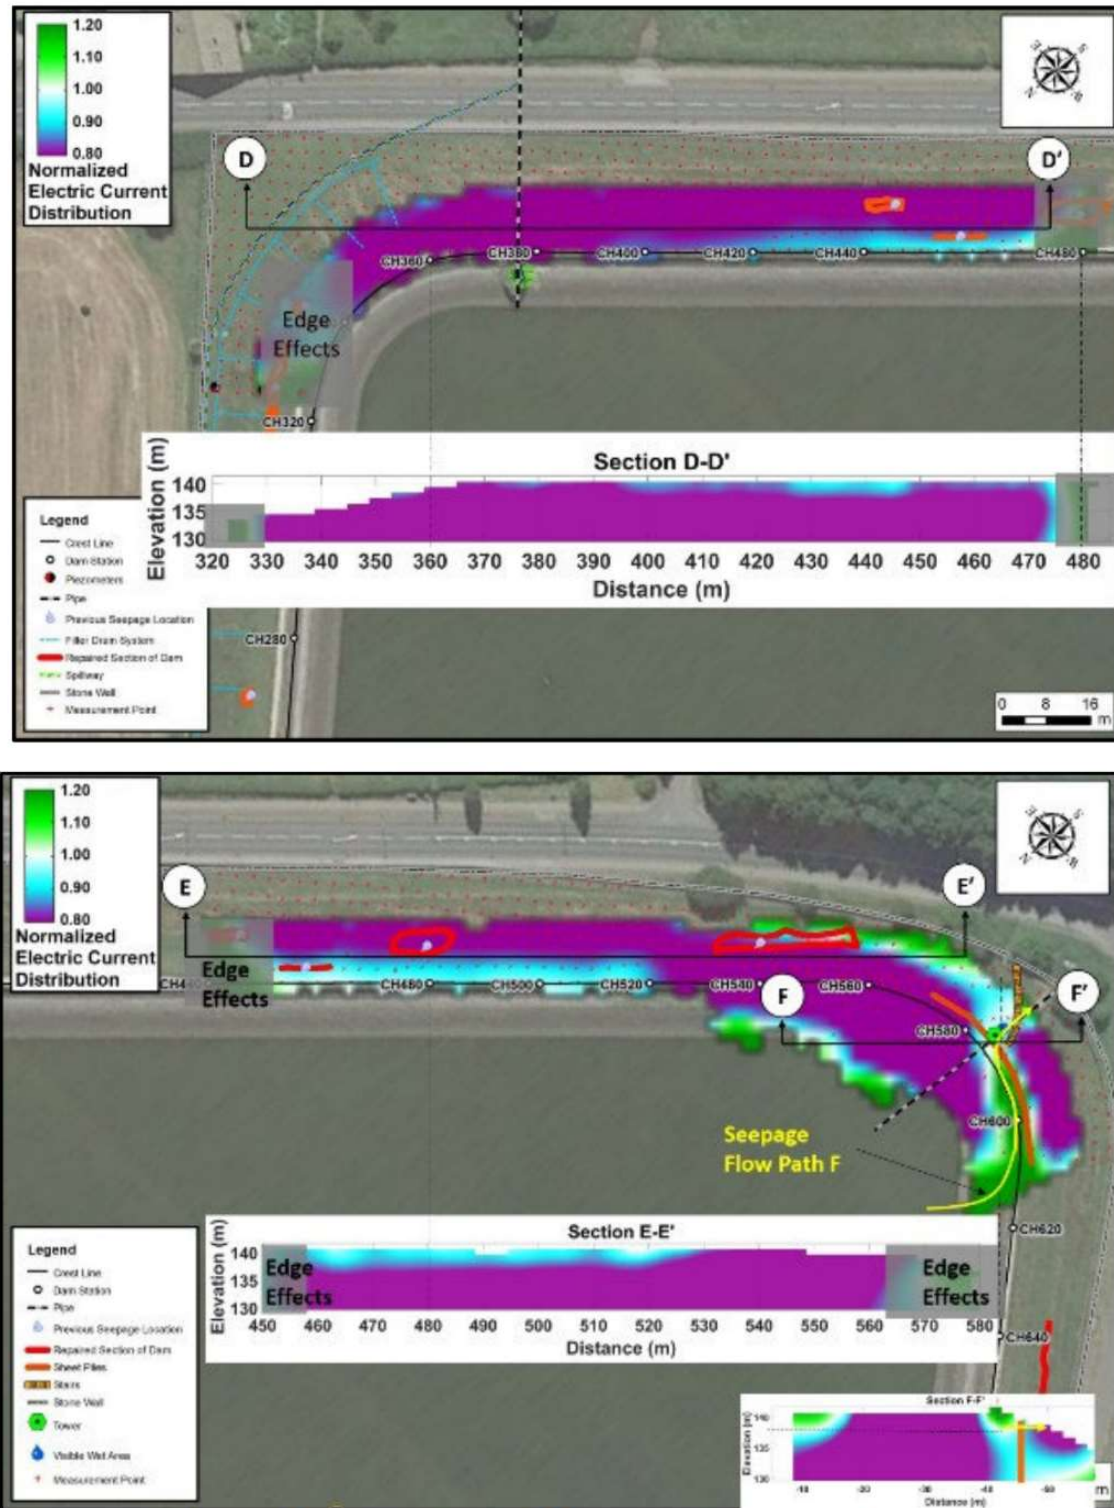
Figure 3. Seepage Paths in the South Embankment

In the south embankment, the survey identified seepage at one preferential location (Figure 3). High level seepage was indicated in the embankment upstream of the core for approximately 130m in length of the embankment. This corresponds to the piezometer data

(as the core readings record a connection but shoulder fill does not) and generally with the Kaplemeyer survey.

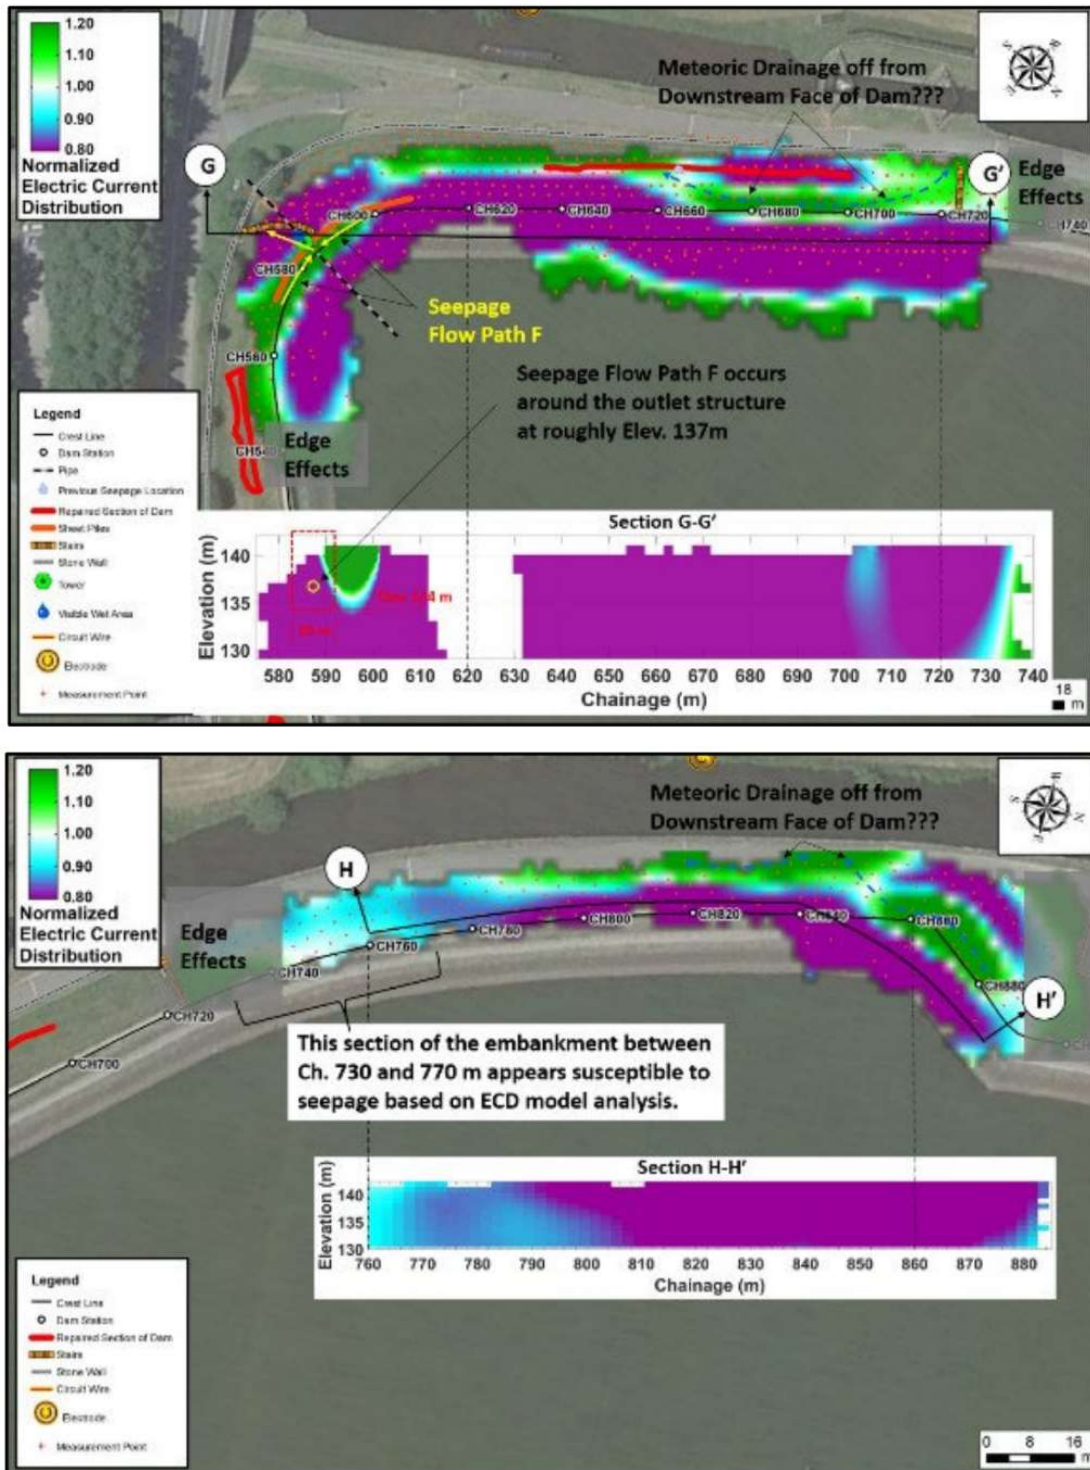
Figure 4. Seepage Paths in the West embankment

In the west embankment, the survey identified a possible seepage-prone area for a 40m length (Figure 4). A line of piezometers installed at this location record no such issue in the downstream shoulder fill nor the foundation. A high-level relationship was noted in the core piezometers and was also recorded by the Kappelmeyer survey.

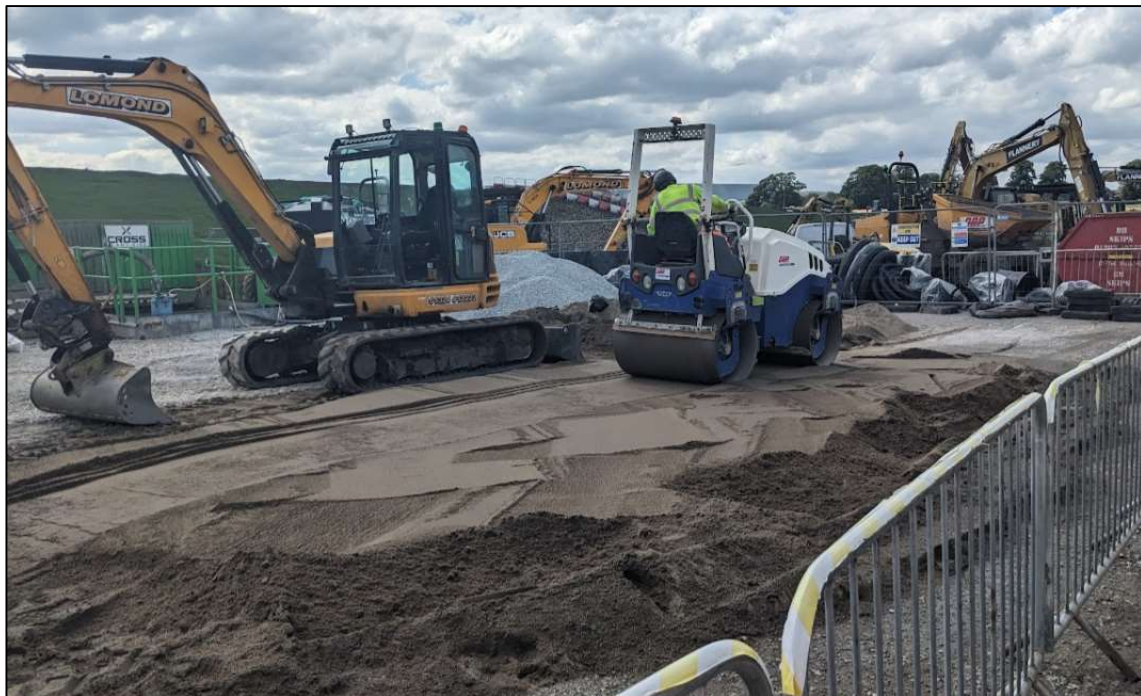
Figure 5. Fine Filter Compaction Trial

Compaction trials for both coarse and fine filter were initially undertaken in early June 2023 (Figure 5). The trials consisted of the construction of two small embankments approximately 20m in length by 5m width. The number of proposed layers being defined as the number required to determine a suitable compaction method to achieve the specified relative density of between 70% and 80%. A number of combinations of compactive plant, vibration frequency, layer thickness and passes were undertaken in order to define the optimum compaction methodology.

Upon undertaking the compaction trial of the fine filter, it failed to achieve the minimum relative density requirements of 70% reliably. Upon analysis of the trial results, it was determined that the minimum density testing results used to derive relative density were unusually high with results of 1.67Mg/m^3 . Table 1 of BS8002 indicated, with a unit weight of 15 to 17kN/m^3 appropriate for uncompacted fine filter, that a realistic range of minimum density should be between 1.316 to 1.574Mg/m^3 with an average of 1.37Mg/m^3 . Upon retesting the material for minimum density, the value reduced and as a result both material trials were re-attempted and met the relative density requirements of the specification.

Particle Size Distribution (PSD) testing undertaken throughout the compaction trial to validate the material source showed evidence that up to 5% material finer than 2mm diameter was present in the coarse filter material, contrary to the requirements of the specification which stated no material finer than 2mm was acceptable. Thorough processing of the material, including washing, eventually achieved the specification requirements by reducing the

material below 2mm diameter to as low as was practically achievable (3%). The risk of increasing <2mm material during the wetter winter months was raised, as processing materials in a wet environment can result in higher entrained silts and clays in the processed material. To mitigate this risk, Mott MacDonald completed a site visit to the Cefn Graianog Quarry in order to ensure the material was washed and processed to a sufficient standard in all weathers.

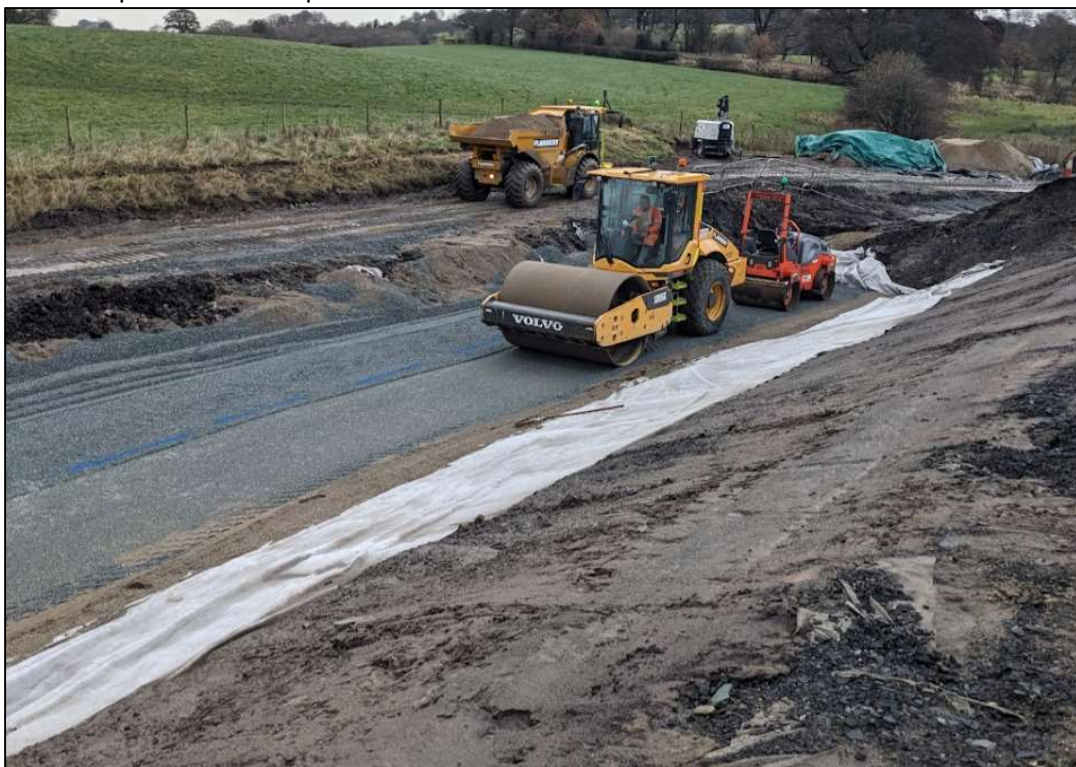
Figure 6. Compaction of coarse filter

Once the first layer was complete, Nuclear Density Meter (NDM) testing and Sand Replacement Density (SRD) testing were undertaken on the fine filter and NDM testing completed on the coarse filter (as this material was unsuitable for SRD) proving a relative compaction of 89% on average was achieved in the fine filter and 92% in the coarse filter. The 803/1 shoulder fill material, requiring 95% relative compaction for compliance achieved an average of 99% with 100% of tests passing. PSD testing was also undertaken to ensure the filter materials had not significantly degraded (i.e. increase in finer sized particles due to particle breakdown) during compaction with acceptable post compaction results of no more than 4% below 2mm diameter achieved for the coarse filter, which was deemed acceptable. The coarse filter, fine filter and Type 1 embankment fill were subsequently placed without incident (Figure 6), with in-situ density testing and PSD testing carried out on each layer to ensure compliance to the specification.
