# Lessons from incidents and geotechnical investigations at embankment dams

Andrew Charles (BRE)  
Paul Tedd (BRE)  
Alan Warren (Motts)

# **Investigation hydraulic fracture at Greenbooth dam: 2001/09**

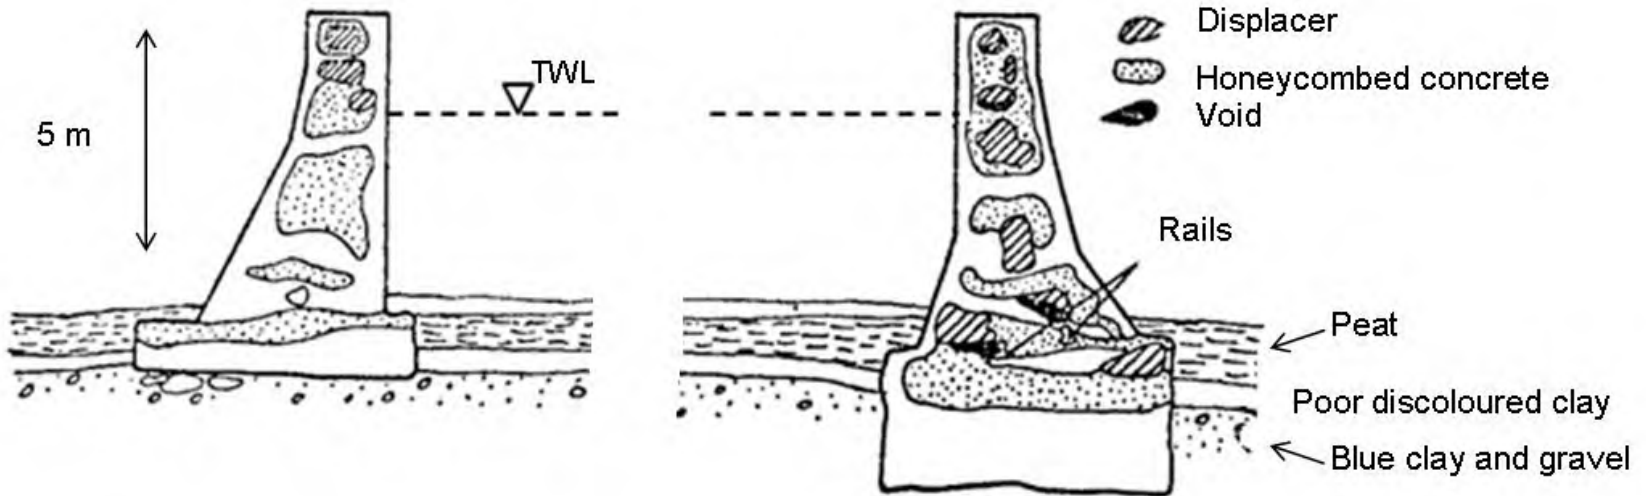
# Eigiau

Foundation: glacial deposit of hard blue clay containing granite boulders, overlain by peat up to 1.5m.

Foundations were specified to be 1.8m below clay surface but were only 0.46m.

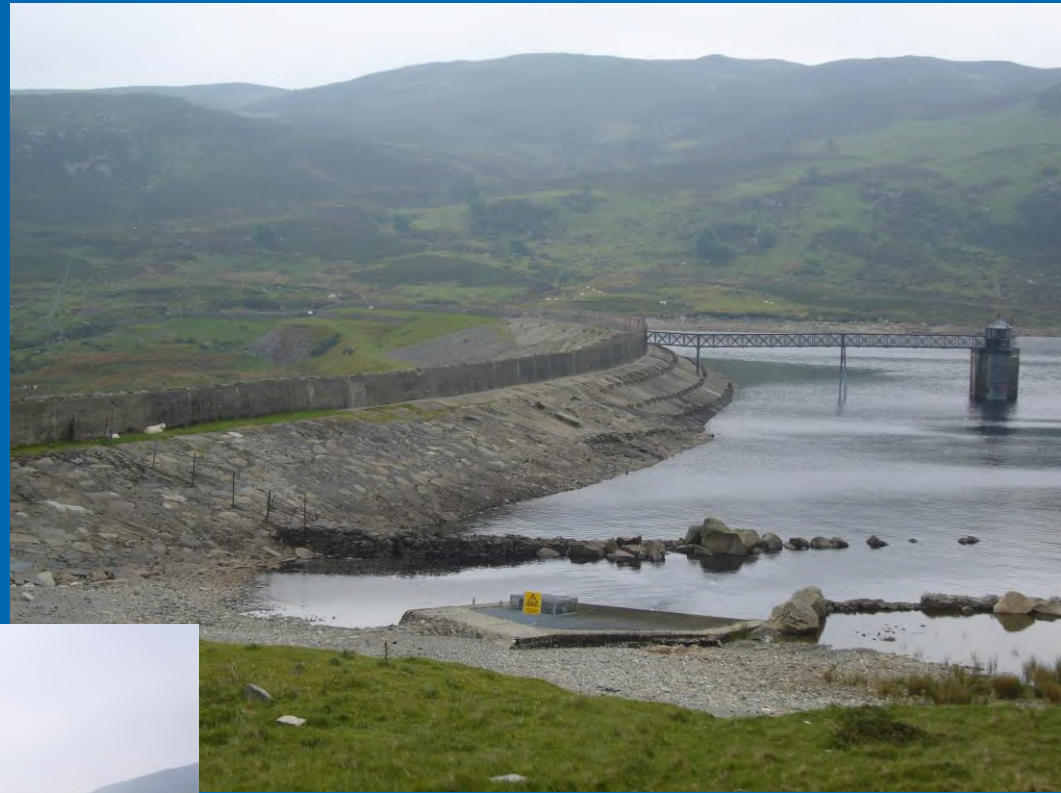
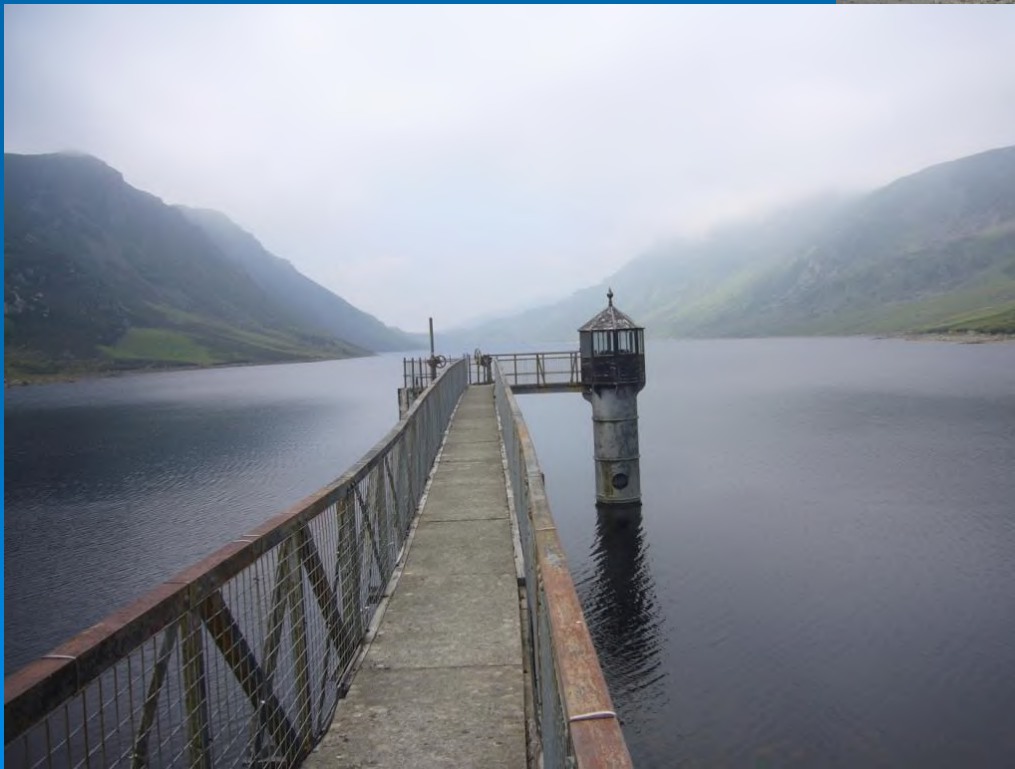
# Cowlyd

31 December 1924

Overtopped and nearly failed.  
Severe erosion of downstream fill  
to foundation level.

New Years Eve was spent  
repairing the dam.

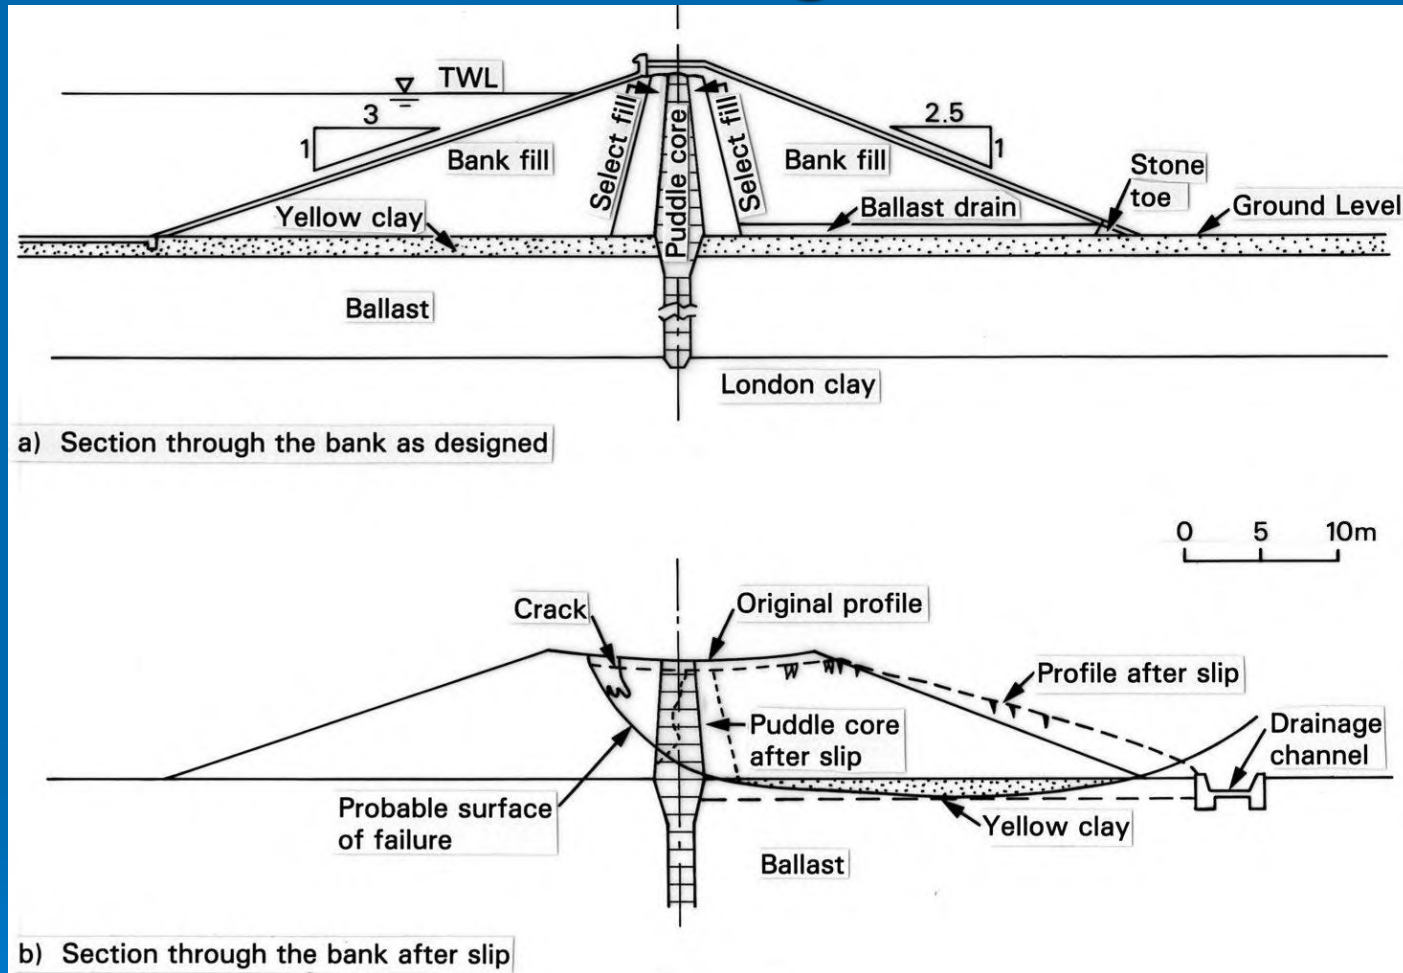
# Shear failure during construction

- Bunded reservoir some 3.5 miles long 10m high built for Metropolitan Water Board adjacent to River Lea.
- 29 July 1937 - a 90m length of the downstream slope failed on a slip surface passing through the core and the layer of soft yellow alluvial clay.
- At this section, the embankment had been built to a height of 8 m in 11 weeks using modern earth-moving equipment imported from America.

- Presence of soft weak clay in foundation, undrained shear strengths of 10 to 14 kPa
- Development of high pore water pressures due to rapid construction
- Little dissipation of pore water pressures
- King George V across the road had been built roughly at one third the rate had no problems.

Redesigned with the help of Terzaghi

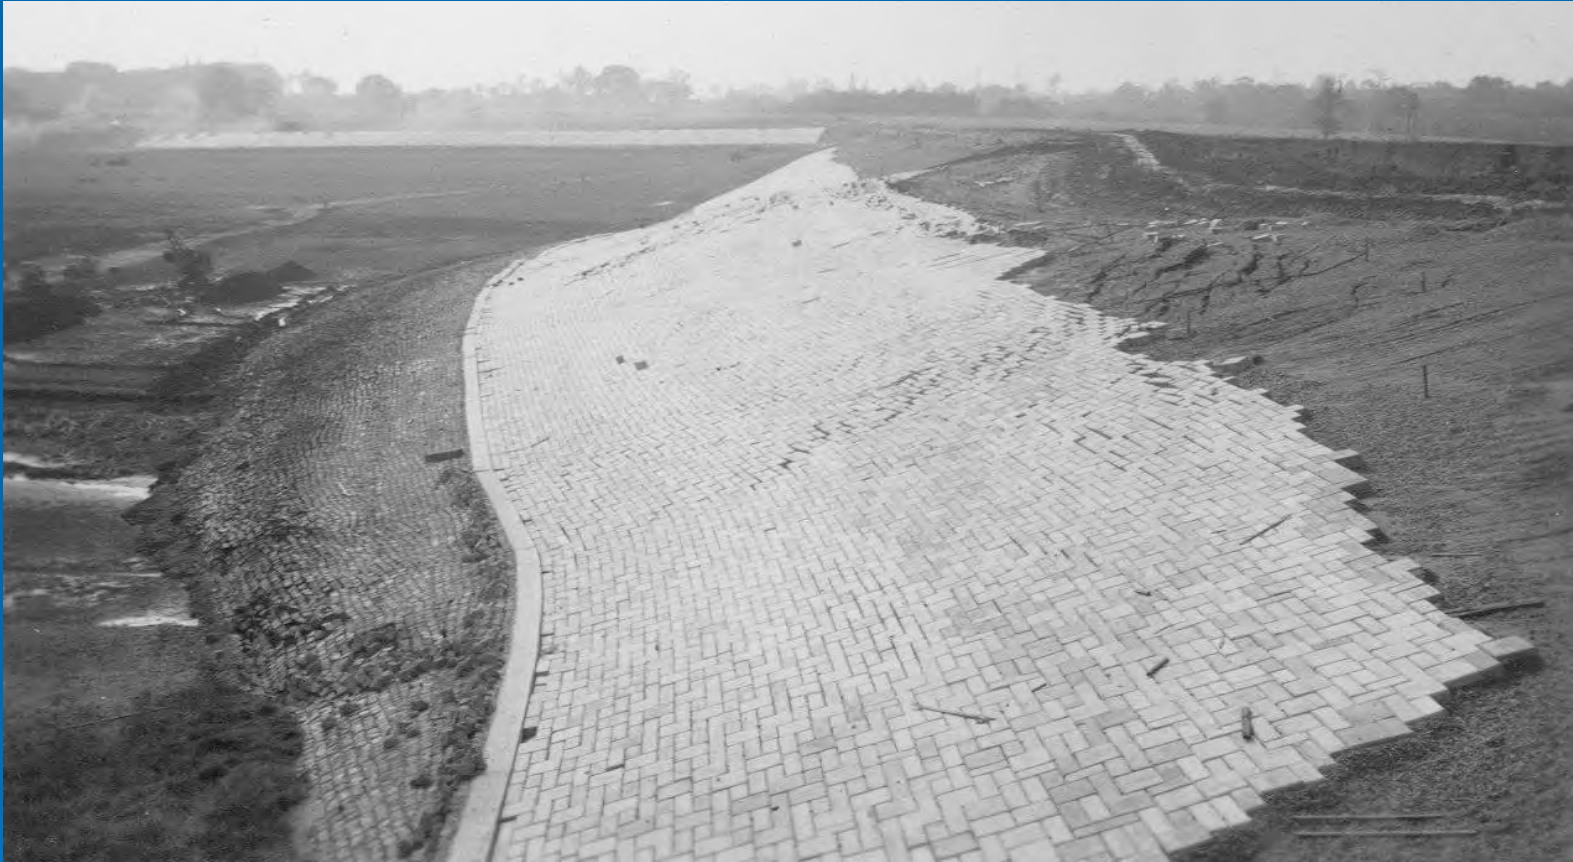
# Abberton Dam

Deep seated upstream slip during construction 20 July 1937,  
nine days before Chingford

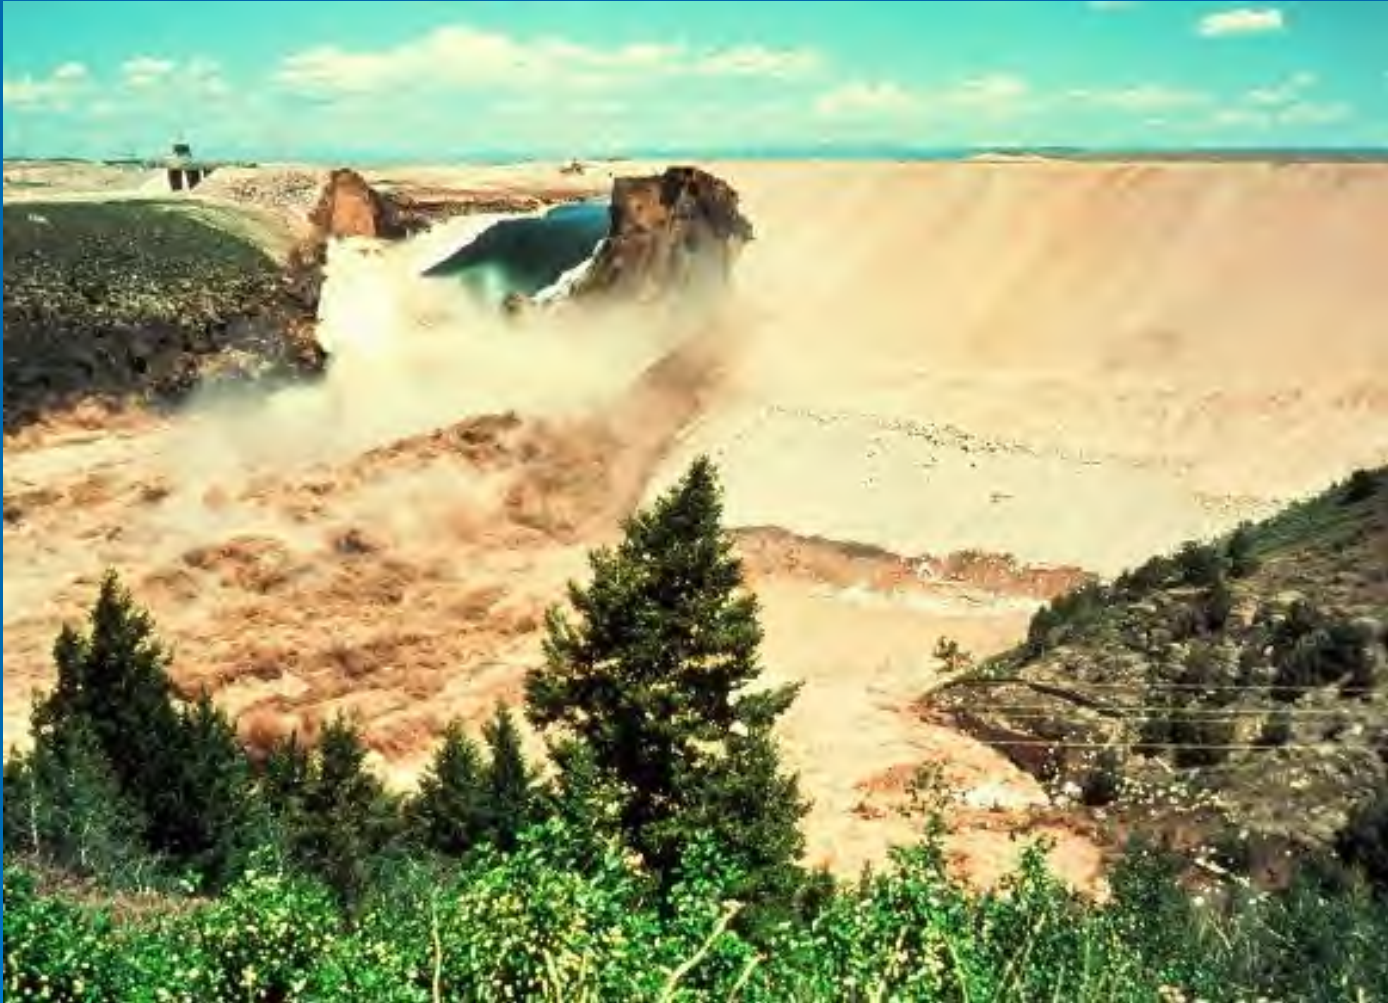
# The Teton dam, June 1976

- Failed on first filling
- Cause - internal erosion
- Deaths 14

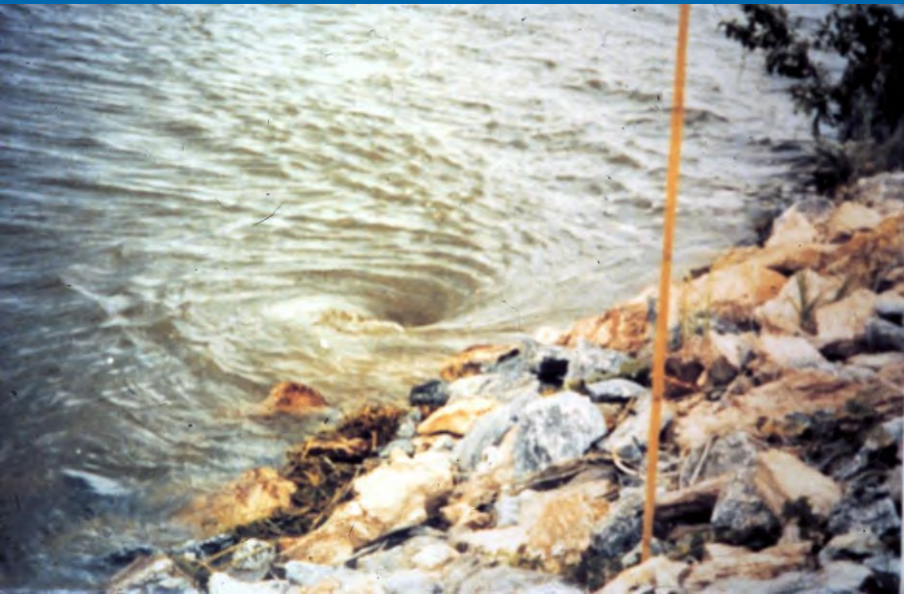
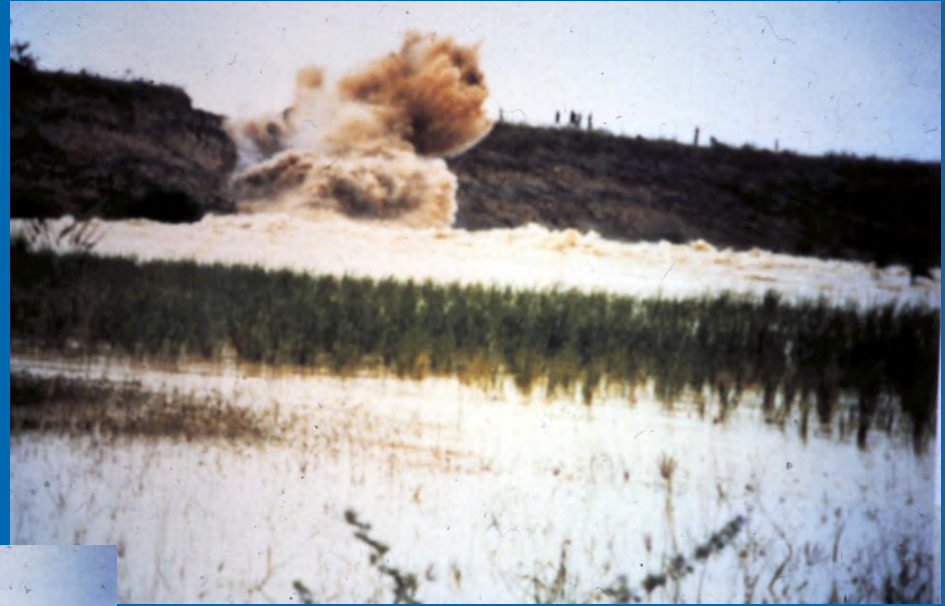
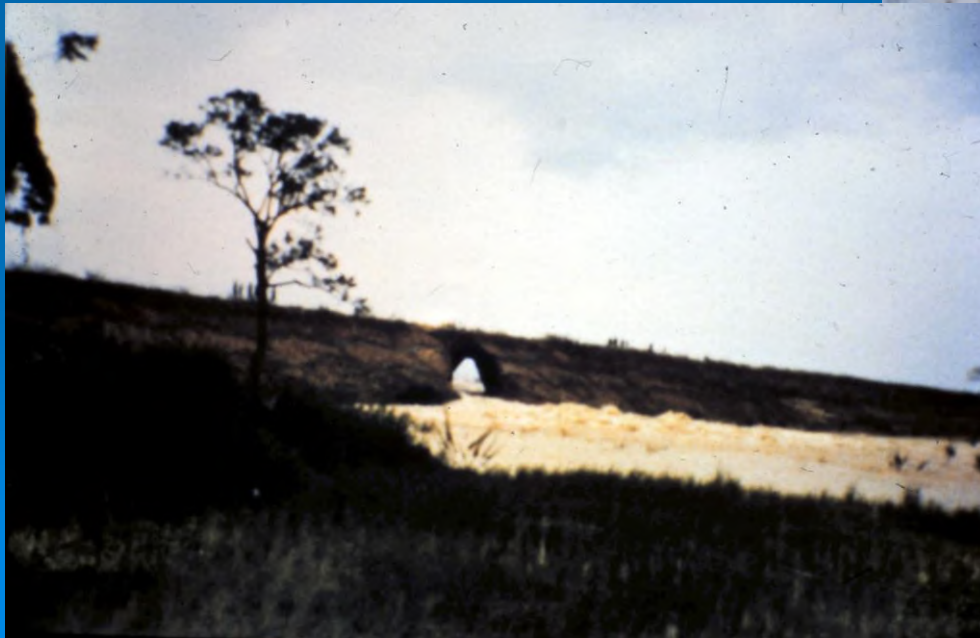
# Huai Takien, Thailand

10m high, built with dispersive clay  
Failure on first filling 1983 over  
period of 8 hours.

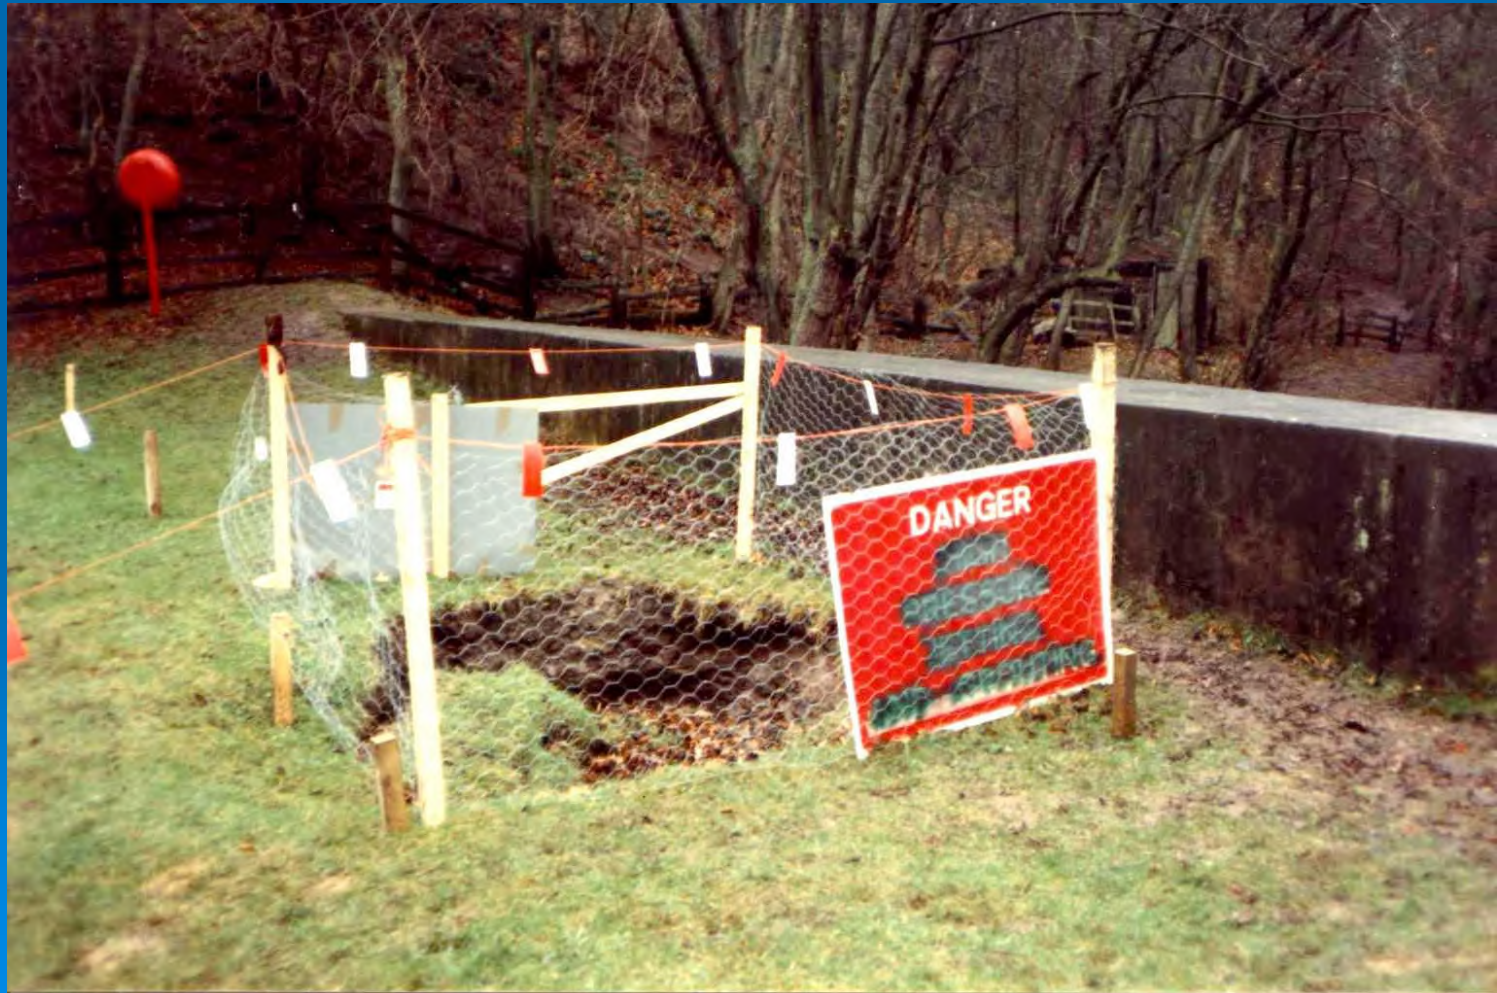
# Oakdale Lower

Nov 1986 sinkhole appeared without warning

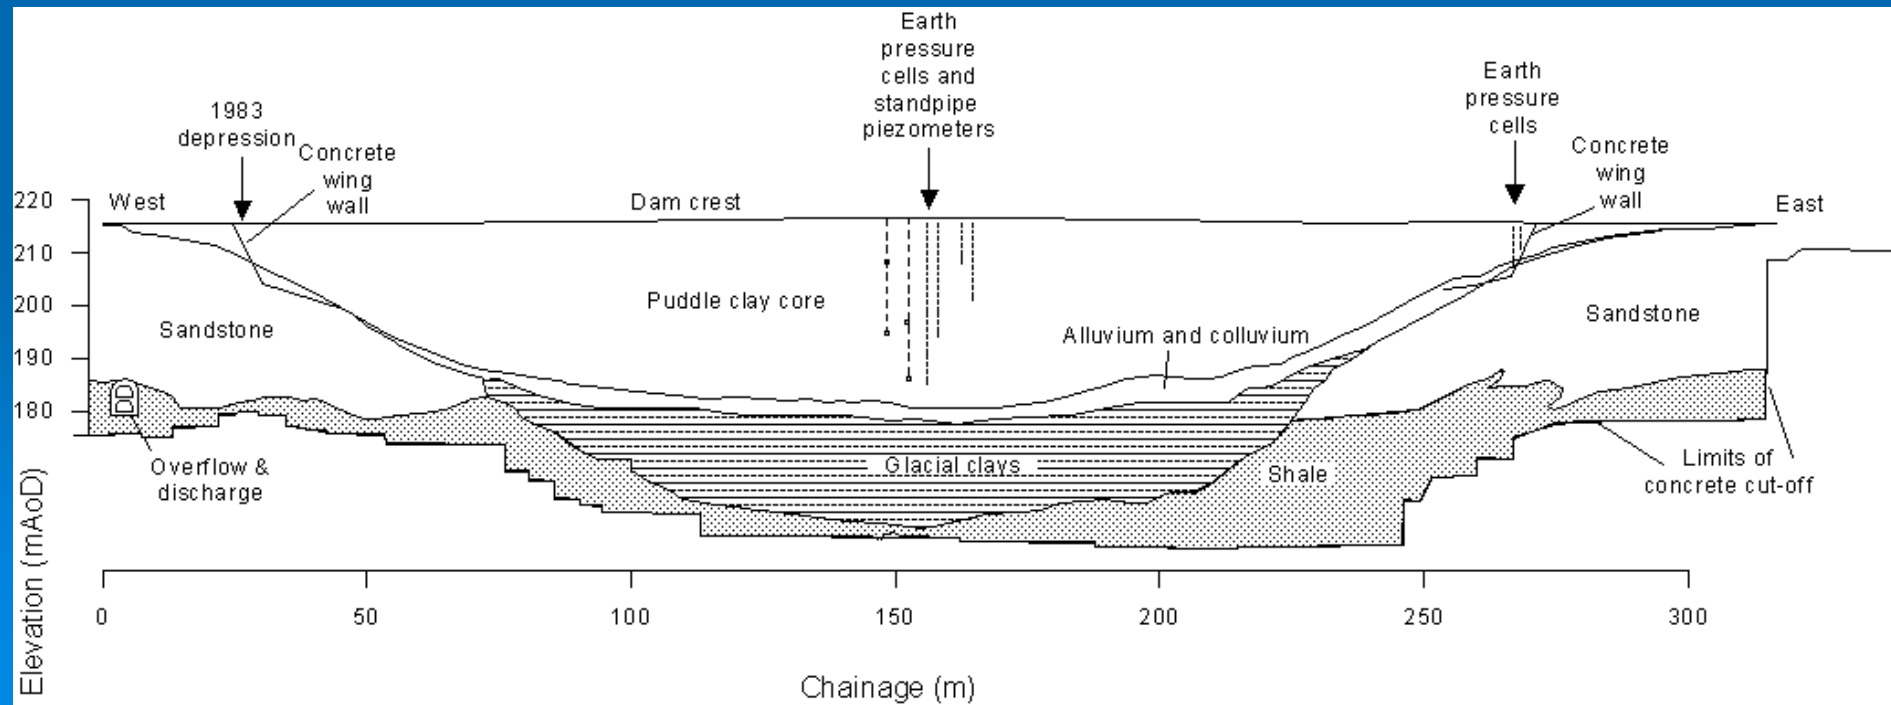
# Longitudinal section

2001 – Borehole investigation for seismic assessment reveals connection between core and reservoir at 6.7m depth in the central part of the dam.

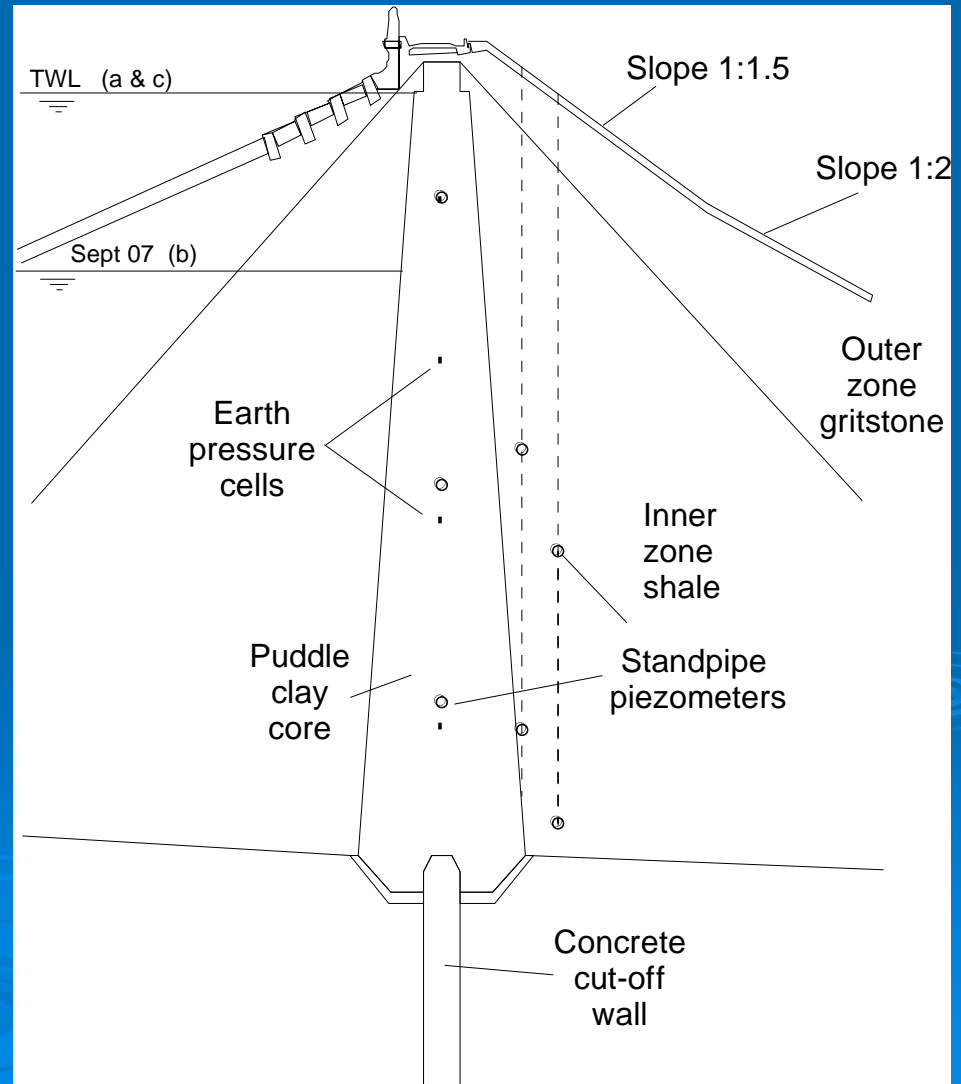
Pressure cell observations September 2004 with reservoir at TWL, six months after installation.

At 30m and 21m the measured earth pressure was significantly less than the pressure due to reservoir head. At 30m, the difference was 9m head (90kPa).

At 7m and 14m, the measured earth pressure was larger than the reservoir head.

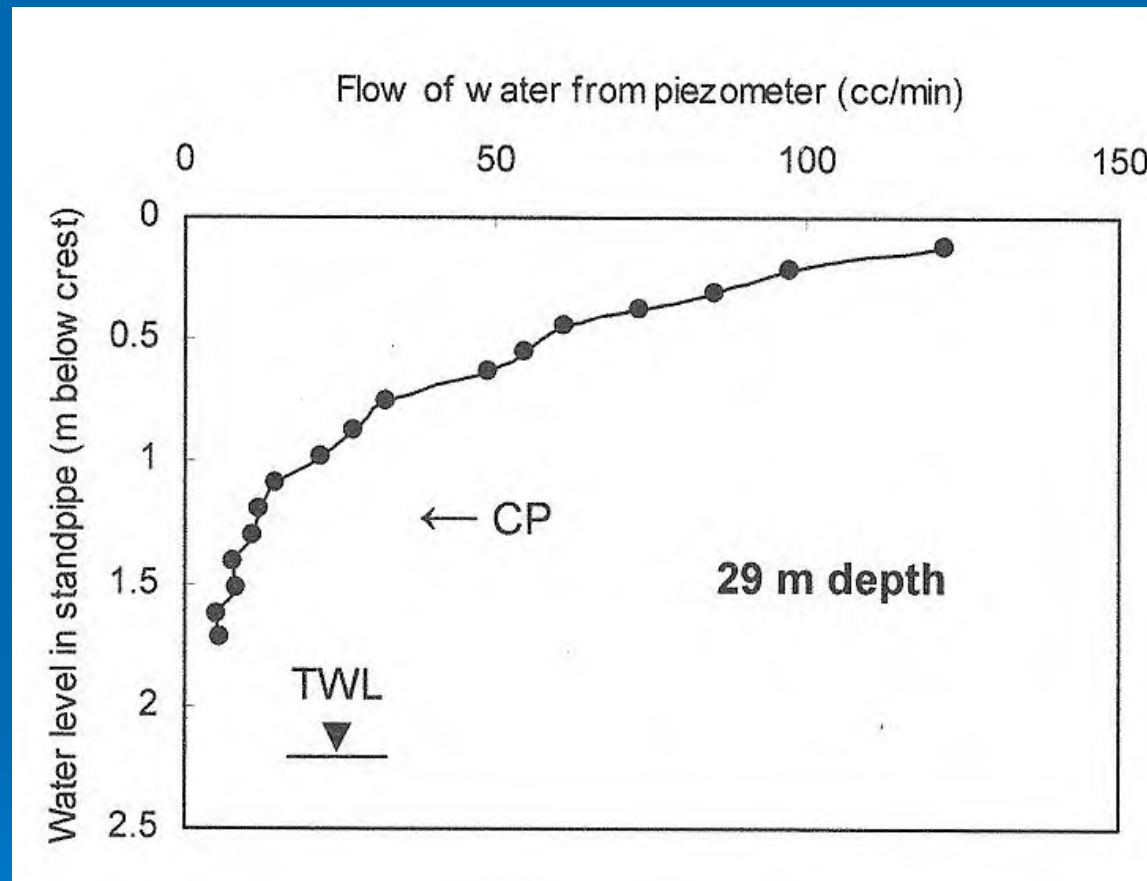
# Critical pressure tests at 29m

The tests suggest that the clay core is unlikely to be susceptible to hydraulic fracture at 21 and 29m depth

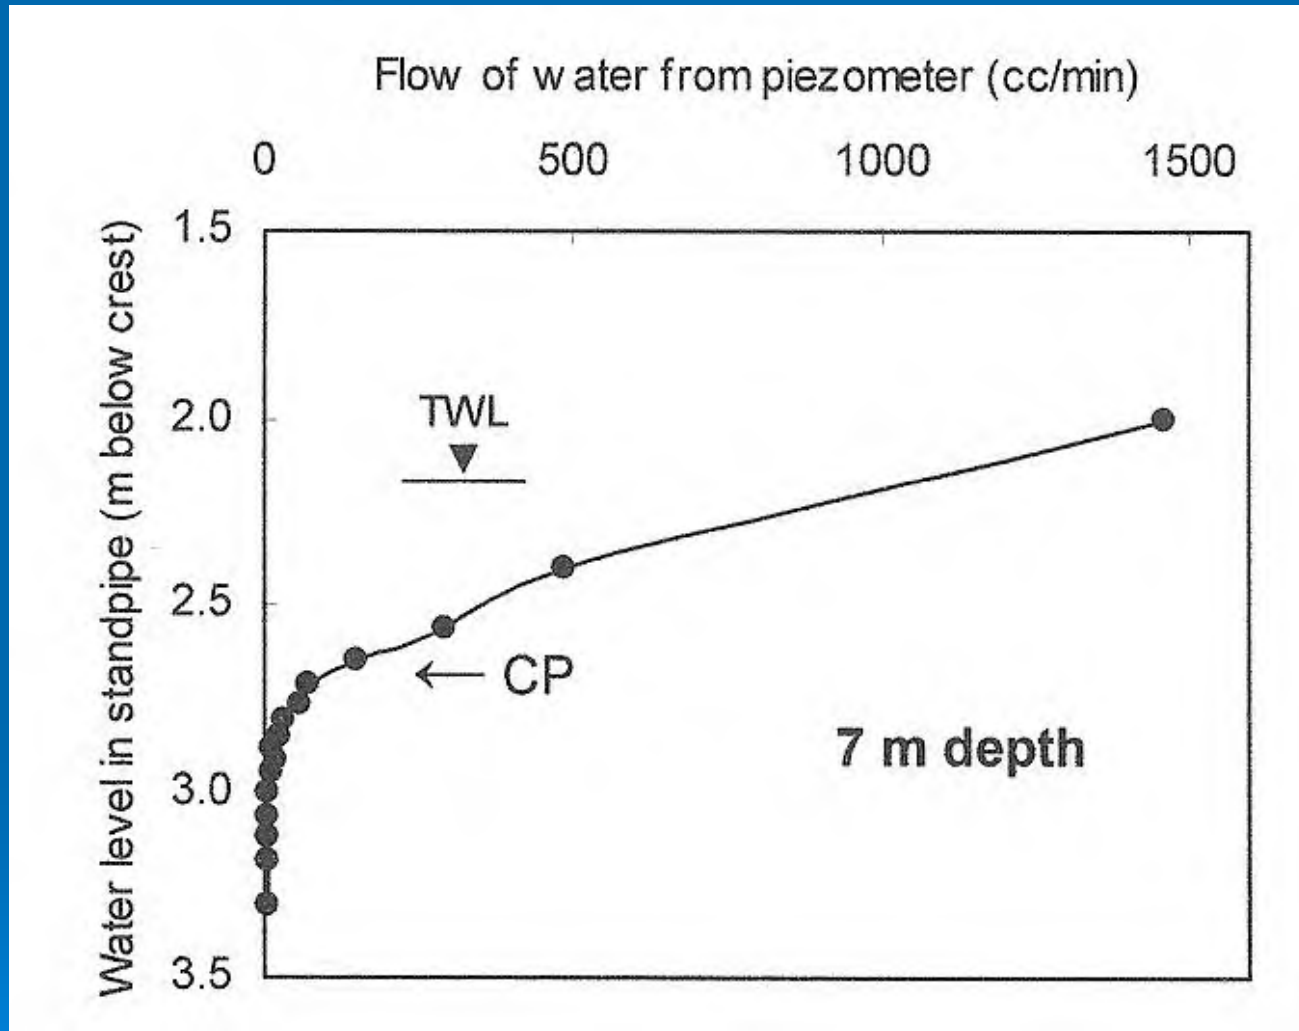
# Critical pressure tests at 7m

The tests suggest that the clay core could be susceptible to hydraulic fracture 7m depth
