The Performance of Thika Dam, Kenya

D. A. BRUGGEMANN, KBR, Leatherhead, UK J. D. GOSDEN, KBR, Leatherhead, UK

SYNOPSIS. Thika Dam is situated on the Thika River about 60km north of Nairobi in the foothills of the Aberdare Mountains where the river bed is 1985m above mean sea level (AMSL). The dam forms a major element of the Third Nairobi Water Supply Project which was constructed between 1990 and 1995.

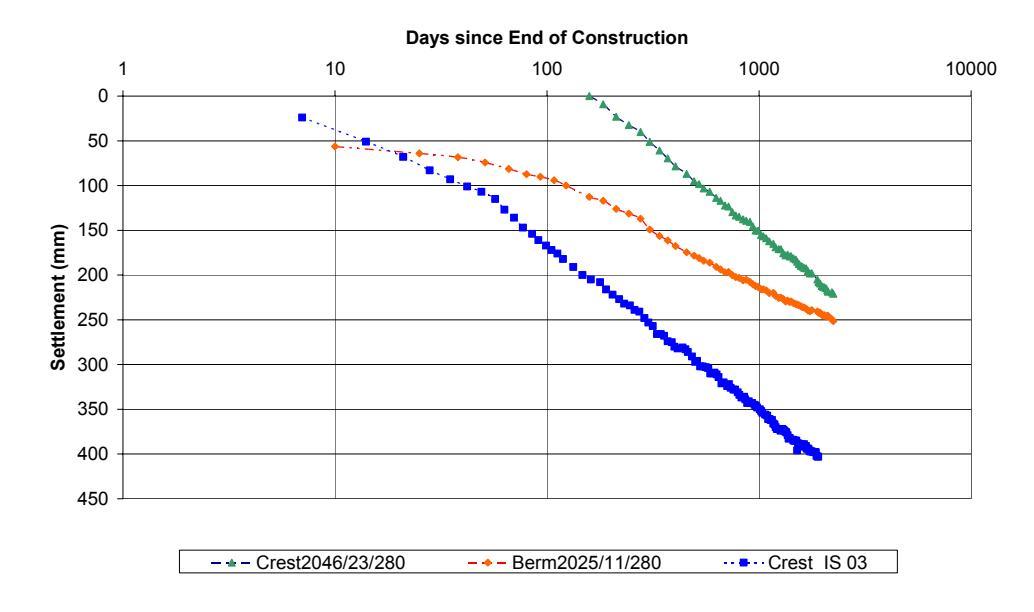
Figure 3 – Post Construction Settlement

Settlement was monitored by plate magnets incorporated in the inclinometer installations and by surface monuments. Figure 3 shows the post construction settlement of the crest and the downstream berm at elevation 2025mAMSL. Crest settlements are shown for the surface monuments and the top plate magnet on the crest inclinometer / settlement gauge. The record for the surface monument is shorter than that for the plate magnet because the surface monuments were installed only after the crest road and wave wall construction was completed.

The cumulative settlement of the crest, as measured by the top magnet, since the end of construction was about 400mm or 0.6% of the maximum embankment height. The crest was provided with a 1m camber and thus the settlement was still within design provisions.

The top magnet at the crest shows that there was a slight increase in the rate of settlement about 60 days after the end of construction and since then, at an average rate of about 55mm/year. The value of the crest settlement index, proposed by Charles (1986), was estimated to be 0.003. The index was developed for puddle clay core dams and a range of 0.002 to 0.074 is given in Johnston et al (1999), nevertheless the index for Thika Dam is at the lower end of the range and suggests the dam's performance appears to be in keeping with other types of dam.

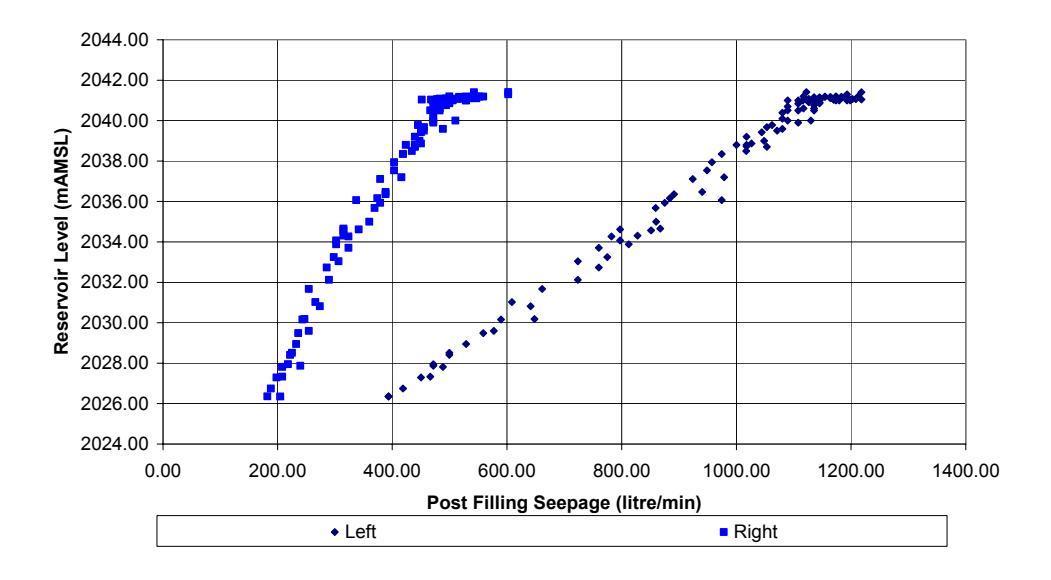
Figure 4 – Blanket Drain Seepage

Seepage through the dam is collected by the chimney drain which is connected to the foundation drainage blanket. The foundation drainage blanket was divided at the valley bottom so that flows from each side of the valley were monitored by V notch weirs. The seepage flow is plotted against reservoir water level in Figure 4. The maximum flow from the left hand side was about 1,200litres/minute (20litres/second) and from the right about 600litres/minute (10litres/second) to give a total seepage from the drainage blanket of about 1,800litres/minute (30litres/second). The minimum compensation release required downstream was 15,000litres/minute (250litres/second) and seepage flow made a contribution to the compensation flow.

The seepage estimates made at design stage were based on conventional hand sketched flow nets with the foundation permeability ten times the embankment permeability and an impervious cut-off. The seepage was estimated at 17litres/second.

This seepage is about 60% of the maximum experienced during operation of the dam and reinforces the recommendation of Cedergren (1967) that drain designs should be based on liberal factors of safety. The magnitude of the seepage experienced in the field suggests that care needs to be exercised in the estimation of the foundation bulk permeability from permeability values determined during the ground investigation.

The data shows that seepage from the left hand side was twice that from the right hand side of the valley. This behaviour could be a result of the foundation conditions on the left abutment, where a layer of boulders was encountered in the area of the jet grouted cut-off. The interlocking of the jet grouted columns was unlikely to be as efficient as when installed in residual soil, as on the right abutment. The greater seepage from the left hand side supports Casagrande (1961) that small imperfections in a cut-off can have a major influence on the overall performance of a cut-off.

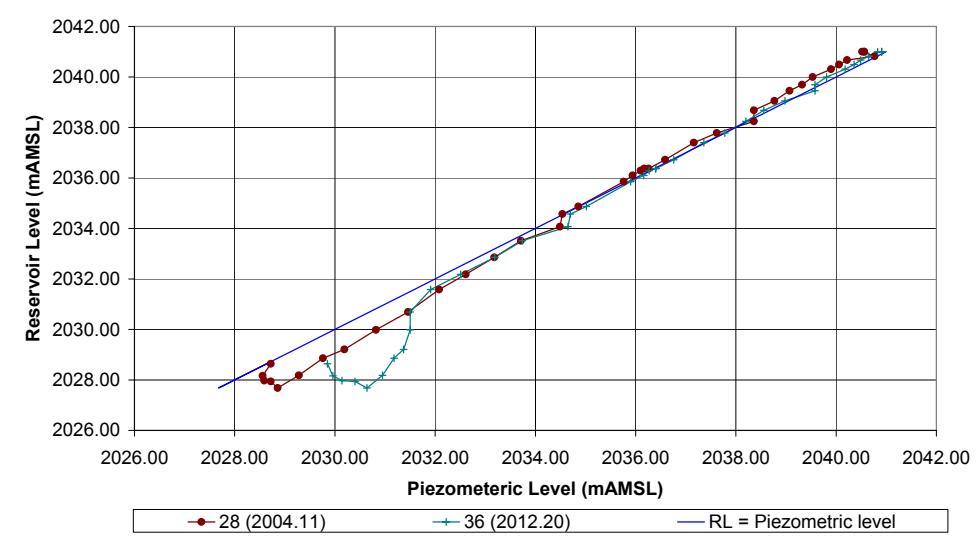
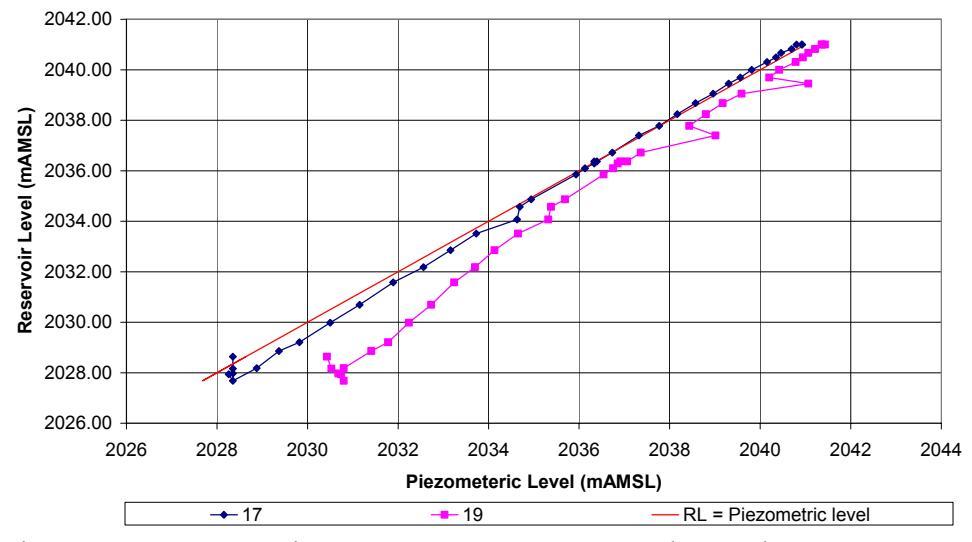
The response of four vibrating wire piezometers situated in the upstream shoulder to an operational drawdown is illustrated in Figures 5 and 6. At the start of the drawdown all four piezometers measured pore pressure

closely reflecting the water level in the reservoir. Although the fill material in both the shoulder and the core has relatively low permeability there is very little head drop in the upstream shoulder.

The drawdown took place between July 1998 and April 1999 from near top water level at 2040.8mAMSL to 2028.7mAMSL. The rate of drawdown initially averaged 0.04m/day but after reaching elevation 2034mAMSL it increased to around 0.1m/day.

At the slower rate of 0.04m/day the pore pressure response of the four piezometers was similar with Bbar ($\Delta u / \Delta \sigma_v$) values around 0.95. This value of Bbar reflects efficient drainage with the pore pressure dropping at the same rate as the reservoir. When the drawdown rate accelerated, the response of the piezometers varied with Bbar values dropping to between 0.6 and 0.9. At these values of Bbar pore pressures will lag behind the reservoir level reduction and the factor of safety of the embankment against slope stability failure will reduce. There is no obvious reason for the varying values of Bbar solely as a result of the location of the individual piezometers. This variation is more likely to be a reflection of local variations in fill material and preferential drainage paths.
