The Discontinuance of Dams – it's not easy and it can be expensive!

PROF AK HUGHES, Director of Dams & Water Resources, Atkins Ltd,
MRS ANNE EVANS, Severn Trent Water
MR ROB GALLOWAY, Severn Trent Water

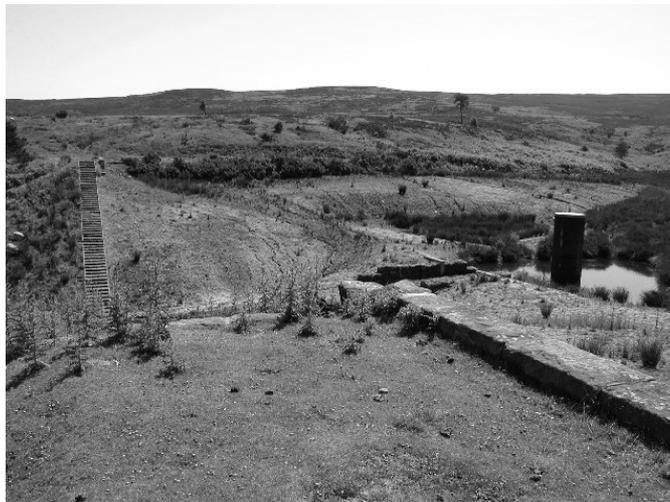
Fig 1: Disused Westworth Reservoir

Demolition eventually commenced in summer 2002 and progressed well once the contractor learnt to deal with clays and not top soil. The dam was breached by autumn 2002 and the stub ends of the dam trimmed with a toothless excavator bucket. This revealed the well-formed puddle clay core which was still well defined, very pliable. The core width increased by about the classic 1" horizontally for 1' depth on each face. However of much more interest was the defined shape of the original dam and the later clay addition as the dam was raised. The first dam's upstream toe was also discovered with the original stone valve tower base. This tower stonework

Reinstatement of the reservoir area was confined to spreading and grading the dam material. No 'artificial' seeding was carried out to encourage native species to colonise the area. This led to the spread material being exposed for a long time – and still not fully green – so the material became incised as stream paths developed with the eroded fine material deposited in the original stream beds that became quite fertile. Relatively lush growth has established in the streams retaining in flowing material and now water moves in a stream-delta formation towards the new outlet weir.

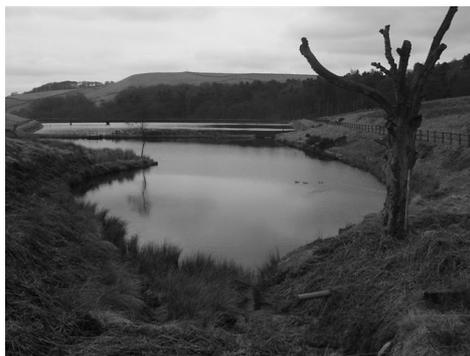
The Reservoirs were fed by Hogshaw Brook via a penstock into the top (small) reservoir. A bywash channel existed to the Western side of the reservoir to take excess flow when the reservoir was full. The construction of the reservoirs was concrete lined with brick facing on the lower basin & stone facing on the older upper reservoir. (Fig. 2)

Fig. 2: Upper reservoir looking in a southerly direction

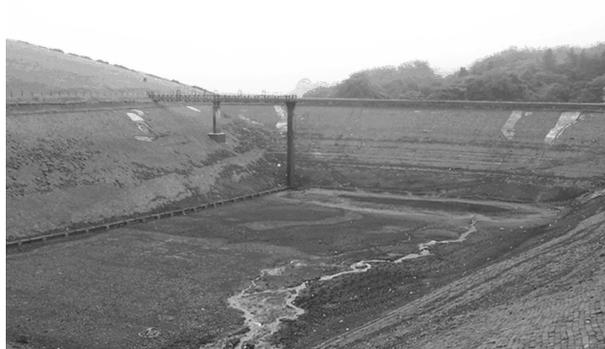
Fig. 4: Lower Reservoir Construction

The scope of the project was to drain down the existing reservoirs, break out the concrete and brick liners, demolish the water tower and valve chambers, cut a V-notch in the lower dam wall, and using the arisings from the dams to re-profile the sides of the reservoir to form a natural valley shape, with a stream at the base feeding 4 pools, which were created to encourage wildlife and aquatic vegetation. (Fig.5) All the materials arising from the earthworks including the concrete and brick were buried on site.

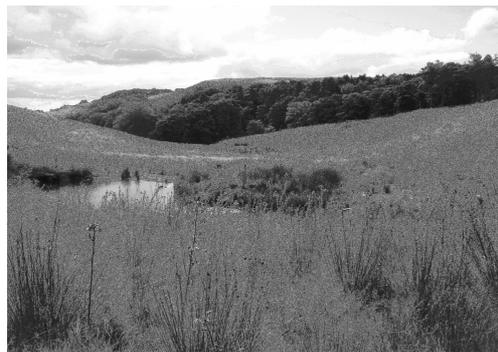
Fig. 5: View from position of top reservoir looking south

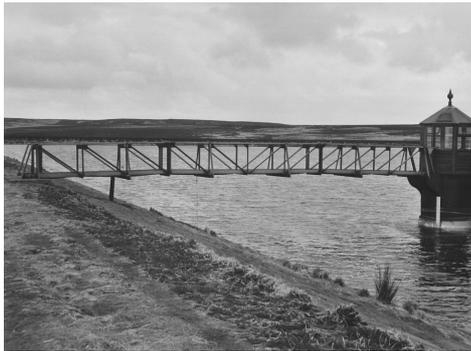
Draw-off arrangements were incorporated into a cast iron segmental valve shaft built into the upstream face of the main embankment (Fig. 5). Three levels of draw-off were connected to a downpipe and a common draw-off main laid within a cast iron, segmental tunnel, which has now been capped off. The main had been severed at the downstream end of the tunnel where water discharged into the tailbay and brook, which ran into the downstream and still existing Little Barbrook Reservoir. The iron and steel components of the tunnel shaft had become so severely corroded that safe operation of the draw-off valves was no longer possible. At the foot of the dam was the site of a water treatment works which was demolished many years ago. The reservoir had not been used for water supply since the mid seventies. The reservoir was also located within the Peak National Park and had been designated a SSSI.

Fig. 6: Valve tower and Bridge

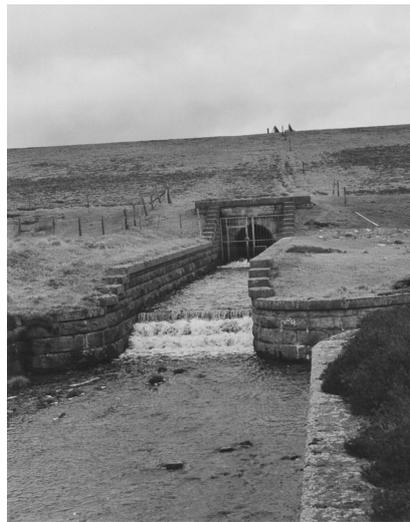
Barbrook Reservoir is situated on Big Moor, approximately 12 km northwest of Chesterfield, and had a catchment area of 3.4 km². (Fig. 6) The reservoir, formed by two earth embankments, had the main dam running NE/SW across Bar Brook, and the side dam at right angles to it, running SE/NW. Both dams had a central puddle clay core. A masonry step-overflow weir was situated at the north east end of the main dam, with the spillway channel running down the northeast mitre where it joined the tunnel tailbay channel. (Fig. 7).

Fig 7: Masonry step overflow weir

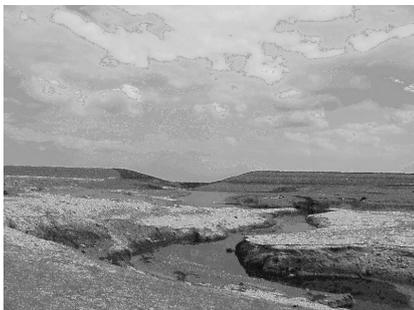
The course of the brook was allowed to form naturally through the reservoir basin (Fig 8). From historical records the brook appeared to return to a similar course to that which existed before the dam was built.

Fig. 8 Course of stream allowed to follow natural course

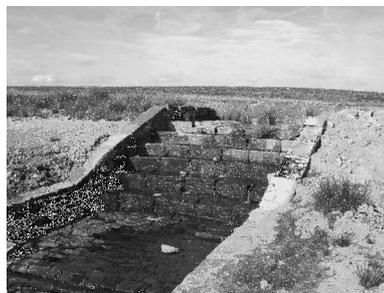
Fig. 9: Stone weir discovered buried

There was a flexible approach to the work on site. The stone weir shown below was discovered buried in the silt after work started. It was decided to utilize it as part of the reinstated water course and to form a pool near the head of the reservoir.

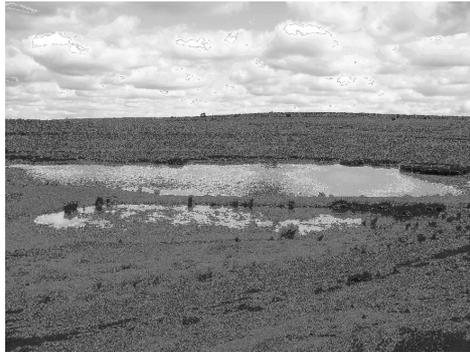
Fig. 10: Pools created in reservoir basin

As part of the habitat creation work clay excavated from the core of the dam was used to create pools in the reservoir basin. (Fig. 10). One of the aims of the project was to retain and reuse materials on site as far as possible. In the event only scrap metal from the draw off tower and some timber had to be removed from site.

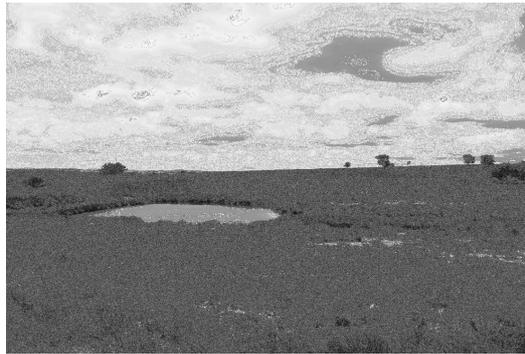
A single contract was let for the discontinuance of both Barbrook and Ramsley reservoirs. The project aims at Ramsley were similar to those at Barbrook but on a smaller scale. (Fig. 11). It also did not have the problem of having a sizeable water course running through the basin.

Fig. 11: Pools created in reservoir basin

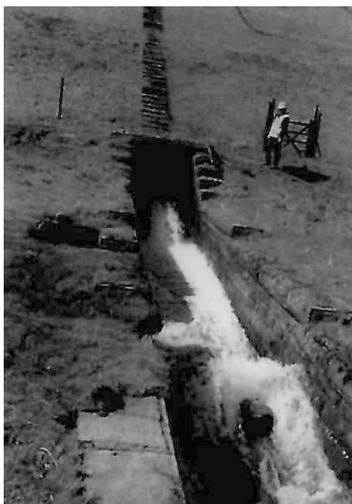
Fig. 12: Spill channel

The embankment was breached by cutting a 'V' notch in the embankment at the position of the draw off tower and culvert and forming a channel through the notch to allow all incoming waters to exit the reservoir basin into the spill channel at the toe of the dam (Fig. 12). Before work could start an inlet diversion ditch had to be dug to divert the inlet water from the inlet weir to the spill channel (Fig. 13).

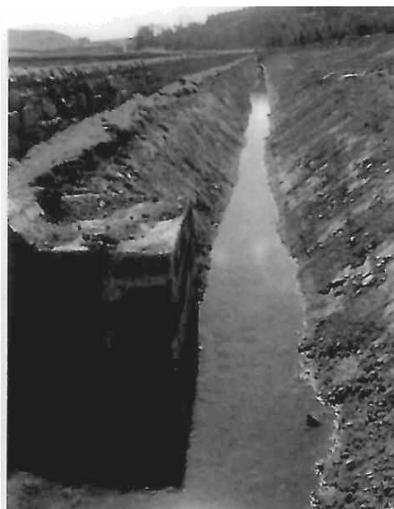
Fig. 13: Inlet diversion ditch

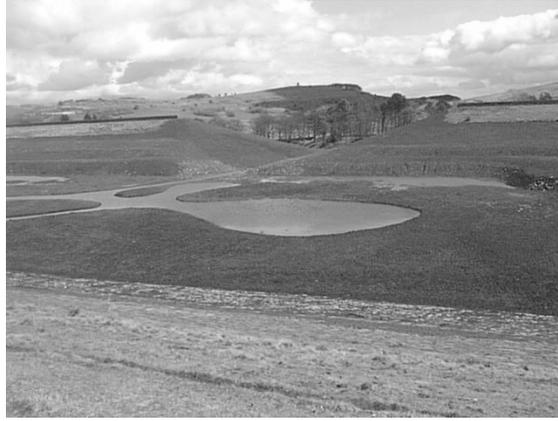
(‘V’ notch location)

Fig. 14: View of the reservoir from the west showing the ‘V’ notch, pools and embankments formed in the reservoir basin.

All the excavated material and masonry lining resulting from the formation of the notch was retained on site to line the bottom of the reservoir, pools and scrapes for habitat creation and embankments within the reservoir basin. The masonry lining removed from the area of the 'V' notch was used to line the new channel and the surplus buried under the mounding formed from the excavated material. It was not considered economic to sell the surplus stone.
