# **The Management of Siltation at Hillsborough Dam, Tobago**

D A BRUGGEMANN AND J D GOSDEN, Jacobs Babbie (formerly KBR)

## **SYNOPSIS**

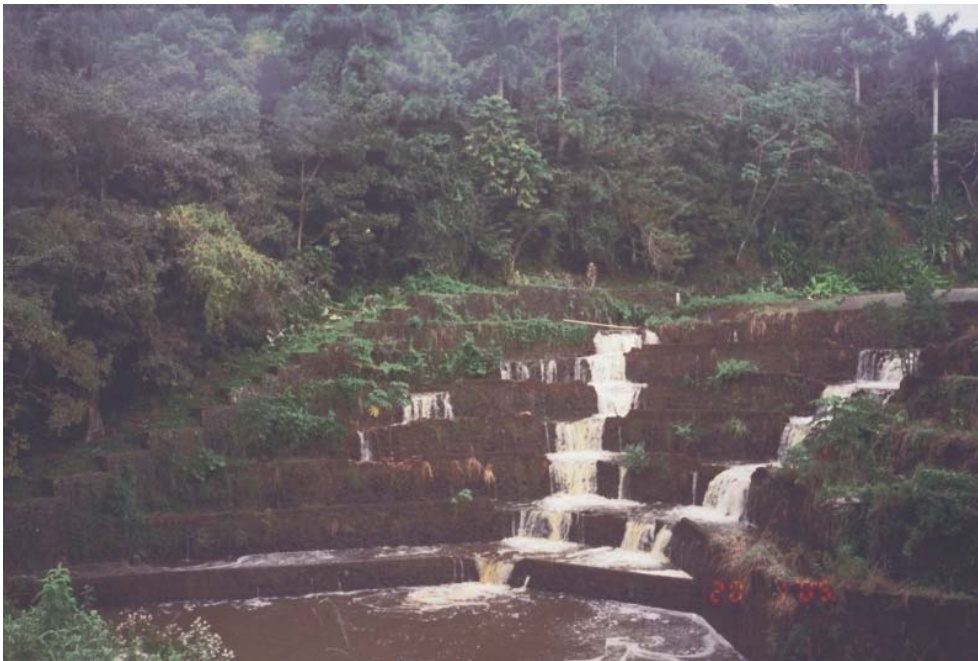
Figure 1 – Masonry spillway in need of rehabilitation

officially commissioned in 1952. The dam is about 18m high and comprises an earthfill embankment with a concrete core wall which was keyed into the foundations. The draw-works comprise a 450mm (18 inch) diameter draw-off pipe positioned on the upstream face of the dam, with draw-off valves at three elevations. A masonry cascade spillway (Figure 1) with a crest length of 30m is provided on the right abutment. The design capacity at maximum retention level is  $1.03\text{Mm}^3$  (about 227 million gallons).

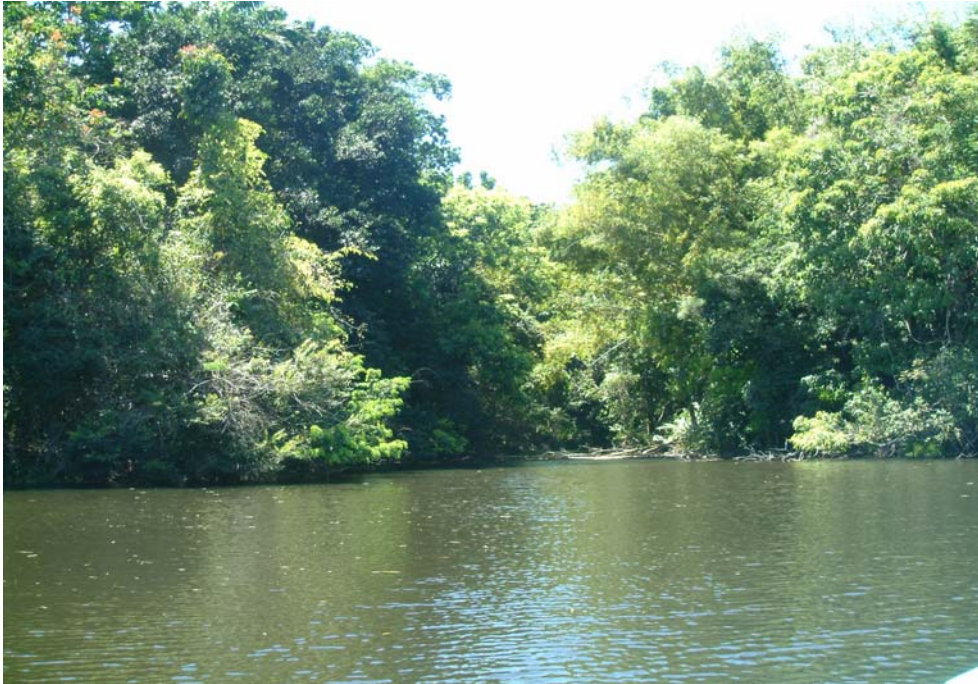
Figure2 – View of lake shore showing dense vegetation

The extent of siltation was difficult to determine because the datum used to derive the original Elevation – Volume curve was unknown, there was little published information on soil erosion studies for Tobago, bathymetric survey was hampered by dense vegetation (see Figure 2) which prevented access to the edge of the lake and the most recent aerial photography was more than 10 years old.

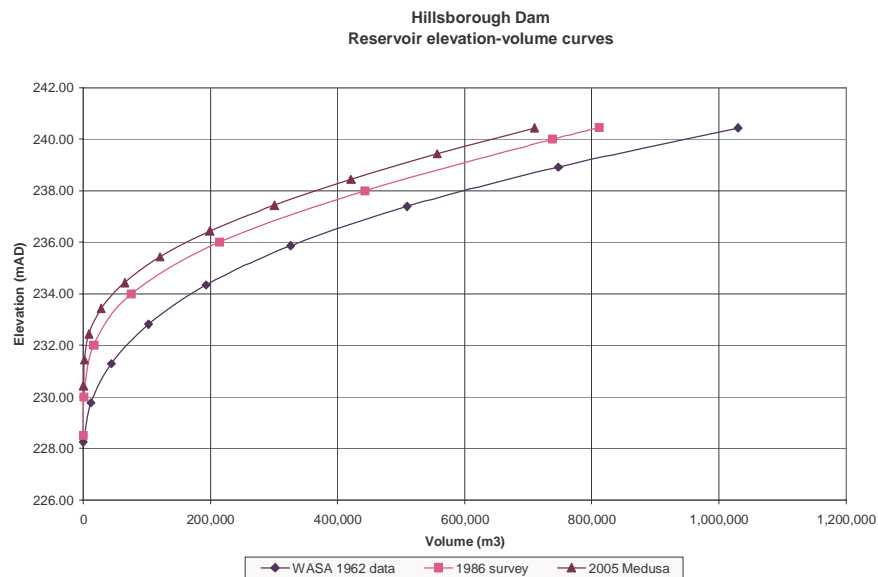
The results of the bathymetric survey were used to build a digital terrain model (DTM) of the reservoir floor and derive an up to date Elevation – Volume curve. The Elevation – Volume curves determined over the life of the dam are shown in Figure 3 below which indicates an ongoing loss of storage volume.

Figure 3 – Elevation – Volume Curves

Examination of the above Table shows that the comparison of the Elevation – Volume curves give relatively consistent sediment yields of 1,500 t/km<sup>2</sup>/yr

and 1,600 t/km<sup>2</sup>/yr. These estimates are also of the same order as that estimated from the published data on soil erosion rates and the readily dredgible volume from the current investigation. On this basis the volume of silt deposited in the lake was estimated at 320,000m<sup>3</sup> from the Elevation – Volume curves. The silt depth probing calculations estimated a volume of between 160,000m<sup>3</sup> and 210,000m<sup>3</sup> of silt. The probing penetrated soft to stiff deposited silt and therefore it was postulated that there was about 110,000m<sup>3</sup> of very stiff to hard silt that was not penetrated by the probe. The presence of compact layer of sediment is credible as the reservoir is drawn down to minimum levels frequently and thus cyclical increased effective stresses in the silt deposits over 50 years could create a highly consolidated and thus compact layer of silt.

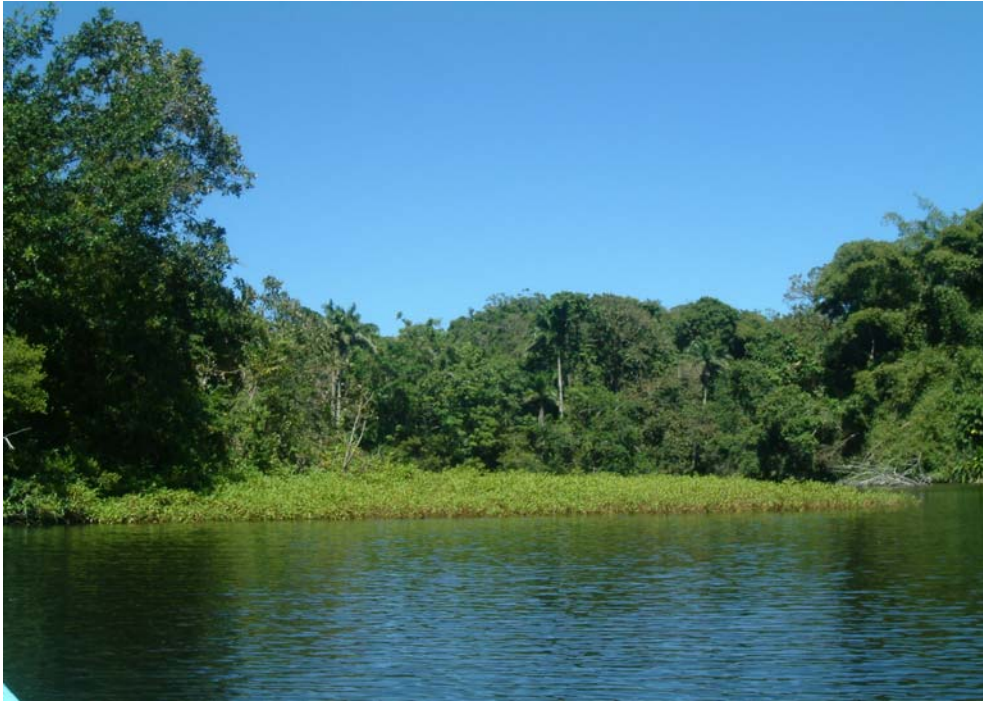
This behaviour is typical of reservoir siltation where silt deposition starts at the upstream end of the reservoir and migrates towards the dam. Additionally throughout the reservoir the extent of islands shown on the old mapping had also increased substantially through deposition of sediment in shallow water. The volume of silt deposited in these areas was estimated at about 60,000m<sup>3</sup>. A typical silted up inlet is shown in Figure 4

Figure 4 – Typical silted up river inlet

The head of the reservoir where the Hillsborough East River discharges into the lake was accessed from the reservoir side. This visit revealed that the river outlet area was completely silted up. Silting up of the tributary river outlets was also observed. The silting up of the reservoir inlets also has an impact on bathymetric surveys as the reservoir surface area at top water level has decreased over time.
