The Hull Tidal Surge Barrier refurbishment project

SYNOPSIS The Hull Tidal Surge Barrier project is a £10M refurbishment of the most important flood risk management asset in the Environment Agency's Yorkshire & North East Region. To put the importance of the barrier into context, without it a high surge tide would result in damages to Hull in excess of £230M with the flooding of 17,000 homes.

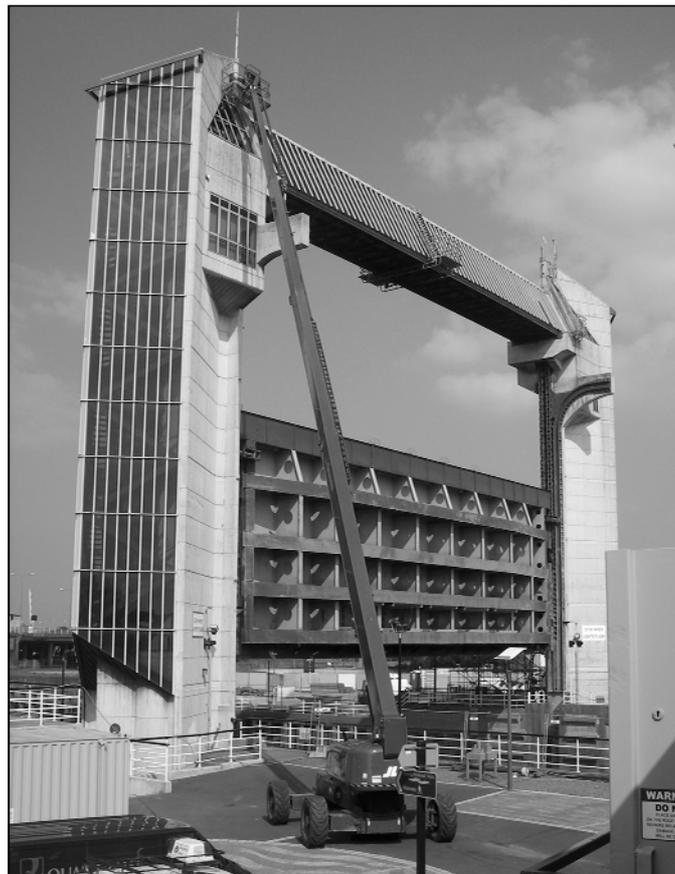
The barrier was built in 1980 and its operating mechanism, which lifts and pivots the 30m span x 10.7m deep x 212T gate in an "up-and-over" motion similar to a garage door, was suffering from wear and tear with the gate itself was suffering from corrosion. There was a significant risk that the barrier could fail to operate when needed and it required a total overhaul.

Figure 1 Gate in Part - Lowered Vertical Position

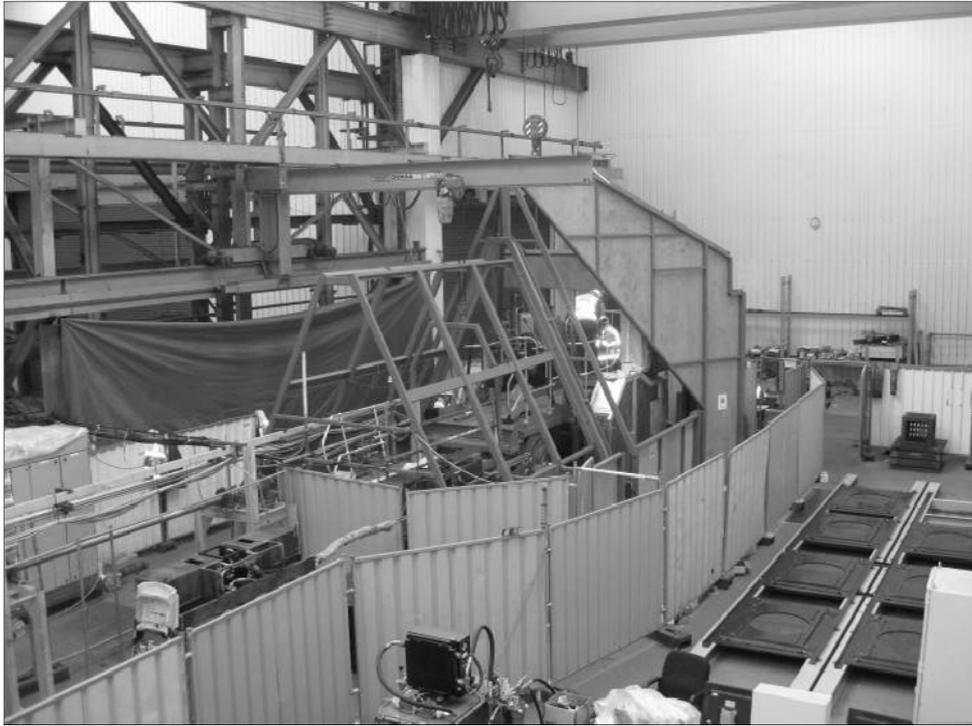
The full machine was built into a life size replica of the barrier machinery rooms within the Qualter Hall factory. Part of the factory roof was removed to enable components to be lowered in by crane and fed through the windows of the replica exactly as they would be on site

This included use of an innovative 'C' hook which was specially designed to facilitate safe lifting and placing of the heavy, large, and irregularly shaped components into the working space.

Figure 3 Works assembly of the New Hoist within the Tower Mock up

This process replicated and proved installation methods to be employed on site and tested the fitters ability to install the machine in the restricted working space. Test weights were also linked up to the mechanism to replicate part of the loads produced by the tidal barrier's gate.

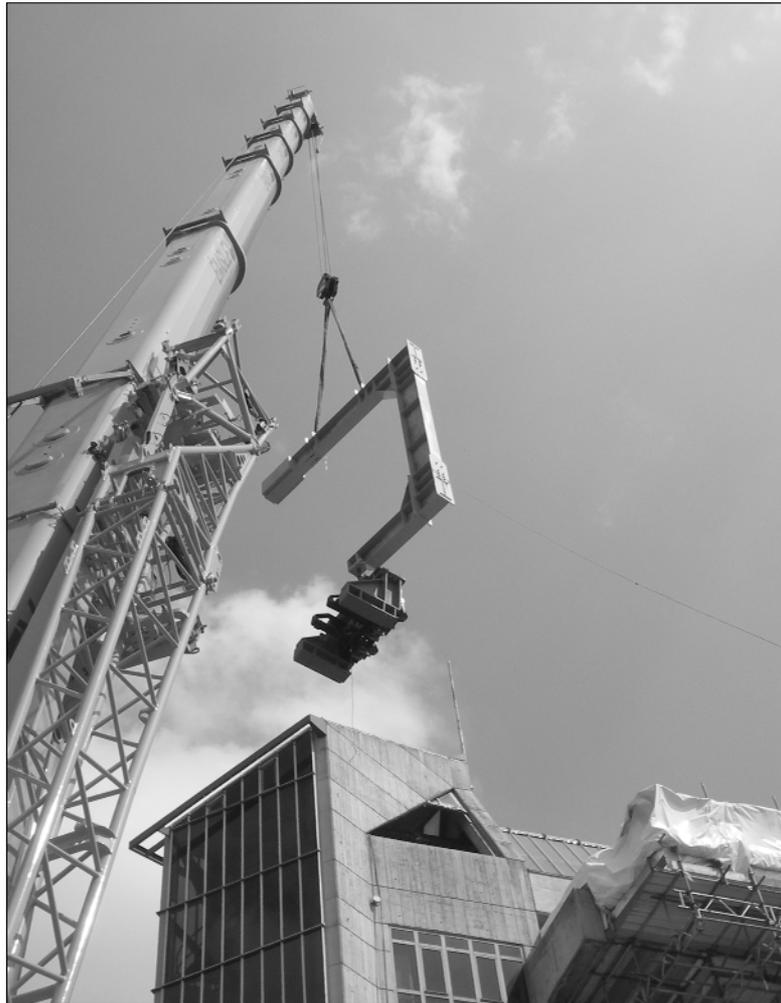
The picture below shows the C hook lifting in the bedplate. This was the first component to be installed once all the original machinery had been dismantled and removed. Meticulous planning was required to ensure components were delivered in the correct sequence and on time.

Figure 4 Lift operation using C hook
