LONG-TERM BENEFITS AND PERFORMANCE OF DAMS

Chapter 2. The use of new materials

Raising of the Ajaure embankment dam by extending the moraine core with a geomembrane

Design and performance of Elvington balancing and settling lagoons

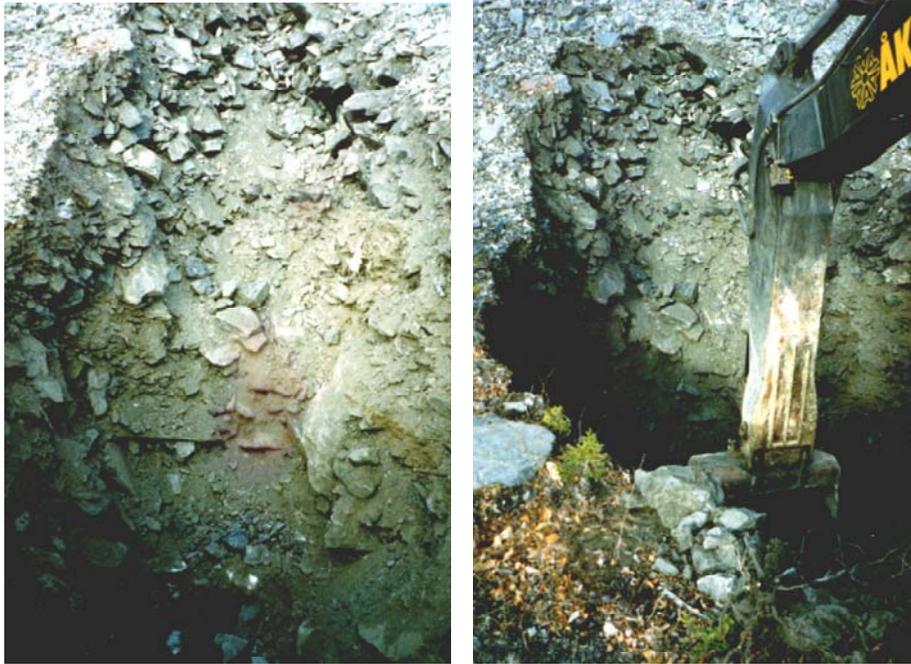
Figure 3. Test pits in the downstream toe of the original supporting fill

Laboratory shear tests showed that crushing of the material occurred to a large extent. The result of these tests established the weakness of the material at high shear stress, as well as exceptionally low shear strength of the material in the supporting fill. The low safety factor indicated that the shear stresses in situ were close to possible mobilized shear stresses at failure. It was concluded that the high shear stress, in combination with the cyclic loading from the reservoir, results in the progressive crushing of the rock fill and that crushing could be causing the continued horizontal deformations.

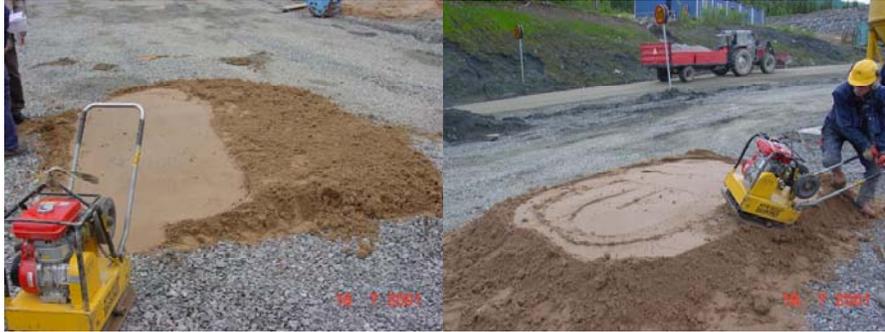
Figure 6. Field trials with BES. At left the trial surface is compacted in layers of 0.1 m and to the right the material is compacted in two layers of each 0.3 m at water content of 15 %.

The BES was tested to determine the optimum density, moisture content and bentonite content in order to achieve the required permeability. Pre-testing of the BES was performed using the following methods: wet screening; sedimentation analysis of material < 0,075 mm; and determination of the hydraulic conductivity at 95 % of Standard Proctor density. The mix was then tested in field trials seen in Figure 6.

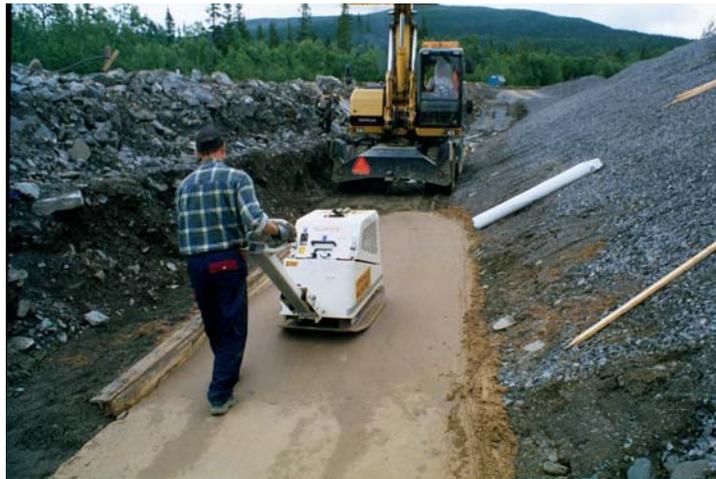
Figure 7. Compaction of the BES bedding layer for the membrane on the existing moraine core. To the right is the compacted coarse filter bedding for the geotextile.

The stripped existing core was compacted and then lightly scarified and sprayed with water immediately before placing the BES. A layer of BES was then placed as bedding for the membrane on the excavated core surface, Figure 7. The BES surface was protected against rain and drying using plastic covers while the geotextile was placed on the coarse filter, see Figure 8.

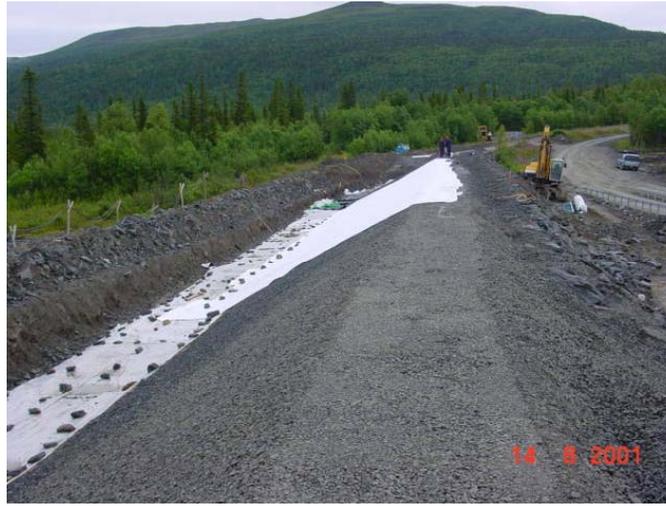
Figure 8. Placing of geotextile on the compacted coarse filter bedding. The textile is temporarily held in place by rocks.

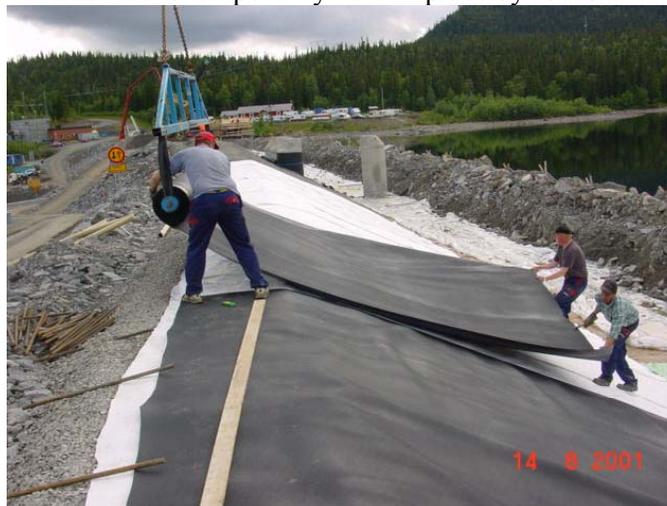
Figure 9. Placing of membrane on the geotextile. The BES (to the right in the picture) is temporarily covered by plastic to protect the core against the heavy rainfalls that occurred during construction.

The next step in the construction sequence was to place and weld the membrane on the slope directly on the geotextile, see Figure 9. As the membrane was placed at an inclination of 1V:2H a temporary anchoring was required at the top of the membrane. This was carried out by nailing the membrane in its upper end with 1 m long, \varnothing 20 mm, reinforcement bars. The load of the fill material on the top part of the membrane as described above achieved the permanent anchoring.

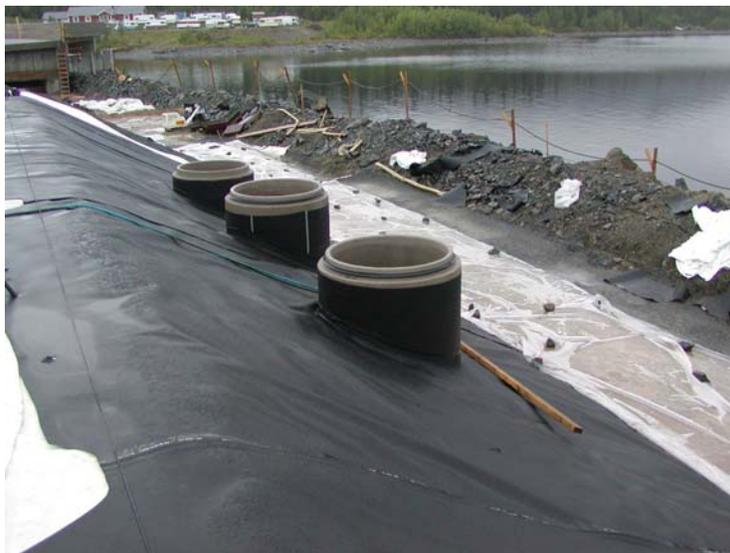
Figure 11. Protected connections through the membrane for instrumentation in the downstream filter.

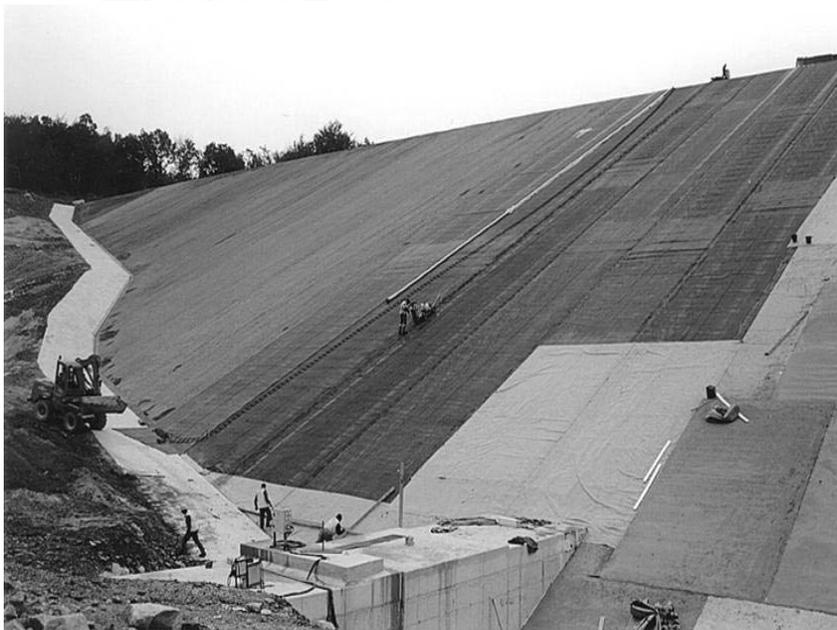
Figure 2: Work in progress at La Galaube

- 10 cm layer of non-bound material, with a 0/20 mm grading, impregnated with bitumen emulsion, to regulate the slope. This required 5,000 tonnes of limestone from a nearby quarry, deposited from the crest and leveled using 2 laser-guided bulldozers.
- 10 cm layer of cold asphalt mix, with a 0/10 mm grading, to ensure the final regulating of the upstream face before laying the geomembrane. This was to be a semi-impervious layer designed to a) reduce leakage flow through the waterproofing structure in case of accidental damage to the geomembrane, and b) to overcome the problems experienced in Corsica, of premature flooding prior to completion. Laboratory studies were carried out to determine the recipe of the cold mix asphalt required in order to achieve permeability around 10^{-6} m/s, as well as ensuring that a workable mix could be achieved.

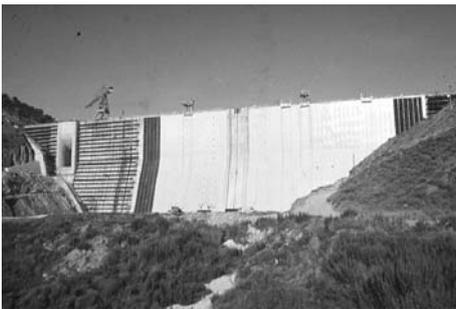
Figures 2 & 3: Pracana 65 m high buttress dam in Portugal, affected by AAR, was waterproofed with an exposed PVC liner in 1992. In 2003 (at right), the owner reports “the concrete dam waterproofing may be assumed to contribute for the reduction of the swelling process”.

The exposed drained PVC geomembrane system was installed in the dry season of 1992, in 5 months, concurrent with major rehabilitation works including construction of a new foundation beam and grout curtain, two sets of concrete struts on the downstream face, local grouting of larger cracks and mass grouting of smaller cracks, construction of a new spillway and a new water intake. Since 1992, the behaviour of the geocomposite waterproofing system has been monitored in respect of leakage and its capability of dehydrating the dam, reducing the water content feeding the AAR. At ICOLD's 21st Congress, the owner reported that the dam waterproofing might be assumed to contribute for the reduction of the swelling process (Liberal et al., 2003).

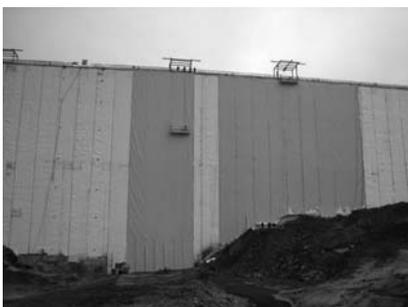
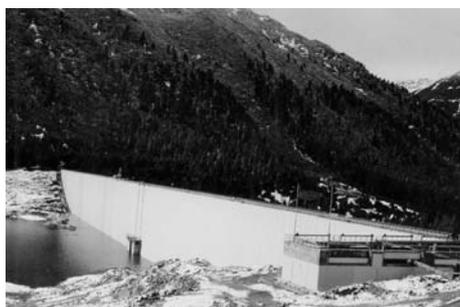
Figures 4 & 5: Beli Iskar 49.7 m high masonry dam, Bulgaria 2002. The exposed PVC geocomposite is installed on an anti-puncture geotextile. The dam is at 1878 m of altitude, ice thickness up to 0.60 m.

The geocomposite is anchored along vertical lines to the masonry by the same patented tensioning assemblies used for concrete dams. The masonry surface was regularised with a layer of mortar under the anchorage assemblies, to provide an even surface for welding of the PVC sheets. Adjoining geocomposite rolls were watertight heat-welded with manual one-track method.

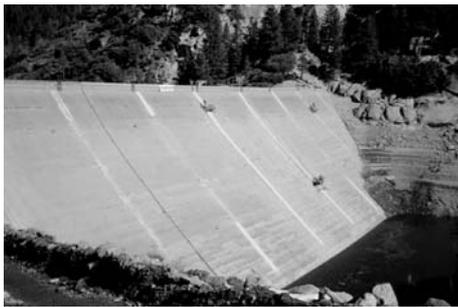
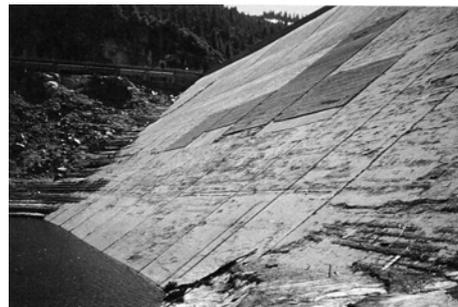
Figures 6 & 7: On the left, Strawberry 43 m high CFRD, USA 2002. The exposed PVC geocomposite was installed as external waterstop on the failing joints. On the right, Salt Springs 101 m high CFRD in USA. The exposed PVC geocomposite will be installed in 2004 to stop seepage across the upper 2/3 of the dam face.

Although the Phase 3 work is yet to be performed and the reservoir was filled in May 2002, and the recorded leakage has been about 85 percent below the 1998 leakage rates, more than adequately meeting the acceptance criteria (75 % requested for the all joints) and well below the historic levels.

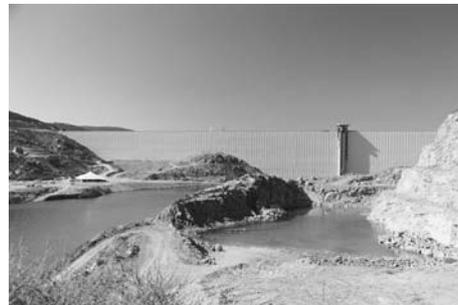
Figures 8 & 9: On the left, Miel I in Colombia, 2002, at 188 m the highest RCC dam in the world. Total leakage from the exposed PVC geocomposite at fully impounded reservoir is 2 l/s, mostly coming from abutments. At Olivenhain 97 m high dam on the right, USA 2003, highest and largest RCC dam in USA, the exposed PVC geocomposite was adopted to assure watertightness in case of a seismic event. At 50% impounded reservoir total leakage from 38,880 m² upstream face is 0.18 l/s.

The waterproofing system is conceptually the same adopted at Miel I. The PVC geomembrane is 2.5 mm thick, and the drainage system differs in that the number of compartments is lower, and there is an additional drainage geonet over the entire upstream face.

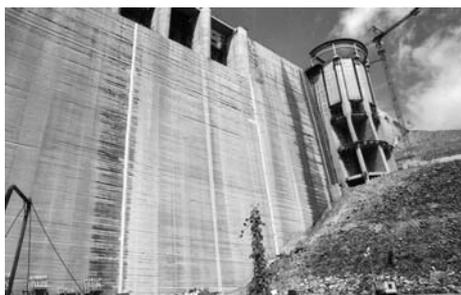
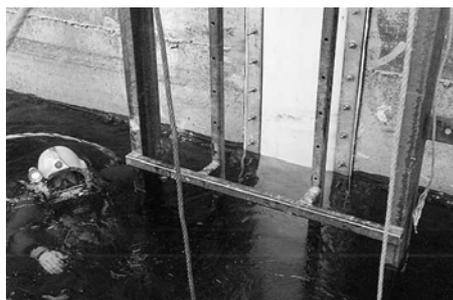
Figures 10 & 11: On the left, the external waterstops on the contraction joints of Porce II 118 m high RCC dam (Colombia 2000). The same external waterstops were installed in 1998 on Platanovryssi 95 m high RCC dam in Greece. In 2002, the external waterstop was used again at Platanovryssi, to repair a new crack that formed during first impoundment. Installation was performed underwater (on right).

Works started on April 22, 2002 and were completed on May 23, 2002. The leak through the dam has been fully stopped and the downstream face in the vicinity of the previous leaking joint is now dry.

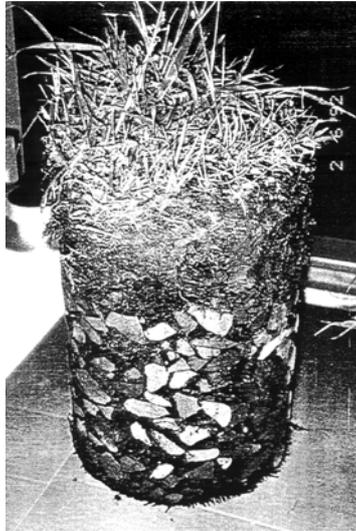
Figure 1: Drilling core extracted from a revetment of Open Stone Asphalt at the project Tielrode (B) with a layer of humus for planting vegetation (Source: ELSKENS 1995)

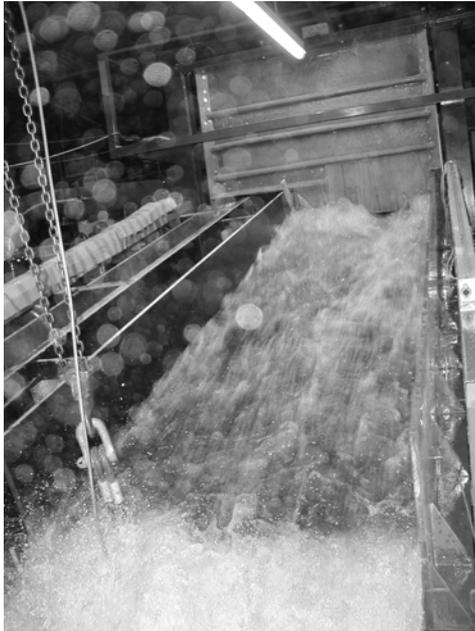
Fig 4: Tilting flume – Self supporting Open Stone Asphalt revetment under a load of $q = 360 \text{ l/(sm)}$ at a slope of 1: 5

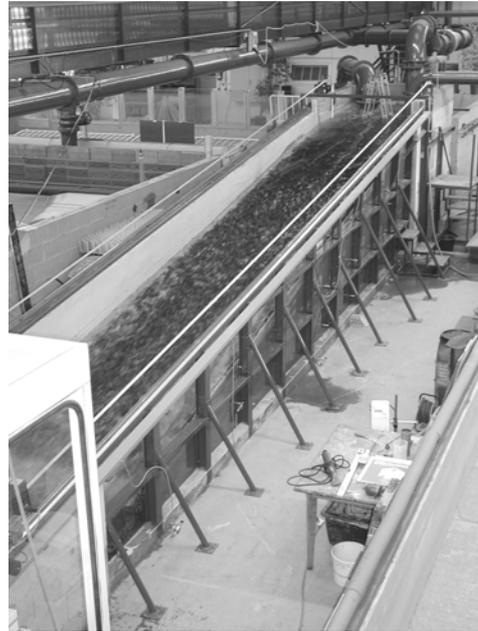
Fig 5: Half dam model for overtopping tests at a slope of 1 : 6 during operation

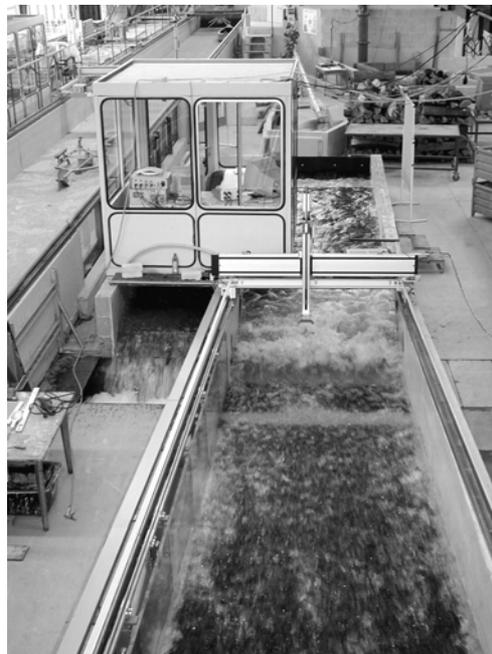
Figure 6: Energy dissipation at the toe of the slope – View from upstream (cf. Bieberstein et al. 2002)

An important aspect of the investigations was to optimise the intended energy dissipation at the transition from the slope to the horizontal area, in order to protect the downstream area from erosion. This was achieved by creating a hollow secured with Open Stone Asphalt acting as a scour protection in the transition area between the slope and downstream the toe. The forces and loads arising during energy dissipation are absorbed by the safety element and discharged to the subsoil. Due to the form of the hollow the hydraulic jump cannot move into the unsecured tailwater (see Fig. 6).

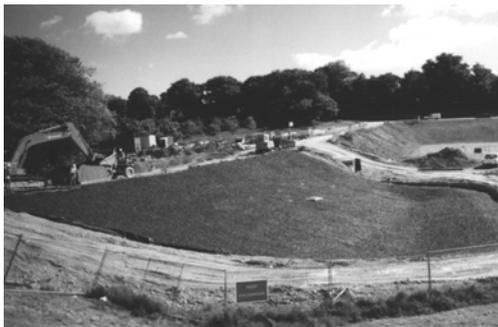
Fig 9: OSA erosion protection as installed

- The in-situ material follows all contours of the stilling basin and is easily placed around manholes and other structures. No cutting of blocks is required.
- A flexible revetment will follow the settlements associated with new earthworks.
- The material is durable and resistant to vandalism and unexpected impacts. In the event of damage to the revetment, the bound nature of the material ensures that damage is not progressive as with a revetment consisting of individual elements.
- The irregular surface voids can support a wider variety of plants than the regular voids in blockwork. The uniformly sized 'pots' in the blocks may suit particular plants which then become dominant.
- A layer of OSA will retain moisture more efficiently than a layer of open concrete blocks where moisture can escape through the holes through the whole block.
- OSA is quick to install and competitive on cost.

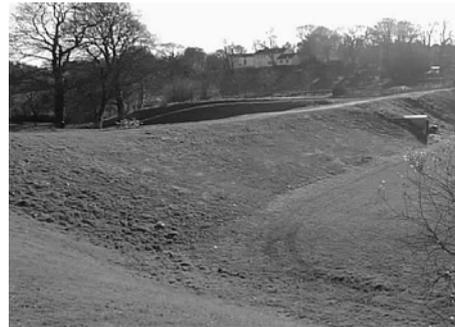
Fig 10: Downstream slope after topsoil/seeding
