## **Watertightness and safety of dams using geomembranes**

A M SCUERO, CARPI TECH S.A., Switzerland

**SYNOPSIS.** Impervious prefabricated geomembranes are a well-established technology to provide or restore watertightness in dams. Since 1959, they have been installed on all types of dams worldwide. The paper gives an overview of how the geomembrane systems have been applied and perform on different types of dams. Some significant case histories on concrete gravity dams, masonry dams, fill dams, RCC dams are presented.

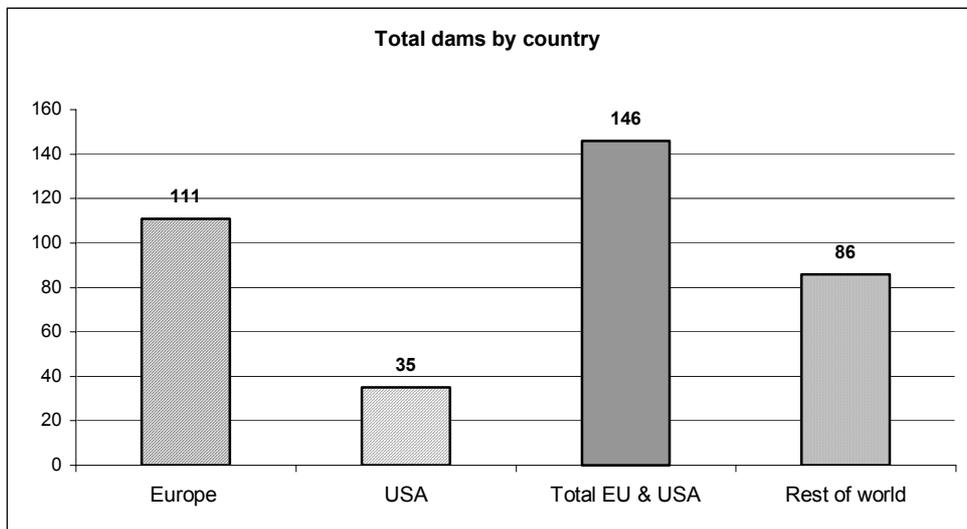
Figure 1: Total dams by country

Europe, with 111 dams out of 232, is still the leader, as already reported in 1998.

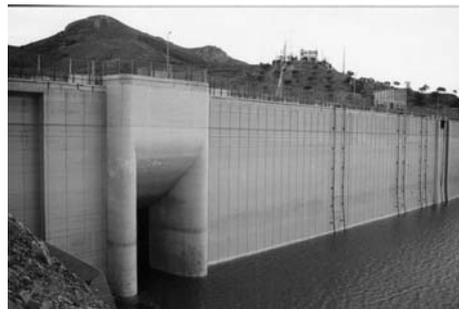
Figures 2 & 3: Pracana 65 m high buttress dam in Portugal, affected by AAR, was waterproofed with an exposed PVC liner in 1992. In 2003 (at right), the owner reports “the concrete dam waterproofing may be assumed to contribute for the reduction of the swelling process”.

Pracana is a 65 m high buttress dam in a seismic region of Portugal, built between 1948 and 1951, and owned by EDP, Electricidade de Portugal. In 1980, the dam was taken out of operation to undertake a thorough investigation of the deterioration related to the continuous concrete expansion phenomena. Investigations ascertained the presence of a secondary alkali-aggregate reaction (AAR), which would be further activated by infiltration of water from the reservoir, creating a critical scenario in respect to sliding conditions along horizontal cracks. Installation of a drained waterproofing liner on the upstream face was deemed necessary to stop water infiltration feeding the AAR, and to avoid the possibility of water exerting uplift in the horizontal cracks, especially in the case of a seismic event.

The exposed drained PVC geomembrane system was installed in the dry season of 1992, in 5 months, concurrent with major rehabilitation works including construction of a new foundation beam and grout curtain, two sets of concrete struts on the downstream face, local grouting of larger cracks and mass grouting of smaller cracks, construction of a new spillway and a new water intake. Since 1992, the behaviour of the geocomposite waterproofing system has been monitored in respect of leakage and its capability of dehydrating the dam, reducing the water content feeding the AAR. At ICOLD's 21<sup>st</sup> Congress, the owner reported that the dam waterproofing might be assumed to contribute for the reduction of the swelling process (Liberal et al., 2003).

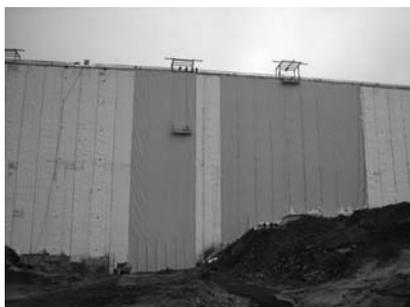
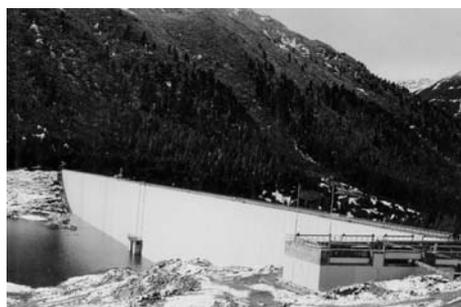
Figures 4 & 5: Beli Iskar 49.7 m high masonry dam, Bulgaria 2002. The exposed PVC geocomposite is installed on an anti-puncture geotextile. The dam is at 1878 m of altitude, ice thickness up to 0.60 m.

Beli Iskar is a 50.7 m high rough rock masonry dam located in the highest part of Rila Mountain, in Bulgaria, at 1878.70 m a.s.l. In 1950, the upstream face was coated with “Inertol”, between 1976 and 1978 the leaking joints were repeatedly repaired with “Soral”, and the face with resin coating. These repairs were washed away. The exposed drained PVC geomembrane system was installed in 2002.

Preparation works included removal of debris and sediments to expose the rock masonry. A 2000 g/m<sup>2</sup> geotextile was installed on the masonry as anti-puncture protection to the PVC geocomposite. The waterproofing liner is SIBELON CNT 3750, a 2.5 mm thick PVC geomembrane coupled during fabrication to a 500 g/m<sup>2</sup> geotextile, and supplied in rolls as long as the section they cover.

The geocomposite is anchored along vertical lines to the masonry by the same patented tensioning assemblies used for concrete dams. The masonry surface was regularised with a layer of mortar under the anchorage assemblies, to provide an even surface for welding of the PVC sheets. Adjoining geocomposite rolls were watertight heat-welded with manual one-track method.

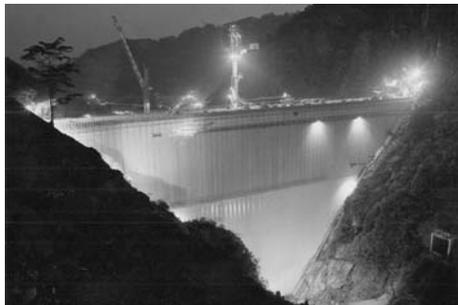
Figures 8 & 9: On the left, Miel I in Colombia, 2002, at 188 m the highest RCC dam in the world. Total leakage from the exposed PVC geocomposite at fully impounded reservoir is 2 l/s, mostly coming from abutments. At Olivenhain 97 m high dam on the right, USA 2003, highest and largest RCC dam in USA, the exposed PVC geocomposite was adopted to assure watertightness in case of a seismic event. At 50% impounded reservoir total leakage from 38,880 m<sup>2</sup> upstream face is 0.18 l/s.

Miel I is a straight gravity dam constructed in a narrow gorge in Colombia. At 188 m, it is the world's highest RCC dam. The dam crest, at an elevation of 454 m, is 354 m long and the entire upstream face is 31,500 m<sup>2</sup>.

To meet the contractual schedule, the original design of an upstream face made of slip formed reinforced concrete was changed to a drained exposed PVC geomembrane system, placed on a 0.4 m wide zone of grout enriched vibrated RCC. Due to the height of the exposed dam face, this double protection was considered necessary (Marulanda et al. 2002). The use of grout enriched RCC allowed applying good compaction of RCC mix at the dam face, assuring a good finishing of the upstream concrete surface. The RCC mix has a cement content of 85 to 160 kg/m<sup>3</sup>; total RCC volume is 1,745,000 m<sup>3</sup>. Contraction joints are placed every 18.5 m.

The waterproofing liner is a composite geomembrane, consisting of PVC geomembrane laminated to a 500 g/m<sup>2</sup> polypropylene nonwoven geotextile. In the deepest 62 m the PVC geomembrane is 3 mm thick, in the top 120 m it is 2.5 mm thick. The PVC geocomposite was installed over the upstream surface, after removal of the formwork. At the contraction joints, two layers of sacrificial geocomposite, of the same type used for the waterproofing liner, provide support-avoiding intrusion of the liner in the active joint.

The attachment system for the PVC geocomposite on the dam face is made by parallel lines of tensioning profiles assemblies, placed at 3.70 m spacing. Where the water head is higher, from elevation 268 m to 358 m, the stainless steel profiles have a central reinforcement. A seal watertight against water in pressure up to 240 m fastens the PVC geocomposite along all peripheries.

Olivenhain is an RCC gravity dam 788 m long and 97 m high completed in summer 2003 in California. It is the highest and largest RCC dam in USA. The dam is a key element of the Emergency Storage Project (ESP) of the San Diego County Water Authority, owner of the dam. About 90% of water is brought to San Diego from hundreds of miles away, and the aqueducts cross several large active faults, including the San Andreas fault. The ESP is a multi year program that will provide water to the San Diego region in case of an interruption in water delivery deriving from an earthquake or drought, thus allowing time to repair the aqueduct.

The waterproofing system is conceptually the same adopted at Miel I. The PVC geomembrane is 2.5 mm thick, and the drainage system differs in that the number of compartments is lower, and there is an additional drainage geonet over the entire upstream face.

The leakage rates from the system described are typically very low: at Miel I, in 2003 the recorded leakage at fully impounded reservoir level from the whole geomembrane system is 2 l/s, at Olivenhain, at 50% impounded reservoir total leakage from 38,880 m<sup>2</sup> upstream face is 0.18 l/s.
