## **Reconstruction of the Znojmo Dam – practical application of hydraulic research**

**SYNOPSIS.** Many dams and waterworks had been built in the Czech Republic during 1950s and 1960s. One of them is the Znojmo Dam. It is an earth dam with a combined spillway block. A nominal discharge of  $Q = 355 \text{ m}^3 \cdot \text{s}^{-1}$  was considered for designing the safety spillway. Extreme flood events which occurred in the Czech Republic in 1997 and 2002 evoked questions relating to the safety of dams. The nominal discharge of the Znojmo Dam safety spillway was enhanced up to  $Q = 610 \text{ m}^3 \cdot \text{s}^{-1}$ . Therefore, the decision on reconstruction of the Znojmo dam spillway block was made. The following modifications were proposed: sinking the existing spillway crest, replacement of the existing flap gates with tainter gates with flaps, installation of breakwater on the dam crest, and necessary modifications of the stilling basin. With regard to the importance of the dam and the volume of the reconstruction planned, assessment on a hydraulic model was necessary. This paper summarises the results of the hydraulic research and its practical application to the processi

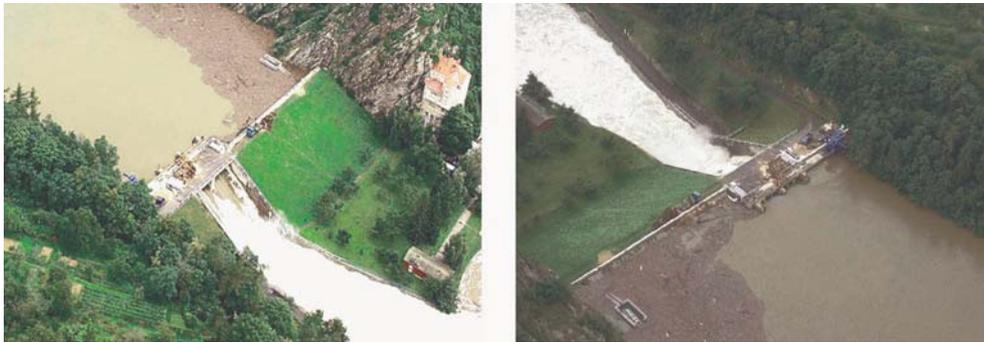
Figure 1. Upstream and downstream air view of the Znojmo Dam during the August 2002 flood

The capacity of the safety spillway was exceeded during the 2002 flood, see Figure 1. A flood peak of  $Q = 379 \text{ m}^3 \cdot \text{s}^{-1}$  was estimated (Kadeřábková, Krejčí, 2004). A nominal discharge of  $Q = 355 \text{ m}^3 \cdot \text{s}^{-1}$  was estimated during

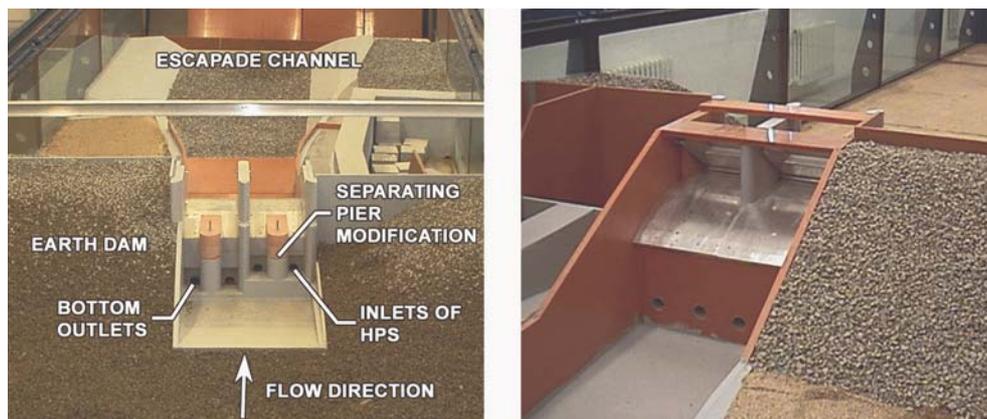
**Figure 2.** Downstream and upstream view of a model of the Znojmo dam spillway block

The dam model was installed in a glass-walled channel which is part of the equipment of the new fully automated Laboratory of Hydraulic Research of the Faculty of Civil Engineering, Brno University of Technology. The channel forms a part of the hydraulic circuit maintaining a stabilised rate of flow of up to  $Q \sim 150 \text{ l} \cdot \text{s}^{-1}$ . The model consisted of a spillway block with parts of the dam, a stilling basin, and a 157 m length (in real scale) of the Dyje river bed. There are 31 pressure holes in the spillway surface. The upstream face of the dam was covered with gravel with a particle diameter of 10 to 15 mm. The bottom of the channel downstream of the basin step was covered with the same gravel as corresponds to the real riprap material. A view of the model is shown in Figure 2.

Model tests proved that the modified spillway enables safe transfer of a flow rate of  $610 \text{ m}^3 \cdot \text{s}^{-1}$ . However, the capacity is affected by the modification of the separating piers placed in front of the spillway, see Figure 2. The results of the research led the designer to the decision to sink the pier top elevation from 223.00 m a.s.l. to 221.60 m a.s.l. The influence of the tested pier shape modifications was negligible (Stara, et al, 2005)). It was recommended to sink the piers without any shape modifications, see Figure 3.

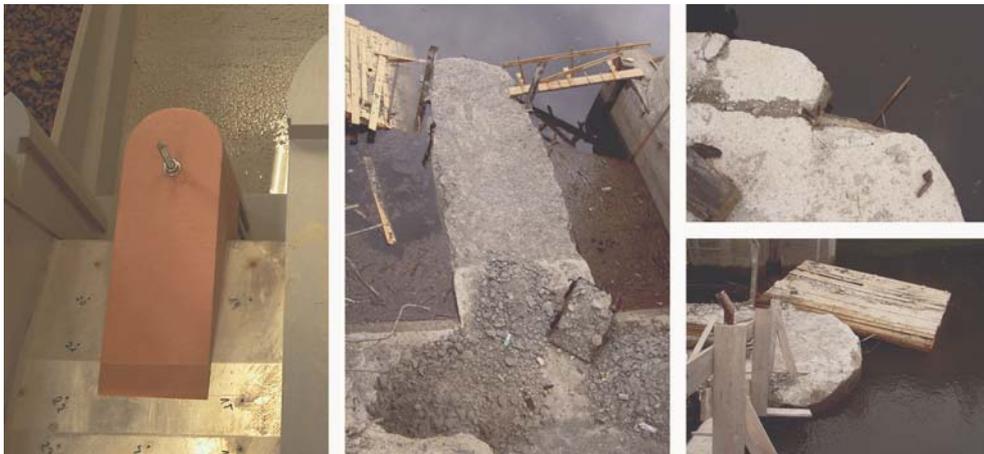
Figure 3. Recommended and applied modification of separating piers

The edges of the separating piers were lightly damaged during the sinking of their top face. So, the edges will be chamfered after alignment and effacement. No significant difference between modelled and real situations is expectable because the shape modifications had negligible effect on the discharge coefficient of the new spillway surface.

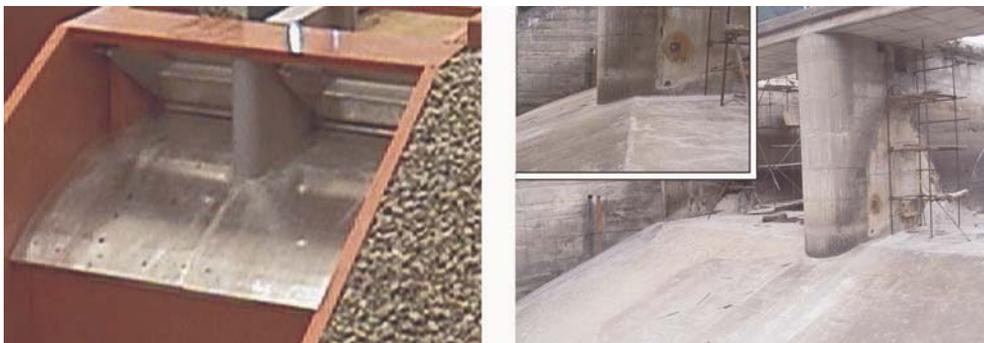
Figure 4. Modelled and realised shape of the spillway surface at the end of central pier

A sharp edge between the horizontal and curved parts of the spillway surface appeared at the end of the central pier after dismantling of the flap gates and demolition of the sill where the gates were installed, see Figure 4. This sharp edge was modelled as rounded according to the given plans. The edge could negatively affect the pressure conditions on the spillway surface compared with the modelled situation.

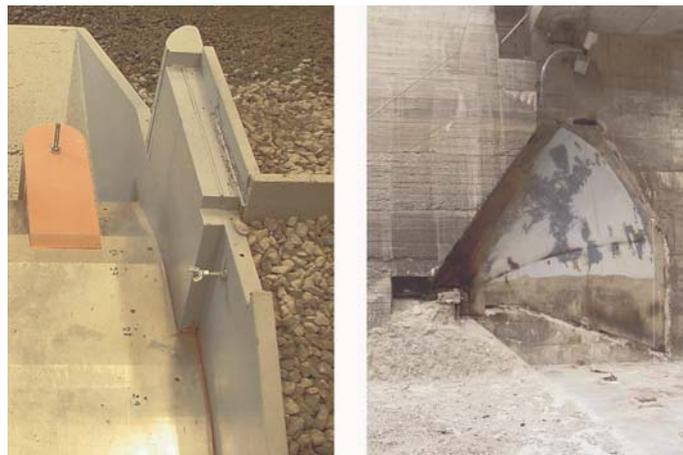
Figure 5. Simplification of shape indentation of diffusion at the installation site of the flap gate

The shape variety of the side pier wall was simplified in the model, see Figure 5. This simplification should not cause significant distortion of the results measured and applied.

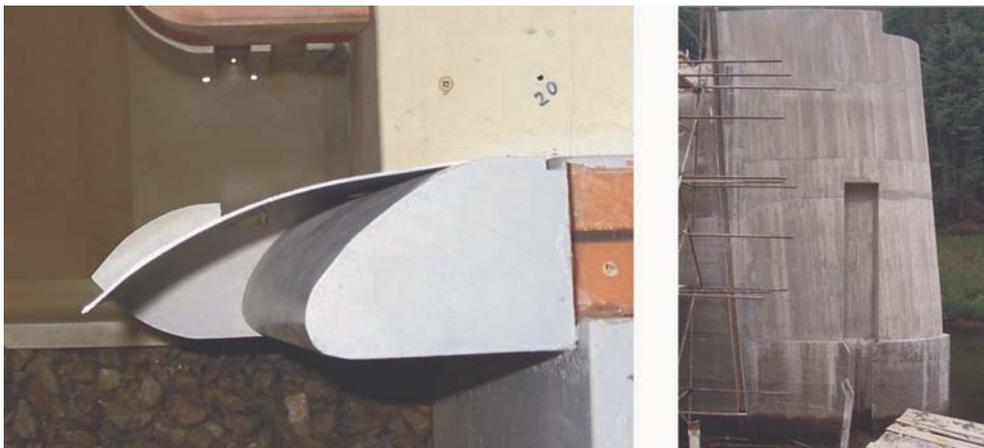
Figure 6. The stream-leading plate set on top of the lower part of the side pier and its realisation by a concrete body with a groove of the cofferdam

A model test proved that the contractions at the side piers have no effect on the spillway capacity because the side piers are ahead of the spillway surface. Wakes cause a water level increase of approximately 1.0 to 1.1 m at side piers when the discharge is  $Q = 610 \text{ m}^3 \cdot \text{s}^{-1}$ . An improvement of wake effects, i.e. decreasing the wave crest, was necessary due to the maximum gate opening during floods. Therefore, several tests of flow improvement and wake elimination were performed by using wing-like steel elements attached to the front part of the pier walls. The minimisation of plate dimensions was achieved by taking step-by-step measurements while using different plate shapes and sizes [Stara and Šulc, 2004), see Figure 6.

The stream-leading plates were realised as a concrete body set on the original piers. The grooves of the cofferdam had to be included, see Figure 6. Keeping the shape of the leading face was necessary to ensure good agreement between modelled and real situations.

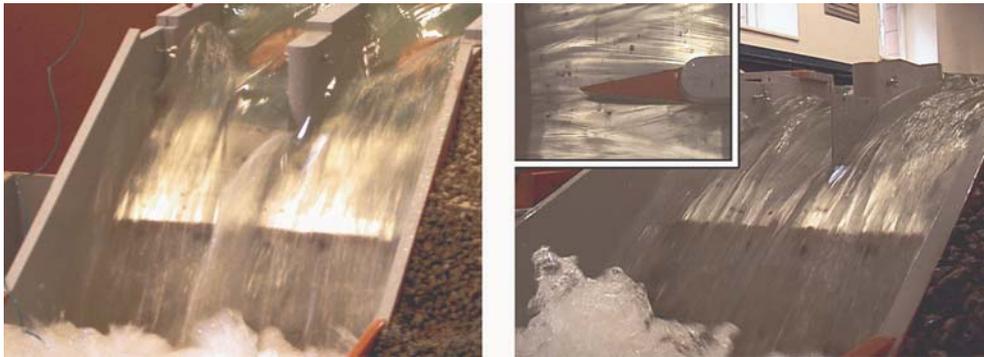
Figure 7. Deformation of the level arising behind the end of the middle pier and its elimination by the NACA profile when  $Q = 610 \text{ m}^3 \cdot \text{s}^{-1}$

The circular trailing end of the central pier was replaced with the rear part of the NACA profile (Ladson, et al., 1996) with the aim to eliminate the wave formed downstream of the pier. The hydraulic efficiency of the NACA profile is shown in Figure 7. This modification will not be implemented.

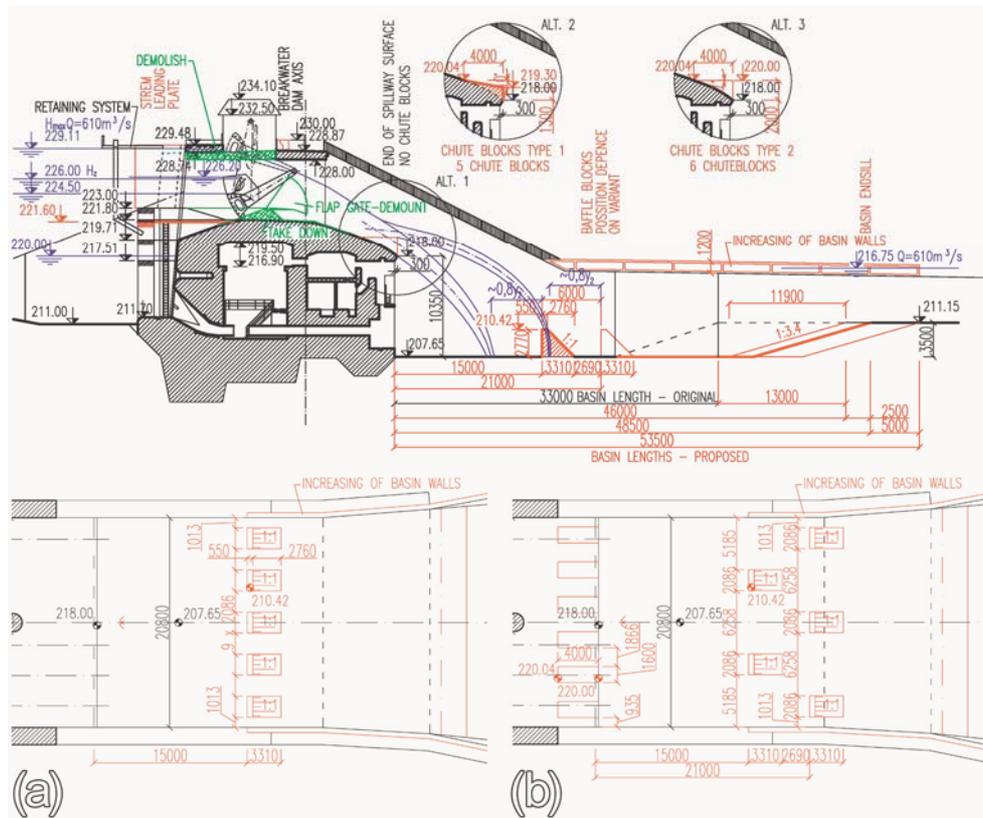
Figure 8. Vertical plane section of operational structure and the possible modifications and ground plan of the optimal layout of baffle blocks: (a) with chute blocks used; (b) with no chute blocks used

The use of chute blocks had a negligible effect on the total energy dissipation in the basin. The use of chute blocks considerably increased the aeration of the stream entering the space above the basin and spread a more uniform load on its bottom. The use of the chute blocks according to variant 3 was proved as more suitable (Figure 8). A  $48.5 \text{ m}$  long basin combined with five baffle blocks ensures low deformations of the channel bottom. Baffle blocks may be laid out in one or two rows depending on the chute blocks used, see Figure 8.

The variant with no chute blocks at the end of the spillway surface combined with installation of five baffle blocks laid out in one row at the basin bottom was chosen for realisation, see Figures 8, 9, and 10. A basin length of  $48.5 \text{ m}$  was also recommended. Due to the spray formed by water impinging on the baffle blocks in the basin, a full concrete barrier about  $1.2 \text{ m}$  high was added on top of the basin walls. A heavy riprap  $15 - 20 \text{ m}$  long with concrete filling in an approximately  $5 - 7 \text{ m}$  long section was recommended as channel bottom protection.

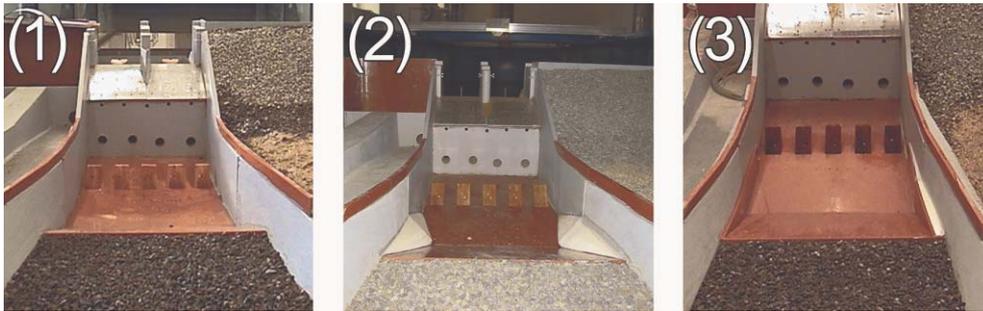
Figure 9. Upstream view of the basin bottom with five baffle blocks laid in one row and variants of modifications of basin walls: (1) original proposal, (2) conical elements, (3) anchored walls

During the basin elongation we found a shallow foundation of the basin walls in comparison with the basin bottom elevation. Therefore, additional sinking of the footing bottom with concrete filling and anchoring into the bearing subsoil were performed. Two variants of stabilizing system were proposed, adding conical concrete elements or adding anchored walls, see Figure 9. The second variant was finally realised. The efficiency of the final basin modification was also assessed on a hydraulic model. The results of measurements have shown that the deepest scours occur near the left bank as was expected. The channel bed scours were similar in all cases, of an approximate depth of 1.2 m located some 5 - 7 m far from the basin sill. Thus it is possible to surmise that the final modification of the stilling basin has negligible effect on its efficiency, see Table 2.

The reduction of stilling basin diffusiveness by left anchored wall (see Figure 9 (3)) positively affected flow in the basin which resulted in symmetrical channel bed scour behind the basin sill and smaller deformations near the left bank.

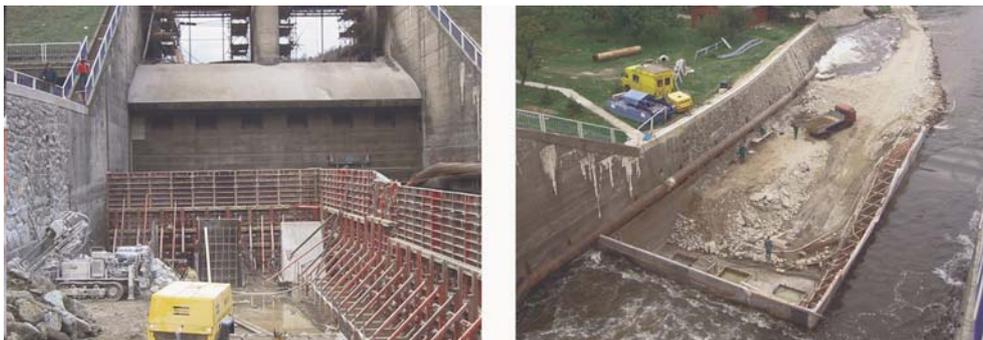
Figure 10. Upstream and downstream view of stilling basin of the Znojmo dam; a part of the basin is under the cofferdam and the preparation of fabrication of baffle blocks is in progress
