Inoperable reservoir valves - why wait for the inspection?

P. ENSTON, Hydra-Ject

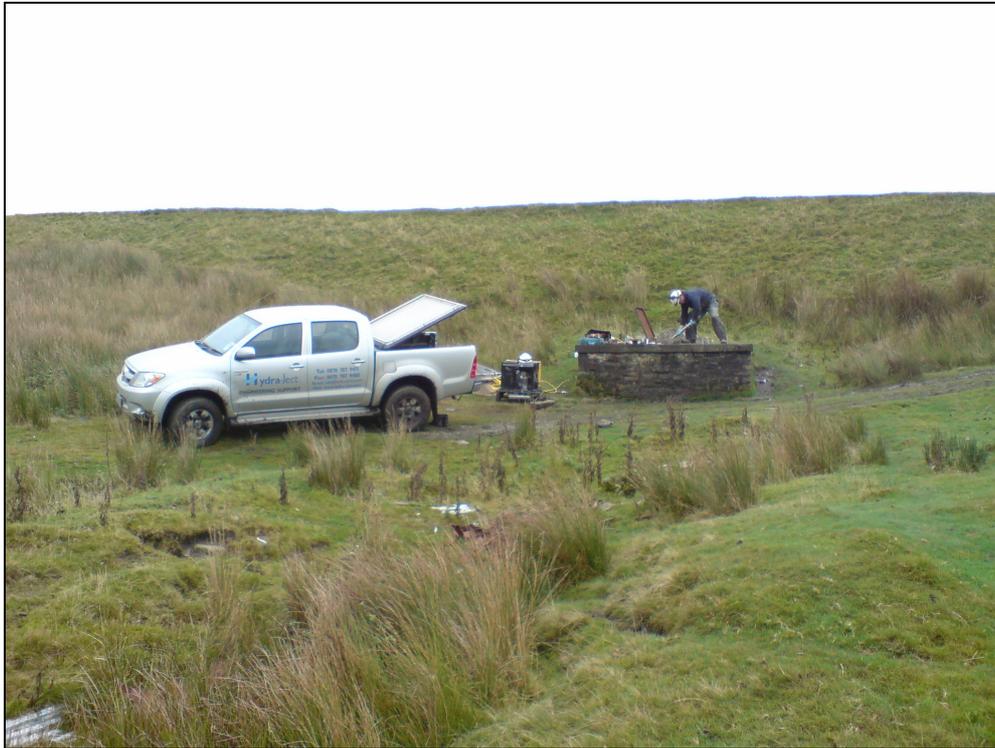
Figure 1: Rhaslas reservoir embankment – scour valve chamber

Rhaslas reservoir is a 60 million gallon reservoir in Ebbw Vale, South Wales, the scour valve was seized shut. Previous attempts at operating the valve resulted in the phosphor bronze spindle being sheared leaving the gate firmly wedged into the valve seats. Following an inspection under Section 10 of the Reservoirs Act 1975, remedial works to the valve were recommended in the interests of safety to make the valve operable.

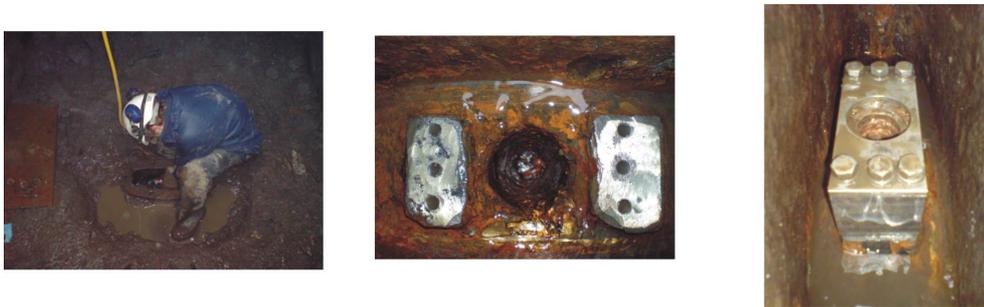
Figure 2: Valve gate prepared for attachment of new spindle nut carrier blocks

At this point the Undertaker became aware of a novel solution for seized valves known as H-Grip. Before this equipment could be attached to the valve, it was necessary to carry out remedial works to replace the broken

spindle. This was achieved by firstly redressing the gate and replacing the carrier blocks for the spindle nut.

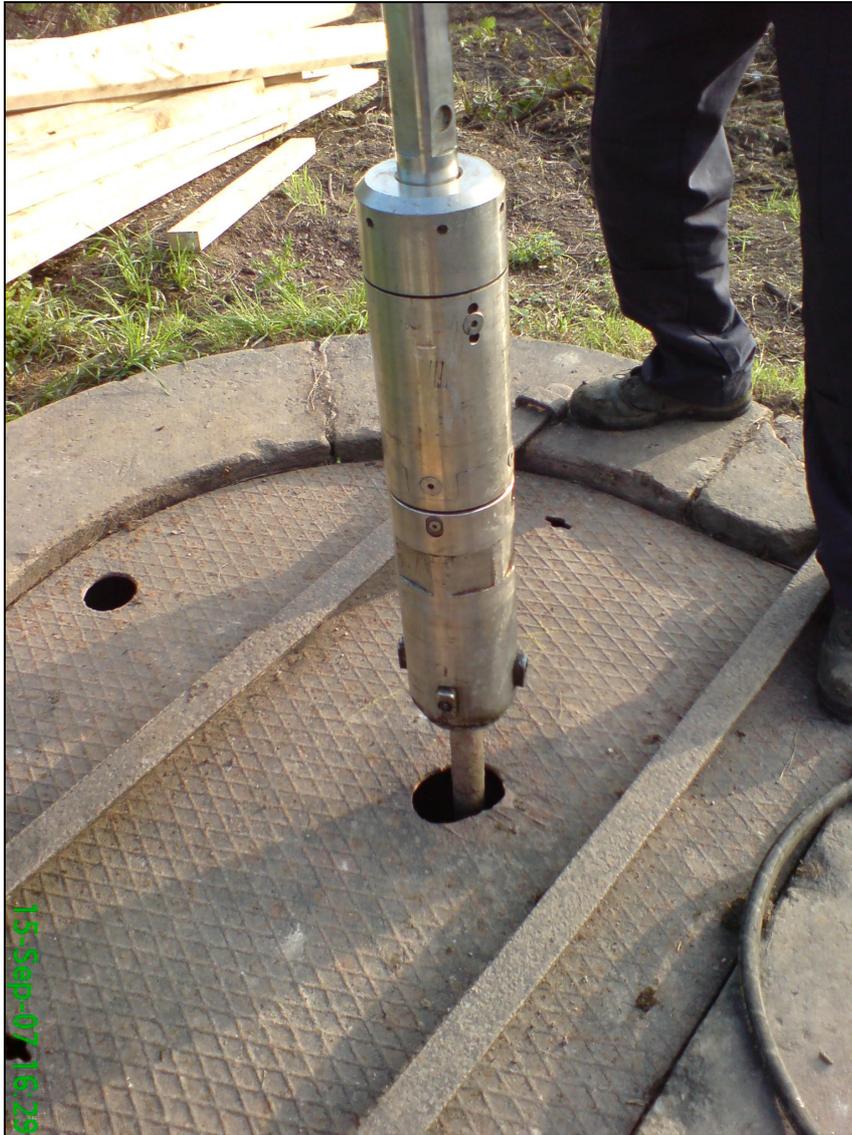
Figure 3: Typical H-Grip set up to release a seized valve

Following this, the bonnet and new spindle were reassembled and then H-Grip was attached. Within a matter of minutes the valve gate was made free and could be cycled with great ease. The risk associated with having a large reservoir that could not be drawn down through the scour valve had been eliminated – in an instant.
