The Dambusters Revisited

J.L. HINKS, Halcrow Group Ltd.
C. HEITEFUSS, Ruhr River Association
M. CHRIMES, Institution of Civil Engineers

SYNOPSIS. The British raid on the Möhne, Eder and Sorpe dams on the night of 16/17 May, 1943 caused the breaching of the 40m high Möhne and 48m high Eder dams and serious damage to the 69m high Sorpe dam. This paper considers the planning for the raid, model testing, the raid itself, the effects of the breaches and the subsequent rehabilitation of the dams.

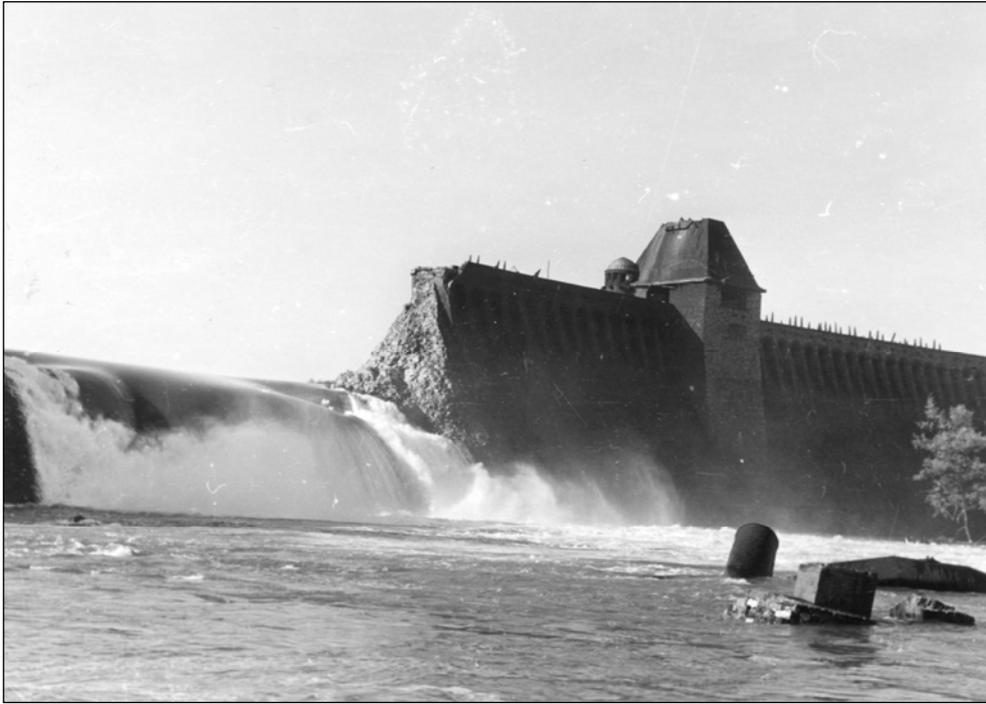
Figure 1. The Möhne Dam after breaching (Ruhrverband)

The Möhne dam was attacked by five aircraft, the fourth of which produced a direct hit and breached the dam releasing most of the 135 Mm³ of water in the reservoir. The Eder dam was attacked by three aircraft, the third of which produced a direct hit and breached the dam releasing most of the 202 Mm³ of water in the reservoir. The Sorpe dam was attacked by two or three aircraft flying along the axis of the dam. It was briefly overtopped and damaged but not breached.

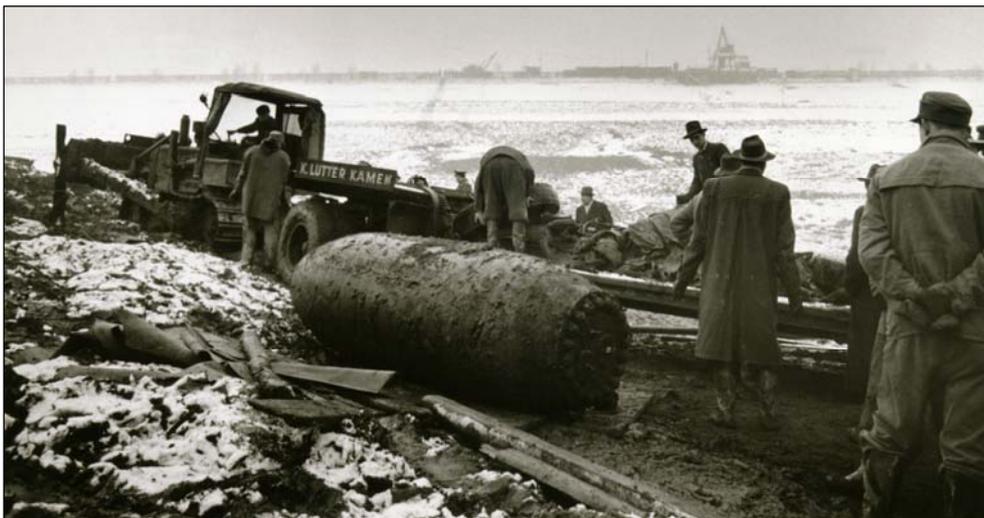
Figure 5. Bomb defused at Sorpe Dam in January 1959 (Ruhrverband)

In 1958 the reservoir was drained for bomb damage repairs, in the course of which workers discovered an unexploded Tallboy bomb. On 6 January 1959 the whole village of Langschede was evacuated while the Chief Bomb Disposal officer for Nordrhein-Westfalen, Walter Mietzke, and British Lieutenant, James M. Waters, jointly defused the 3.6m long bomb that still contained 2,500 kg of high explosive and a highly unstable acid fuse.
