Dam Safety in the (Somewhat) United States

DEL SHANNON, ASI Constructors, Pueblo, Colorado, USA

SYNOPSIS. Dam safety laws for the more than 82,000 dams within the United States are as varied as the states and regions and people of our country. The individual autonomy of states, and their desire to establish their own rule of law, is the driving force behind nearly every aspect of life in the US, including dam safety. Currently, there is no federal law requiring individual states to have dam safety laws. One state, Alabama, has rebuffed efforts to establish these laws and currently has no formal dam safety laws. Even within the federal government there is disagreement with adopting standard dam safety laws. The US Army Corps of Engineers, National Resource Conservation Service, Bureau of Reclamation, Federal Emergency Management Agency, and Federal Energy Regulatory Commission all have their own unique dam safety standards. Determining regulation for an individual dam is a question of ownership, location, and use.

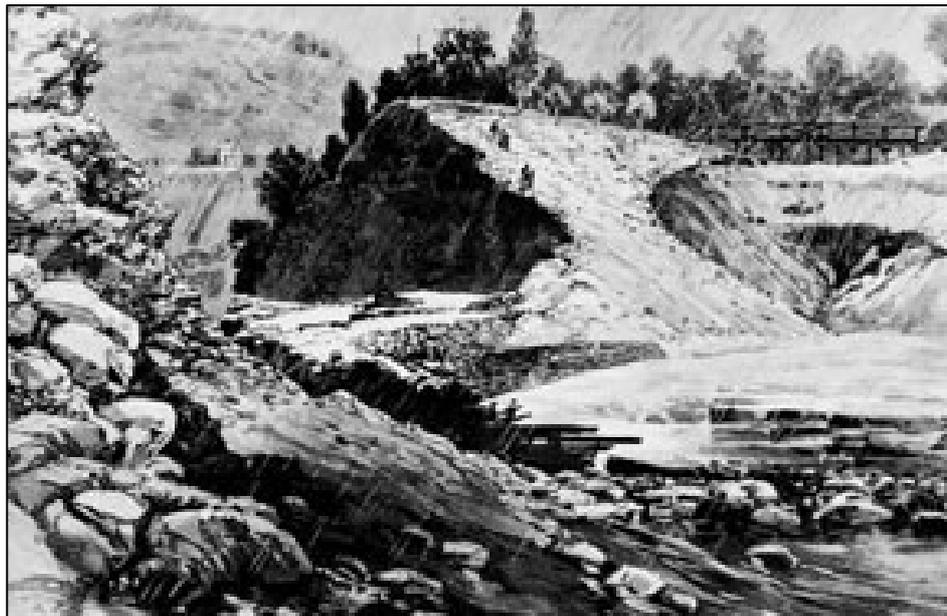
Figure 1. Artist's Drawing of Breached South Fork Dam

A contemporary illustration of the broken South Fork Dam from Harper's Weekly.

flood caused by the failure. The Western Reservoir dam was located 14 miles upstream of Johnstown and was owned and maintained by the South Fork Hunting & Fishing Club, whose membership included Andrew Carnegie, Andrew Mellon and many of Pittsburgh's most elite and wealthy individuals. The embankment dam was 72 ft (22m) high and retained approximately 14,700 acre-feet (18Mm³) of water. From its initial construction in 1852, to provide water for local canals, it was poorly maintained. This poor maintenance included the construction of fish screens across the spillway to inhibit fish from being washed out of the reservoir, but which trapped debris and significantly reduced the spillway capacity. The dam was also lowered to permit two carriages to pass each other at the same time, but which also reduced critical freeboard. The difference between the spillway crest and the dam crest at the time of the failure was only four feet. Lastly, and most critically, the original owner of the dam removed the low level outlet works, selling them for scrap metal, and these were never replaced.

On 31 May 1889 a large rain storm moved into the area, dropping between 6" and 10" (150mm to 250mm) of rain in 24 hours, and most people in Johnstown went indoors to wait out the storm. At 3:00 pm the dam overtopped and a 40 ft (12m) high wall of water travelling at 40 mph (65 kph) raced down the valley. When it was over 2,209 people were dead including 99 entire families; 396 children had been killed, 322 lost either

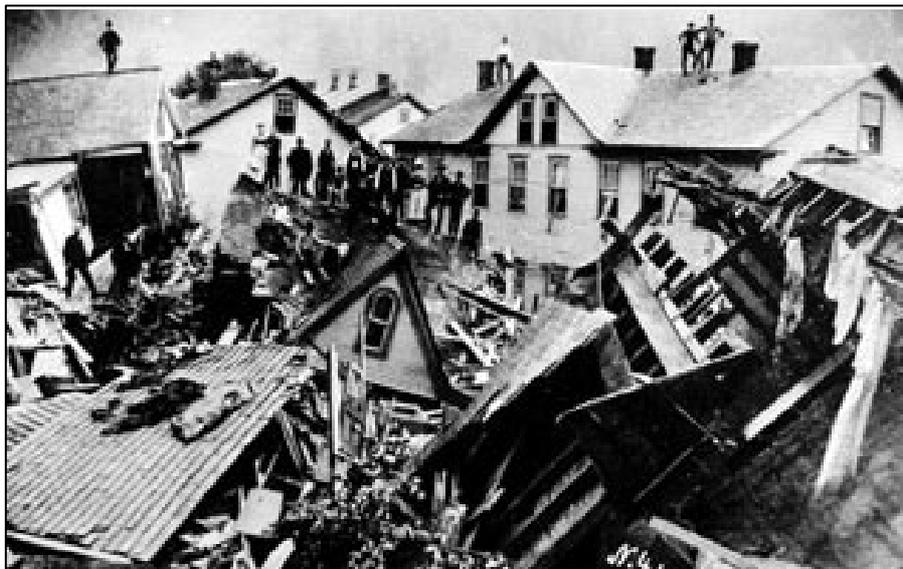
Fig. The people standing on the rooftops in this striking image are likely sightseers who have come to see the flood destruction.

The Johnstown Flood (Johnstown, Pennsylvania) of 1889 was one of the first significant dam failures in the United States and it remains the largest loss of life dam failure, with over 2,200 people perishing as a result of the

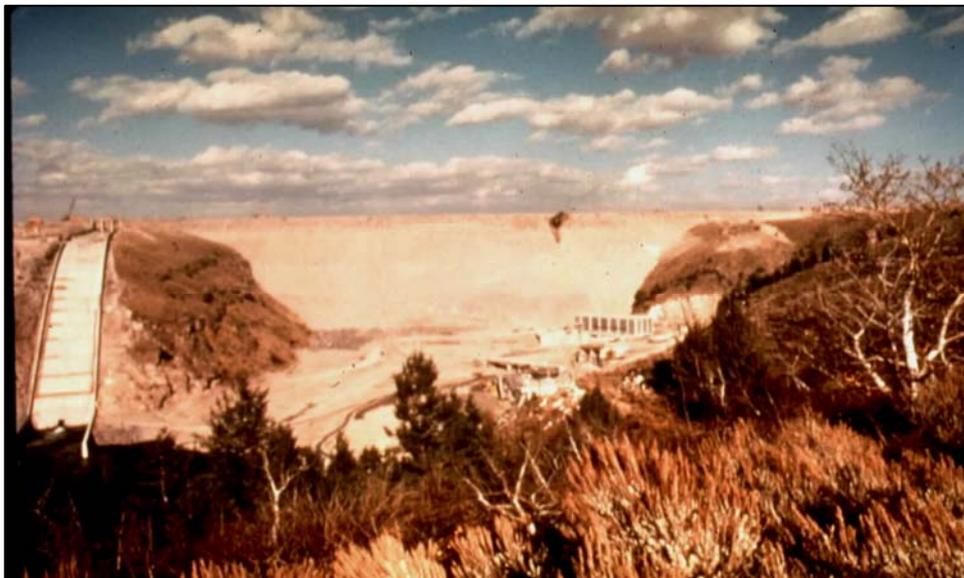
Figure 6. Teton Dam Days Before Failure

The Teton Dam was located on the Teton River in rural Idaho, near the town of Rexburg, Idaho. The dam was designed and constructed by the Bureau of Reclamation. The Teton Dam was 305 ft (93m) high, was a zoned embankment dam, and stored approximately 230,000 acre-feet (284Mm³) of water. The rock at the dam site was predominately rhyolitic tuff, which was formed from ancient volcanic ash flows. This material was highly fractured and quite permeable in places and to address these issues an extensive grouting program and deep and narrow cut-off trench were designed.

Initial filling of the dam began in the Spring of 1976 before the spillway and outlet works were completed and fully operational. Idaho is in an arid climate and there was pressure to store spring runoff water for the upcoming irrigation season, with the reservoir rising at a rate of approximately four feet (1.2m) per day. Even with the outlet works and gated emergency spillway being non-operational, the reservoir was near the normal maximum pool elevation on 3 June when the first small seeps near the downstream toe and right groin area of the dam first appeared. These seeps were small, approximately 2 cfs (55 l/s), and were not considered problematic. At 7:30 a.m. on 5 June these seeps had increased and the water was very muddy, however engineers on site were still not concerned. At 9:30 a.m. a seep on the downstream face of the dam began producing water at a rate of 20 to 30 cfs (0.55m³/s to 85m³/s) and two bulldozers were dispatched to try and fill a sinkhole that had formed. By 10:30 a whirlpool was observed in the reservoir, the bulldozers were withdrawn and the order was given to evacuate as many people as possible downstream. At noon the Teton Dam failed and it took only 6 hours to completely drain the reservoir. Because the disaster occurred during the day, the death toll was minimized and only 11 people died. The population impacted by the flood was estimated to be around 10,000 and, had the failure occurred at night, it is believed the majority of these people would have been killed.

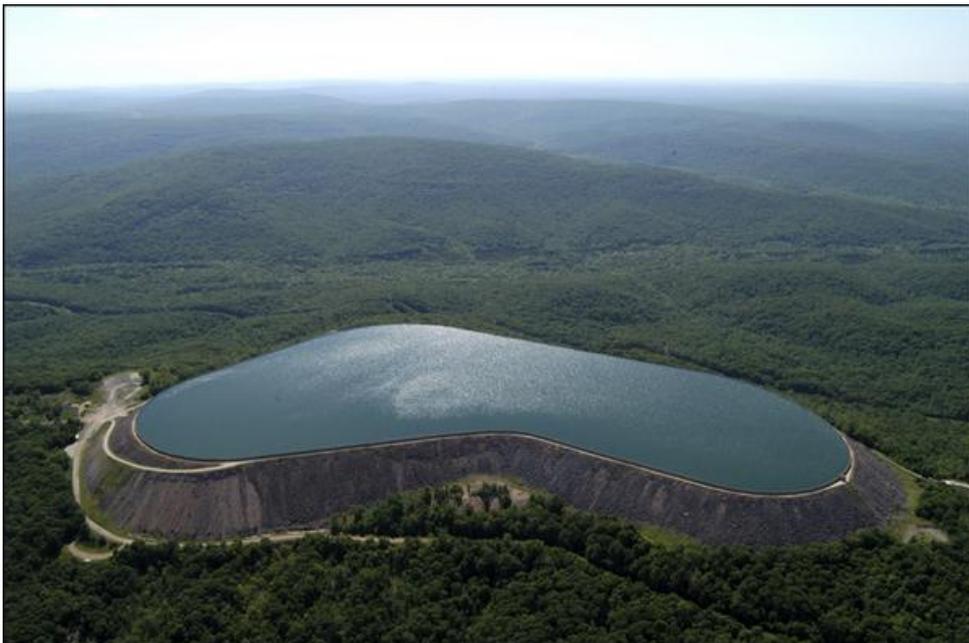
Figure 9. Taum Sauk Dam Before Failure

The upper dam of the Taum Sauk pumped storage hydroelectric project was built as an asphalt-faced rockfill dam in the early 1960s. In the early morning hours of 14 December 2005 (at approximately 5:20 a.m.) the upper dam of the Taum Sauk pumped storage project was breached due to overfilling. The dam had no spillway. The entire reservoir (approximately
