Blalock Dam and Reservoir Improvement Works

SYNOPSIS. The H. Taylor Blalock Reservoir is a water supply reservoir in South Carolina, USA. The reservoir is owned and operated by Spartanburg Water System (SWS) and provides vital storage to their water network which supplies over 180,000 people in Spartanburg County.

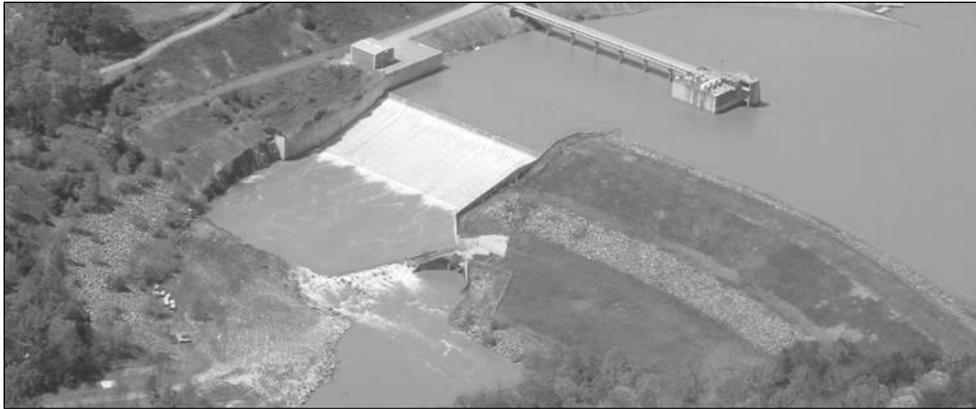
Figure 1. Blalock Dam prior to the Improvement Project

Blalock Reservoir is one of three water supply reservoirs owned and operated by SWS. The reservoir was formed in 1983 by the construction of a homogenous earthfill dam across the Pacolet River near Spartanburg, South Carolina. The dam is 216m long and about 21m high with an 82.3m long spillway at its western end. An aerial view of the original dam is shown in Figure 1.

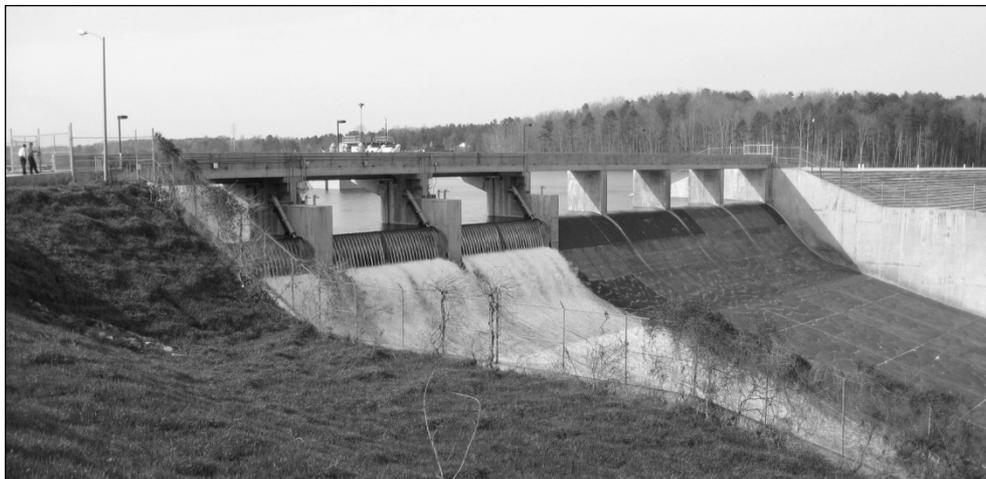
Figure 5. Finished Bridge and Spillway

The new spillway crest includes a seven span precast concrete beam bridge above the crest supported on reinforced concrete piers. In addition to providing access to the embankment, the bridge also serves as access to the crest gates for maintenance and for raising and lowering stoplogs upstream of the gates.

The bridge is 3.66m wide above the fixed crest spillway and increases to 7.32m wide above the three bays incorporating gates. This provides access for a mobile crane for gate maintenance and handling of stoplogs.

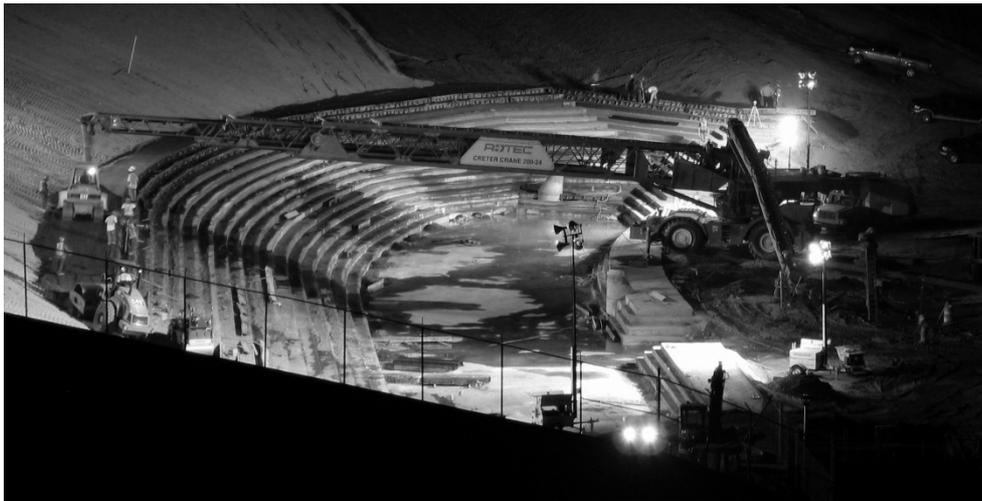
Figure 6. Placement of RCC armouring to embankment dam

Placement of the RCC was predominantly by a Rotec Creter Crane; a smaller unit was used to place material where the Creter Crane could not navigate. Figure 6 shows the Creter Crane in operation.

When RCC placement was near to the pugmill, a conveyor system was used to transport the RCC to the Creter Crane. Elsewhere dump trucks were used to transport the RCC to a feed conveyor which supplied the Creter Crane.

Spreading the RCC to the required thickness was carried out by a bulldozer and then compacted using a vibratory roller. A smaller double drum vibratory roller was used in tighter spaces for compaction. On the embankment crest the final layer was placed by a paver in order to achieve tighter tolerances on the finished surface.
