Cobbins Brook Flood Storage Reservoir

S. LEE, Anser Project Managers (formerly of Halcrow Group Ltd.),
J. CASS, Jackson Civil Engineering
S.CORNICK, NEAS, Environment Agency
M. BRADLEY, Halcrow Group Ltd.

SYNOPSIS. Cobbins Brook flood storage reservoir was the preferred option for a flood alleviation scheme to reduce the risk of flooding to the town of Waltham Abbey, Essex. The reservoir is formed from an earth embankment with a sheet pile cut-off and can hold 754,000m³ when full following a 1:100 year (1%) probability flood event. It is the largest flood storage reservoir in the Thames North East Area of the Environment Agency.

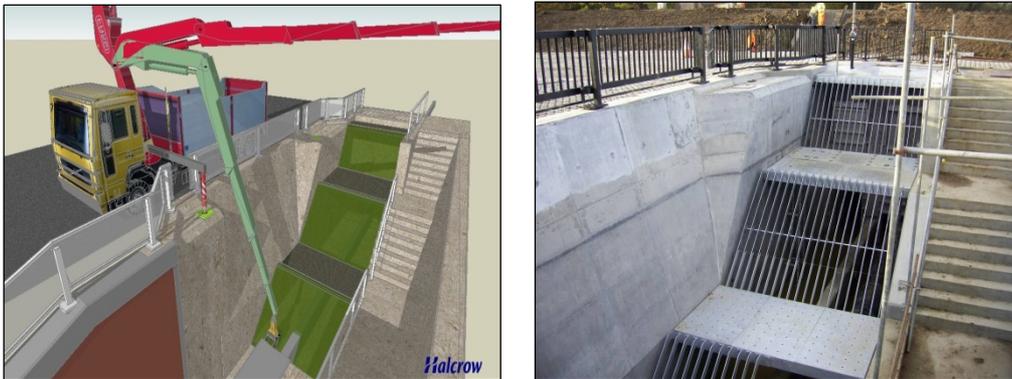
Figures 3 and 4. 3D Model and As-constructed inlet structure

The Environment Agency's Operations team requested confirmation that their grab lorry would be able to reach the base of the trash screen of the inlet to the control structure. In order to test the design and demonstrate that this would be possible a 3D computer model was developed, initially using the package Sketch-Up. Detailed dimensions of the lorry and the grab arm were taken and used to create a 3D model of the lorry and inlet structure. Clash detection software was used to test the operation and revealed that the original proposed design with vertical walls would restrict access to the screen. As a result the design was changed to accommodate a sloping wall. Without the use of the 3D modelling it would have proven difficult to determine and potentially delay handover with expensive re-work required on site. See Figures 3 and 4.

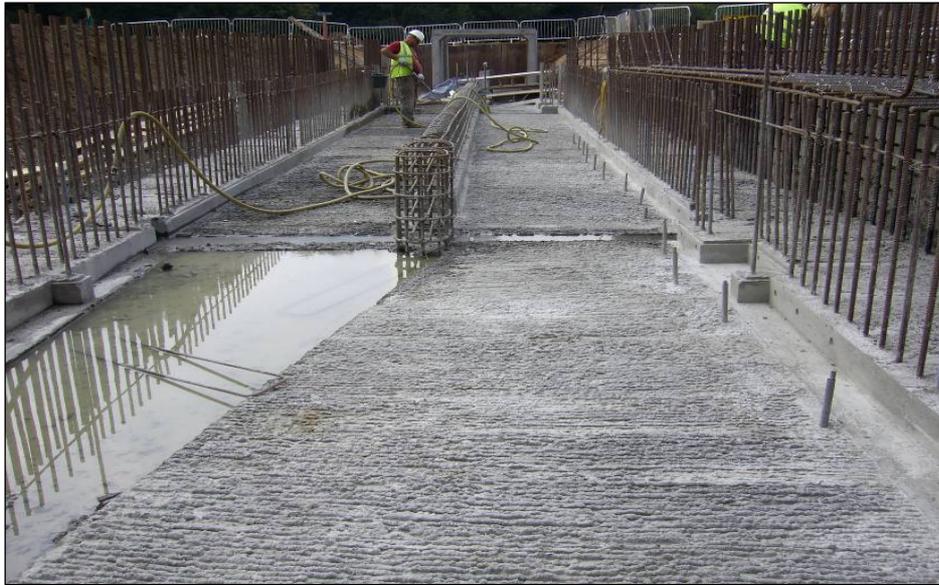
Figure 5. Textured bed at inlet achieved with a rake finish

A textured bed was also proposed to allow a roughened surface for additional grip. This also had the benefit of aiding fish movement by creating a non-uniform surface. See Figure 5.

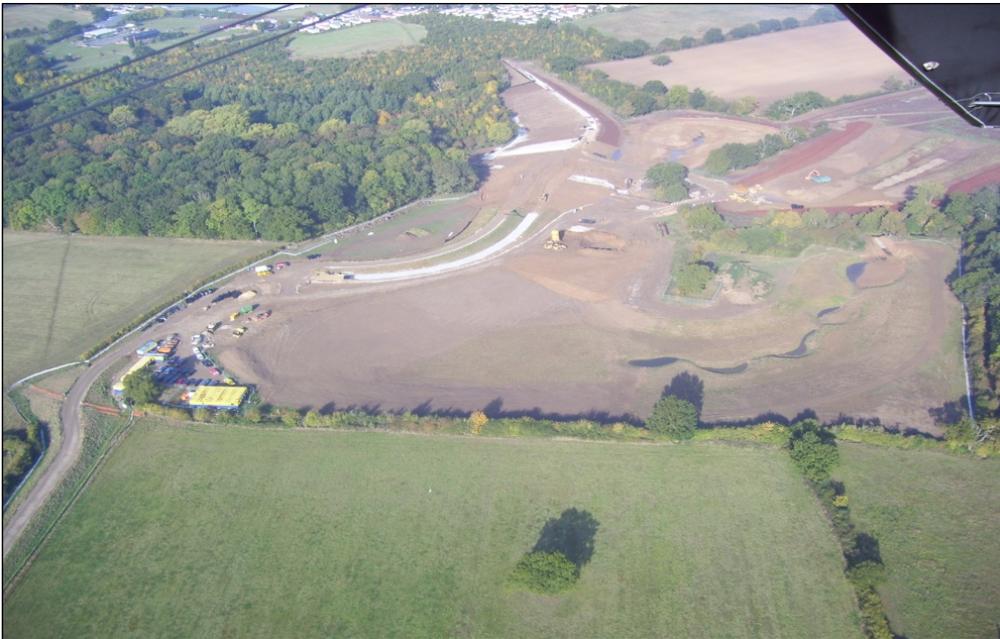
Figure 6. Aerial view of the reservoir under construction.

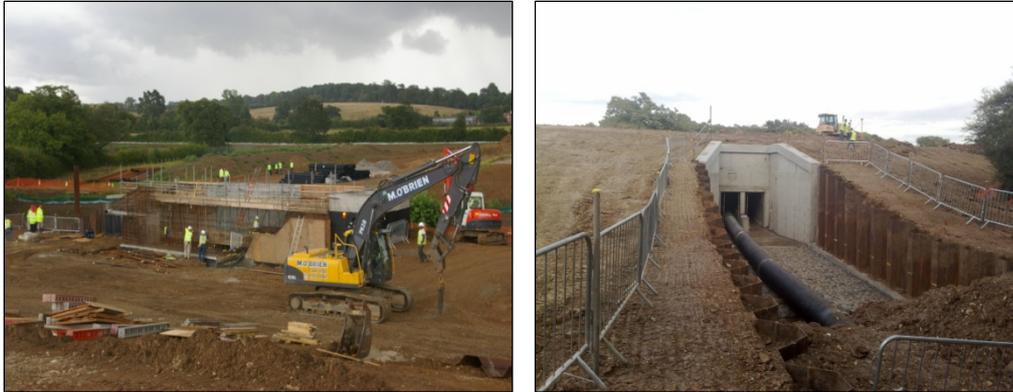
Figures 7 and 8. Inlet structure in construction and pipe through structure.

Options of over pumping were considered but dismissed due to the fish in the river, back-up capacity, refuelling close to the watercourse, cost and potential vandalism to the pumps. A solution was found by putting the brook in to a 600mm diameter and 120m long pipe. A temporary clay bund was built at the upstream end to channel the water into the pipe and a sheet pile and clay bund was built at the outlet in case of high flows. Before the water was diverted into the pipe the inlet/outlet weir to the main borrow pit was completed, as this would provide 3500m³ of storage within the borrow pit before the works would flood. The pipe was in place from September to December 2009, with only three occasions during that period where there was over 10mm of rain in a day. At this point the main borrow pit filled and the flow exceeded the pipe's capacity but by this time the main earthworks had been finished with only minor channel finishing works remaining. This allowed early issue of the Preliminary Certificate allowing impounding of water and early reduction of flood risk to Waltham Abbey. See Figures 7 and 8 below.
