Case studies from permanently installed siphon works

SYNOPSIS Adequate draw down of reservoirs by gravity means only may not always be feasible. Siphons may be seen to be a suitable option and efficient means of drawing off the upper portion of a reservoir volume. This paper looks to cover case studies of schemes completed in recent years.

Mott MacDonald Bentley (MMB) planned and undertook works at the following:

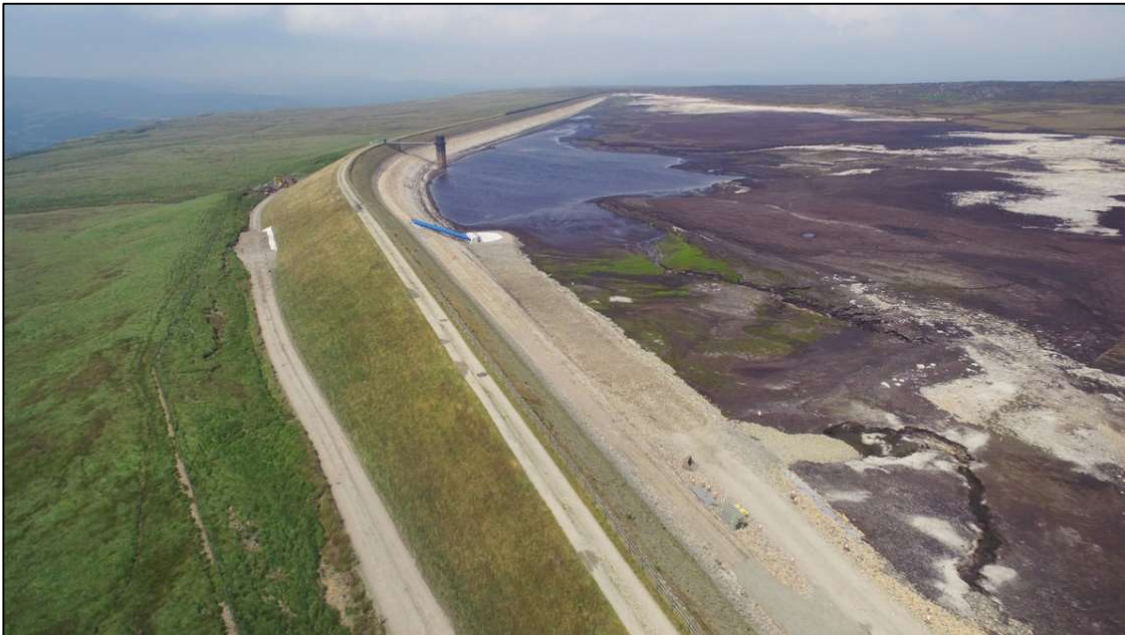
Figure 1. Warland Reservoir drawn down by 8m, and upstream pipe work installed

The reservoir was drawn down by 8m to facilitate the construction of the upstream section of the siphons. The inlet works were undertaken first, and once installed, the reservoir was allowed to partially re-fill. To pressure test the pipes a blanking plate was left on the end of each pipe, which was removed by divers following a successful test.

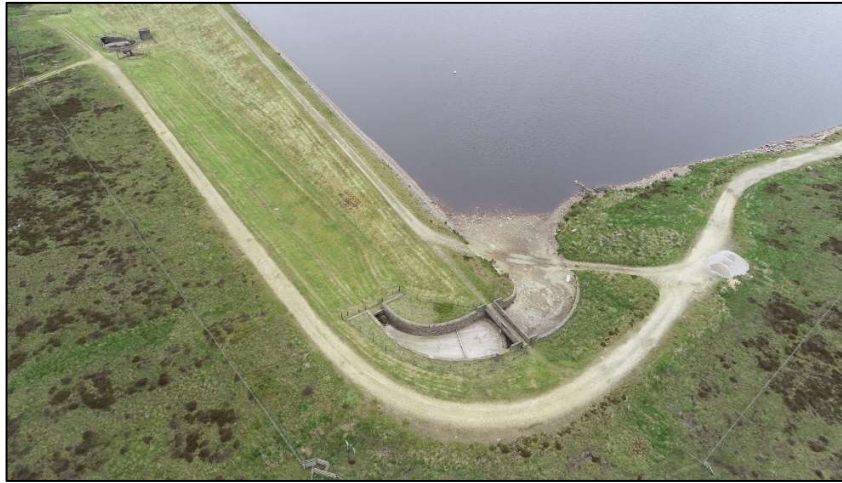
Figure 3. Aerial view of Warley Moor Reservoir

Warley Moor Reservoir is located in West Yorkshire and is owned and operated by Yorkshire Water Services (YWS). The reservoir is impounded by two dams with a crest level of 407.3mAOD. The overflow system is formed of concrete culverts with a trapezoidal grass reinforced channel situated above to take excess flows. A stilling basin connects the two culverts as well as taking flows from the scour pipe.

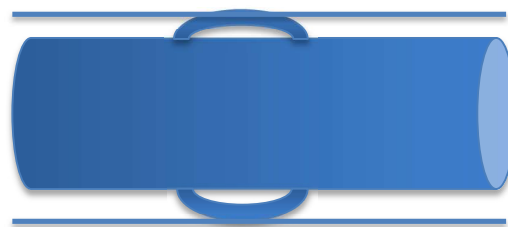
Figure 6. Illustration of "spacers" on the pipework

The dual containment solution utilised 600mm diameter twin wall pipework as the outer pipe with the 350mm HDPE siphon pipework threaded through. The construction methodology involved excavating the trench and installing the dual containment pipework first. Spacers were designed to be welded onto the siphon pipework using offcuts from plastic pipework on site, reducing waste and costs (Figures 5 and 6). The purpose of the spacers was to keep the siphon in the centre of the dual containment pipe, prevent the pipework from moving excessively when the siphon was in operation and to prevent the pipework from catching on the inside of the twin wall. The innovative design led to minimal programme increases and the spacers were effective at allowing the siphon pipework to smoothly slide down the twin wall dual containment pipework.

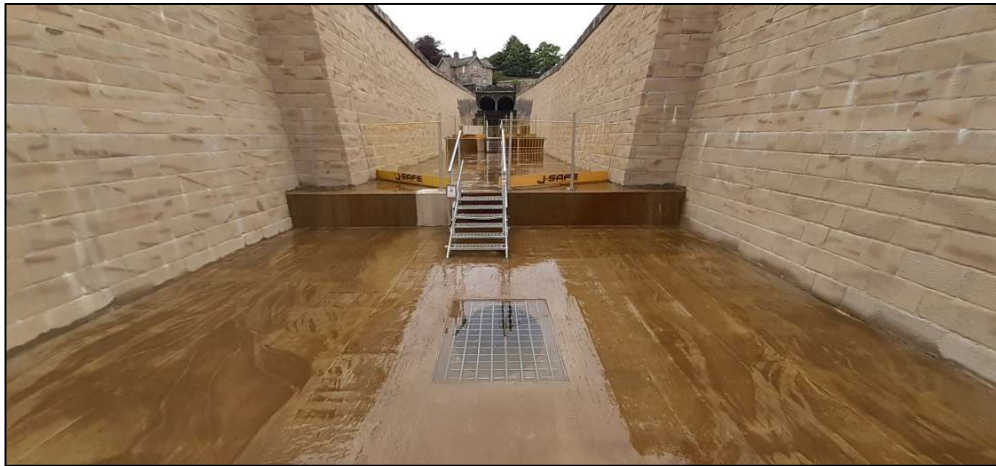
A solution was developed where the new siphon would discharge through the floor of the newly developed spillway, along with some minor amendments to the hydraulic design of the siphon (Figure 8).

Figure 8. Siphon outlet in spillway invert

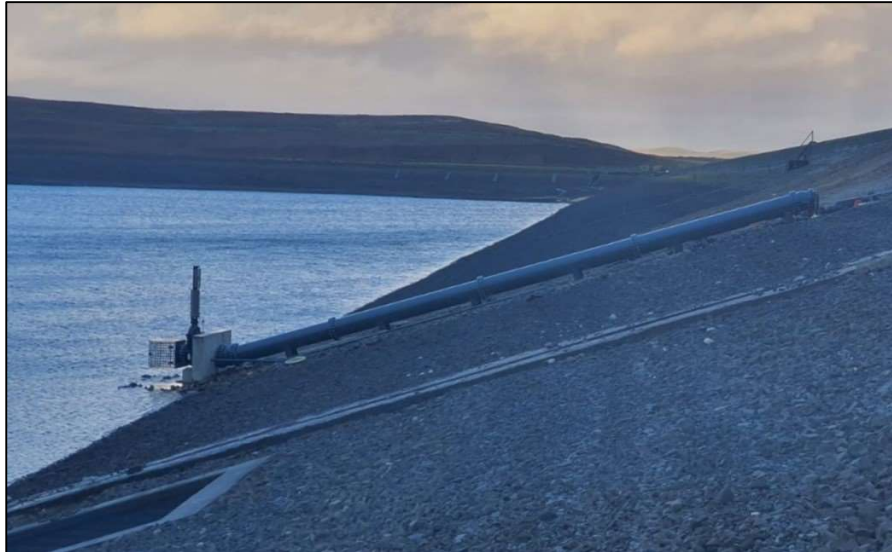
The siphon works required a significant draw down of the reservoir level to be able to work on the inlet structure safely (Figure 9). As this was quite a long duration for the works, it would impact the programme significantly and equally impact the spillway structure. It was decided to work from both ends of the pipe where practicable and to use a make-up piece at a bend on the downstream side of the embankment as a connection. This would aid in any minor tolerance issues in the pipework and ensure that the pipe closed correctly.

Figure 9. Upstream leg of siphon

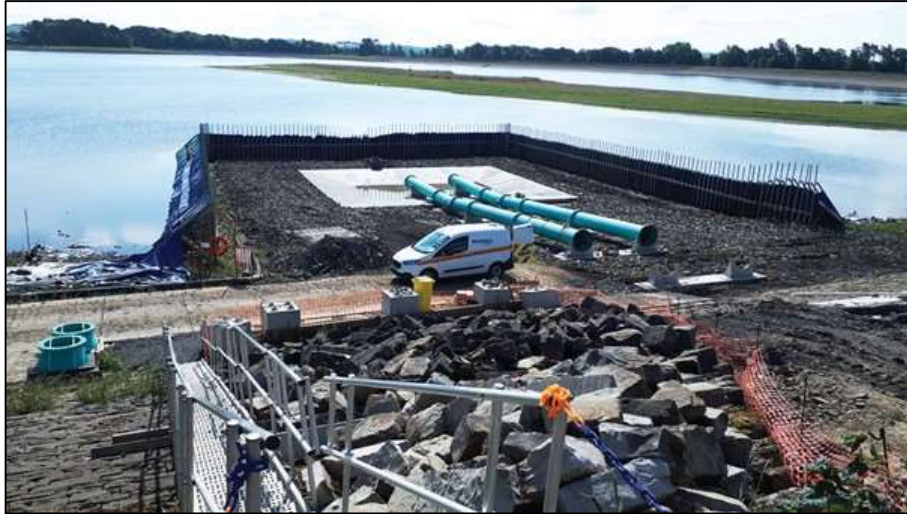
A cofferdam was installed to provide a dry area to construct the intake bay. It was erected in the wet by operatives wearing buoyancy suits, and then pumped out and an excellent seal was achieved. The cofferdam also allowed plant access around the pipework whilst the stone pitching was reinstated.

Figure 11. Siphon intake bay constructed within the cofferdam.

The intake bay was located along the Small Burn which originally ran across the middle of the reservoir and was diverted into the adjacent Coal Burn in the 1880s via a DN375 pre-cast concrete pipe. The ground around the intake bay was found to be poor and was excavated down to competent sub-grade and reinstated with 340 tonnes of gabion stone and 60 tonnes of Type 1 capping material. As this area is normally under a 5m depth of water it was inaccessible during the ground investigation stage.

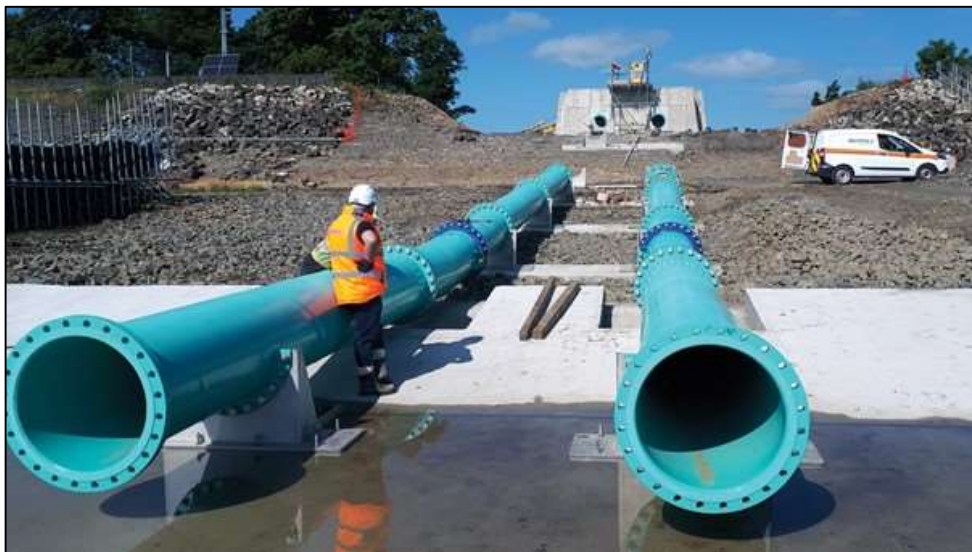
Figure 12. DN700 siphon pipework during installation

As the DN700 pipes are fabricated from coated mild steel, a Type 1 pressure test (water loss method) was required. All bolts had been tightened and the torque readings recorded but achieving a pass proved difficult due to sunny weather. A temperature rise on the above-ground pipework led to a pressure loss of more than 0.2 bar in the water filled pipe voiding the test on a number of occasions. Eventually cloud cover enabled a valid test.
