Overflow and outlet screens

J BENN, JBA Consulting
J HOWARD, JBA Consulting
C DALE, JBA Consulting

SYNOPSIS Overflow/outlet screens are often fitted to reservoirs to prevent human exposure to hazards, to catch large debris, or to prevent fish and mammals being washed downstream.

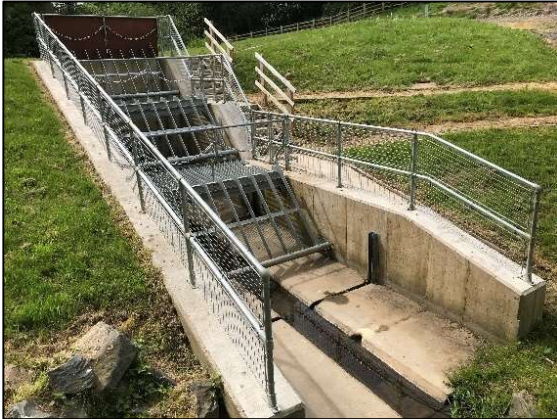
Figure 1. Multi-stage inlet screen to a FSR outlet

- Trapping of debris which would otherwise present an unacceptable risk of blockage to an overflow, gate or outlet ('debris screens') (Figure 1),
- Reduction of exposure to hazards and hence harm from accidental or intentional entry ('security screens') (Figure 2),
- Prevention of fish / bird / mammal 'wash-out' into an overflow or outlet ('fish or mammal screens') (Figures 3 and 4).

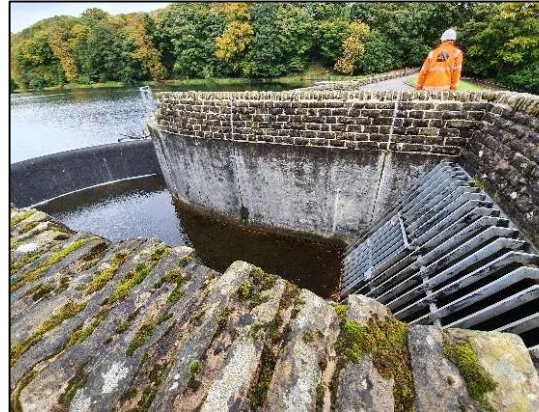
Figure 2. Single stage inlet security screen to a reservoir overflow culvert

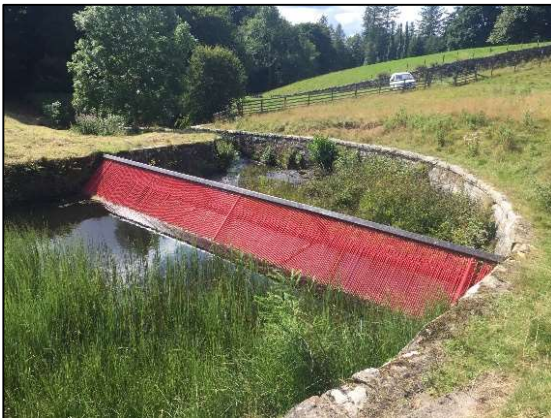
Figure 3. Fish screen on a reservoir overflow spillway inlet

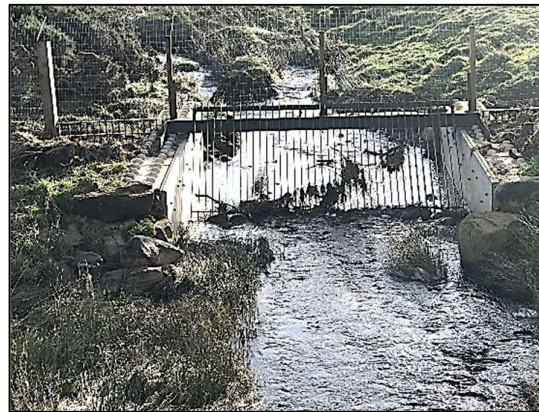
Figure 4. Mammal screen on inlet channel to an amenity lake

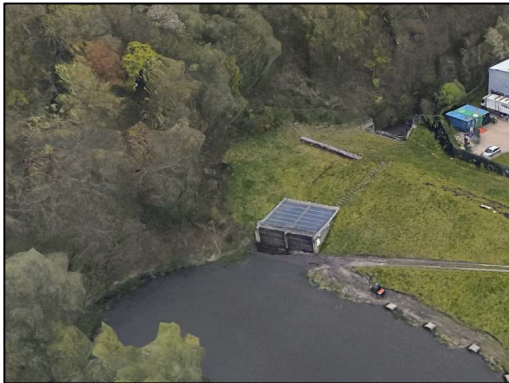
The reservoir has a storage capacity of 32,600m³ when full to the point of spilling (which is a level of 100.6m AOD). Twin Type 1098C Hydro-Brake™ vortex flow control units located in a reinforced concrete chamber (Figure 6) are designed to limit the 'pass forward' flow out of the reservoir via two low-level 1.5m diameter concrete pipe outlets to 5.7m³/s when the reservoir is full to the point of spilling. The flow of 5.7m³/s is estimated to be the maximum capacity of the Newton Bank Road culvert which carries the Blackburn Brook beneath the Business Park downstream of the reservoir.

Figure 6. Devil's Bridge Pond – aerial view of the Hydro-brake™ chamber and dam. Note the access ramp leading down to the screen.

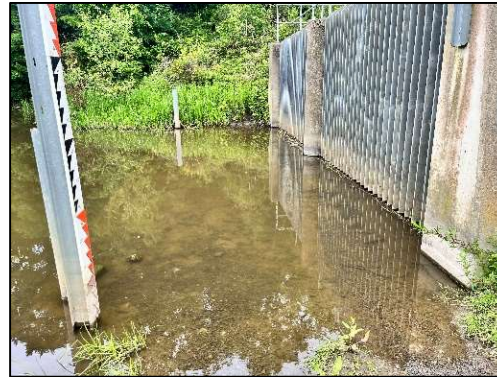
Twin 3.2m high, 200mm clear spacing vertical bar debris screens cover the entry to the twin Hydro-brakes™ (Figure 7). The net effective area (i.e. the area between the bars below the overflow level) is 15 times larger than the inlet area of the Hydro-brakes™. The control structure is also designed to allow easy removal of large debris by means of a concrete invert slab and access ramp.

Figure 7. Devil's Bridge Pond – debris screens on inlet of the Hydro-brake™ chamber. Note the concrete invert to aid cleaning of the screen.

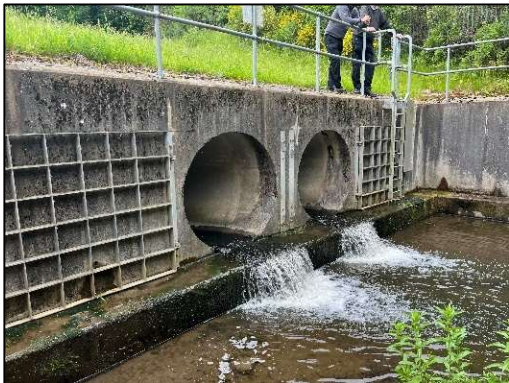
The original design risk assessment concluded that the hazard to people presented by the twin pipe culverts was low and that it could be mitigated by the security fence around the reservoir perimeter and the site security measures which included CCTV. However a post-construction site-wide public safety audit recommended the addition of 200mm x 180mm 'mesh' security screens to the outlet which were subsequently installed against the Supervising Engineer's advice (Figure 8).

Figure 8. Devil's Bridge Pond – outlet culverts with security screens open

Since the November 2019 event, the outlet screens are now normally left open (or they are opened as soon as the reservoir starts to fill). A further high flow event in October 2023 - which is estimated to have been greater than that seen in 2019 ($4.0 \text{ m}^3/\text{s}$) - saw the reservoir fill and reach a level of 99.9 mAOD. The reservoir did not spill. The outlet screens were open before and during the event.

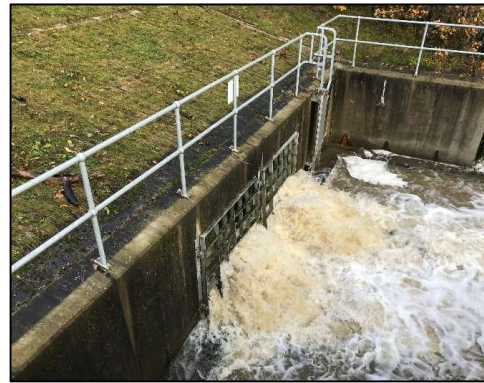
Figure 9. Devil's Bridge Pond – outlet culverts with security screens closed

Following heavy rain during the 7th and 8th November 2019 the reservoir filled for the first time and the overflow spillway started to operate, discharging the excess flow that could not be passed through the Hydro-Brakes™ and the low-level outlet. The outlet security screens were closed during the event, and because of the high water levels in Blackburn Brook they could not be safely opened (Figure 9).

Following the event the screens, culverts and overflow spillway were inspected. While the inlet debris screens had minimal debris accumulation, the outlet security screens had accumulated small debris (mainly grass) representing a 25% loss of area between the screen bars.

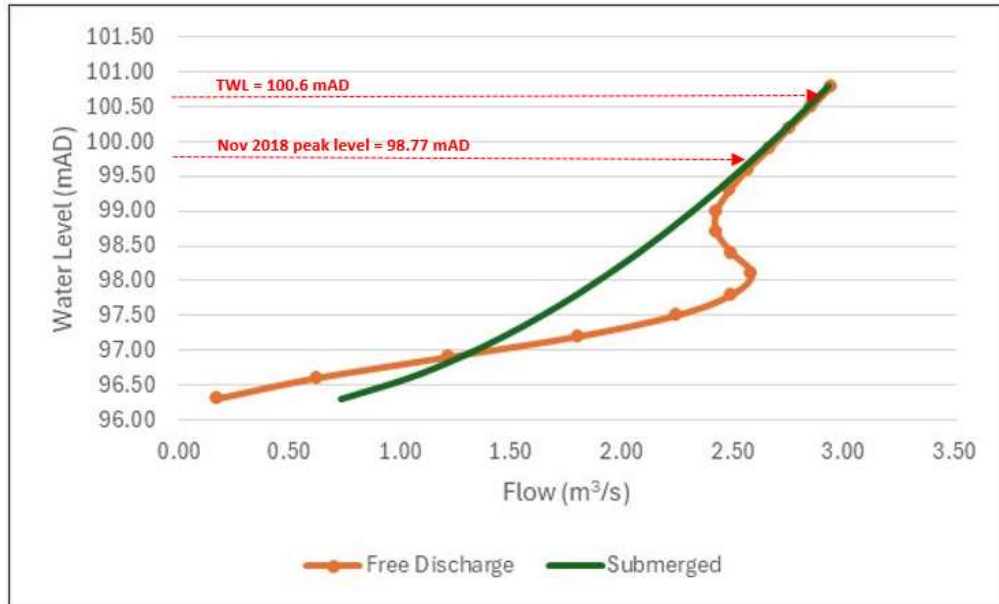
Using the observed rainfall and a hydrological model, the peak inflow to Devil's Bridge Pond was estimated to be 3.5 m³/s. This had an estimated return period of between 5 and 30 years. This was substantially less than the design 150-year inflow of around 11 m³/s for the reservoir to fill completely. The modelling shows that if the Hydro-Brakes™ had operated in accordance with the manufacturers rating curve the reservoir level should have peaked at 98.77 mAOD – well below spill level of 100.6 mAOD.

Further analysis using hydraulic modelling showed that the tailwater effect from the partially blocked outlet screens had prevented the Hydro-brakes™ priming fully and they therefore acted as simple fixed orifices. This reduced the average pass forward flow through them by 62% (Figure 10).

Figure 10. Comparison of Devil's Bridge Pond Hydro-brake™ rating curves under free and submerged outlet conditions (for a single 1098C Hydro-brake™ unit)

Had the design flood event occurred in October 2019 with the security screen closed, the reservoir would not have provided the standard of protection expected, with potentially severe consequences both for public safety and property damage as the flow capacity of the Newton Bank Road Culvert would have been exceeded and the business park would have flooded. The presence of the security screens, even though they are normally open, presents a hazard to the safe operation of the reservoir. This hazard must be balanced against the consequences of unauthorised access to the outlet culverts.

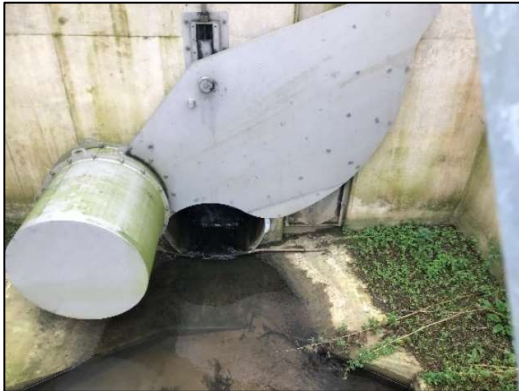
The Pocklington Flood Alleviation Scheme (POCFAS) protects the town of Pocklington in the East Riding of Yorkshire. The main component of the scheme is an $87,000\text{m}^3$ capacity on-line flood storage reservoir. The reservoir outlet consists of a $1800\text{mm} \times 1800\text{mm}$ box culvert with an upstream inlet comprising a 1000mm diameter orifice controlled by a self-activating 'Hydroslide®' scissor gate (Figure 11). There is a debris screen just upstream of the scissor gate with 140 mm spacing between the bars. The net effective area of the debris screen is 14 times the orifice area. A security screen was installed at the downstream end of the culvert to prevent unauthorised access. The security screen has a spacing of 100 mm

Figure 11. POCFAS – scissor gate at the 1000mm diameter inlet to the FSR control structure (photo taken from inside the debris screen)

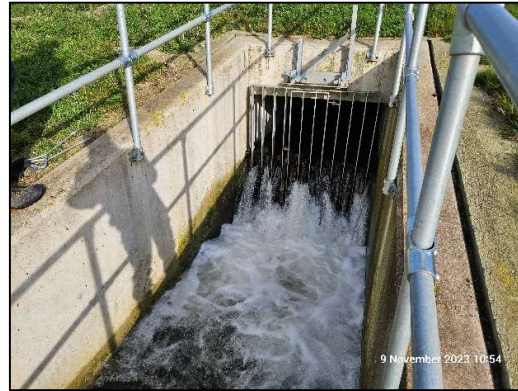
between the bars (Figure 12). The net effective area of the security screen is 0.9 times the culvert area.

The upstream debris screen is designed to be easily cleared using rakes from the access steps and platforms provided. In contrast, the security screen includes no provision for cleaning, although in an emergency the whole gate can be dropped to the horizontal using an emergency release. Once the emergency release is operated there is no easy way to lift the screen back into position.

Figure 12. POCFAS – outlet security screen in November 2023

The FSR was completed in 2019 and had its first substantial filling in November 2023. During this event it was noted there was temporary blockage of the inlet and outlet screens from small floating debris of 20% and 40% of the effective area respectively. The resulting headlosses resulted in the impounded water level being 500mm higher than would have occurred if the screens had been completely clear of debris. This represents approximately 12% of the live storage volume. Following the 2023 event the removal of the outlet security screen is being considered based on a risk assessment using the CIRIA C786 manual.

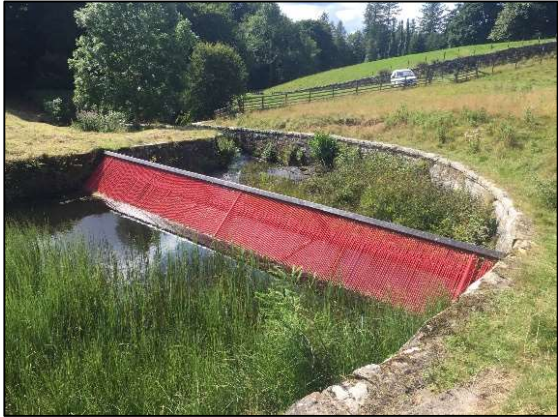
Due to concern about the loss of fish and ducklings from the lake, an inclined 15mm clear spacing bar screen was placed by the owner on the inlet extending to the full height of the overflow wing walls (Figure 13).

Figure 13. Fishing Lake in Northumberland - Fish screen on the inlet to the spillway

Visual monitoring of the screen over a period of four years has shown that the fish screen is easily blocked with small floating debris and requires regular cleaning with a rake. While raking is possible when the lake is not spilling it becomes more problematic when water levels are higher due to the lack of a safe access platform. It was concluded for flood study purposes that the effective starting reservoir water level should be the top of the fish screen. This showed there was minimal freeboard and even a modest flood rise would result in flow over the dam crest. In October 2023, following heavy rain, the screen did indeed block and acted as a weir. The dam crest was overtopped for most of its length (Figure 14).

Following consultation with a fish and bird ecologist and the Supervising Engineer, a replacement screen has been designed which is half the height of the current one and with a wider 25mm spacing between the bars. This is a compromise between fish and duckling protection and flood risk. To discourage fish movement towards the screen an apron of gravel has been placed in front of the screen.

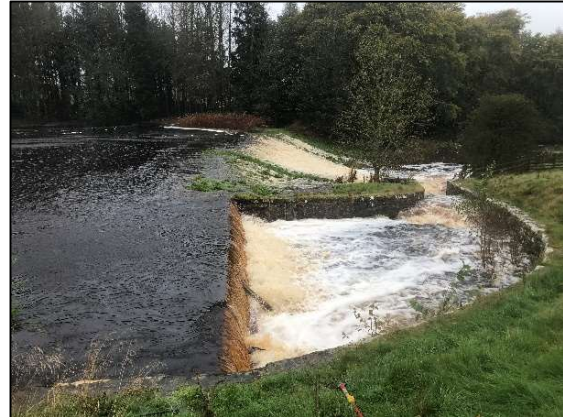
Figure 14. Fishing Lake in Northumberland – flows during Storm Babet, October 2023

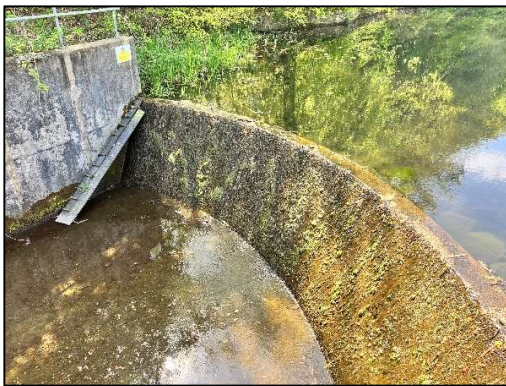
For aquatic birds, eels and mammals, consideration should be given to the provision of ramps to allow weirs and steep drops to be negotiated (see examples in Figures 15 and 16). They can also replace the need for a ‘fish’ screen in some circumstances. These are best as simple wooden ‘plank’ structures and do not need to be able to withstand floods.

Figure 15. 'Duck' ramp installed on an overflow weir as an alternative to a screen

13. Consider 'duck ramps' as an alternative to a screen to prevent bird/mammal injury.

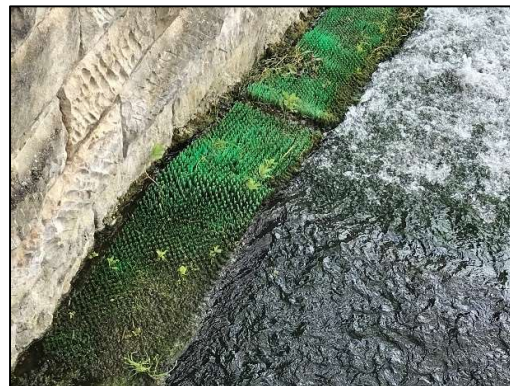
Figure 16. Eel pass installed on a reservoir spillway

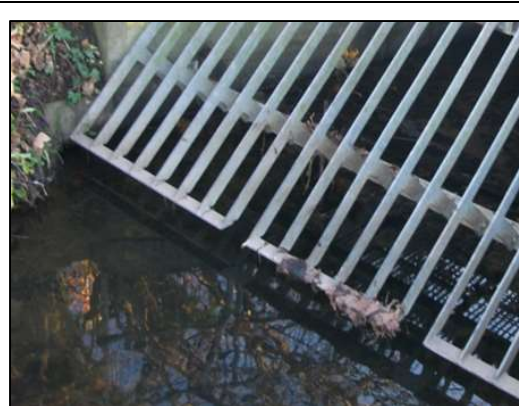
- i. Provide a rectangular (letterbox-shaped) opening of any orientation to allow the beaver to flatten out sideways and squeeze through.
- ii. Provide an opening size of 200mm by at least 250mm for the comfortable passage of adult beavers.

- iii. Avoid square openings unless oversized.
- iv. Avoid sharp edges that could cause injury. Exposed bar ends or edges should be rounded.
- v. For a screen with 150mm centre-to-centre bar spacing, opening size should be 140mm by at least 300mm - this is the minimum requirement. The screen must have a gap between the toe of the bars and the stream bed, which should be at least 150mm high, larger if this can be achieved without compromising the security function of the screen (e.g. part of the opening is permanently below water).
- vi. Any horizontal bar at the toe of the screen must have one or more breaks in (see Figure 18).

Figure 18. Example detail to allow for beaver through a screen
