Springwell Service Reservoir, managing and effectively mitigating ground risks in design and construction.

SYNOPSIS Northumbrian Water Group appointed Mott MacDonald Bentley to design and construct a new 43ML service reservoir in Springwell, Gateshead to increase network capacity and resilience. The structure is 100m by 75m by 9m deep adopting a semi-precast concrete solution. It is founded largely on competent incompressible sandstone however, the southernmost third will encroach over significantly more compressible weathered rock. This presents a risk of early and long-term differential settlement that could impact reservoir structural integrity and potential safety if not adequately managed in design and construction.

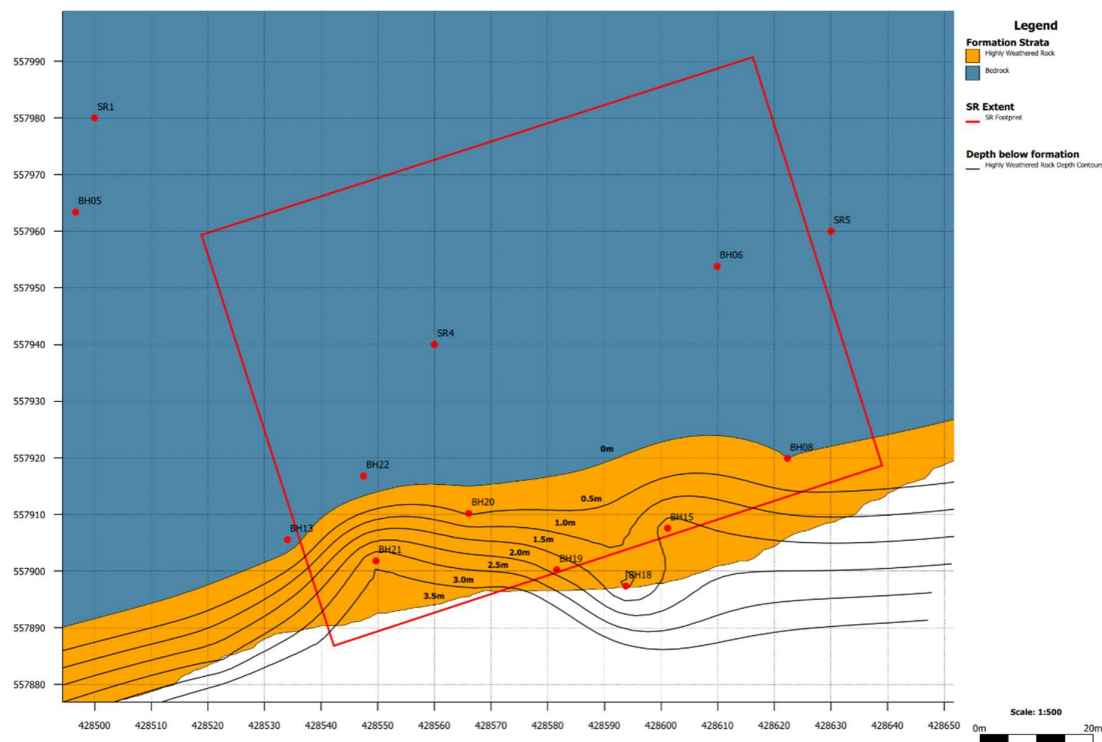
Figure 1: Formation strata; distribution of competent and weathered rock alongside interpreted thickness of weathered Sandstone

A detailed 3D ground model was developed in detailed design based on all the available GI data across the site. The volume of available input data gave confidence that the ground model would be representative and reliable. Interrogation of the ground model identified that the SR formation strata would approximately comprise competent Sandstone over the northern most two thirds and largely Sandstone weathered to a residual Sand and Gravel to the southern third. Figure 1 illustrates a horizontal section cut at the structure formation level showing the general transition from competent to weathered rock with contours illustrating the general thickening of weathering to the South.

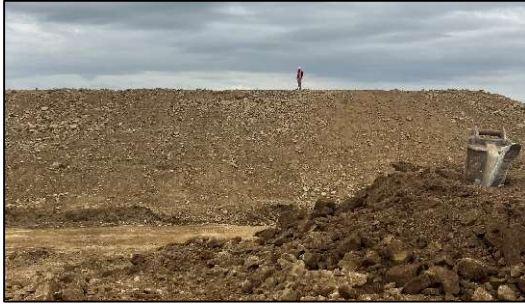
Figure 4 Constructed surcharge bund

The surcharge bund was constructed using as dug material comprising a combination of Glacial Till and weathered Sandstone to a height of 8m (Figure 4). The top of the surcharge bund extended 16m into the SR footprint on the western wall and 2m on the eastern wall to apply loading to the full extent of weathered strata. The approximate extent of the surcharge bund is shown in blue in Figure 5.

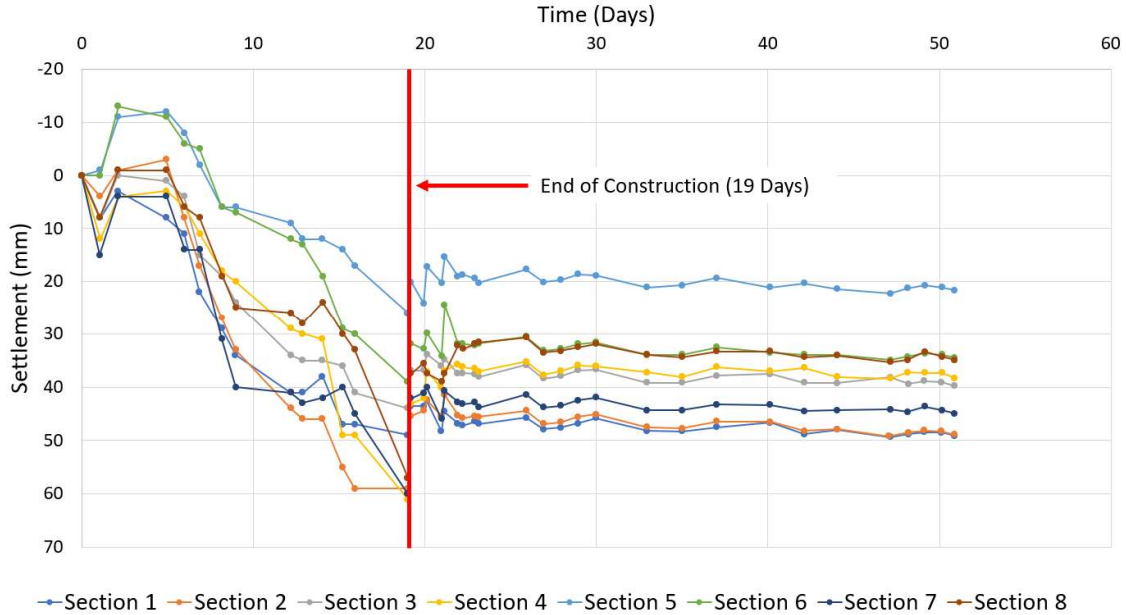
Figure 6: RSG Settlement Monitoring

Figure 6 presents observed settlement for each of the RSG's. Notably, there is an apparent 'rebound' in the readings following initial construction at day 20. This apparent rebound is a result of mathematical adjustment of settlement data to account for loss of RSG verticality that was induced by heavy construction plant constructing the bund.

Figure 6 illustrates a pronounced initial steep increase in settlement during the construction and progressive raising of the surcharge bund. Whilst data from a limited number of RSGs (Section 5 and 6) suggest an initial 'heave' this is attributed to the selected monitoring instrumentation that was rapidly replaced by a precise level monitoring instrument with a +/- 1mm accuracy; it is not considered that the underlying ground 'heaved'. Some of this observed heave, however, could be linked to RSG disturbance whilst placing fill materials.

Beyond the construction period it is observed that no further discernible settlement occurs (Figure 6). This observation confirmed that settlement of the underlying strata was limited to immediate settlement with little evidence of further consolidation settlement. This observed behaviour gave confidence that the reported weathered Mudstone, recorded as residual Clay, was more likely simply a drilling induced phenomenon opposed to an in-situ condition and likely long-term material behaviour. As such, risk of future consolidation settlement of the permanent structure could be discounted.

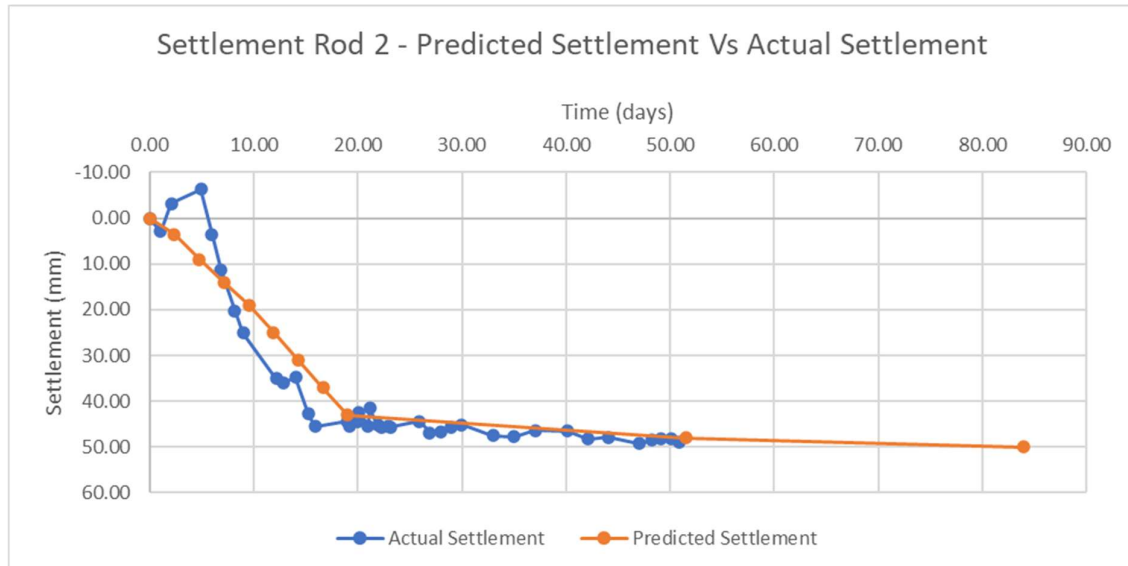
Figure 7: Example actual settlement vs predicted settlement for RSG2

The settlement of each RSG against that predicted from the initial settlement analyses to determine the size of bund required and surcharge timescales (Figure 3) is summarised in Table 3. The observed settlements for the surcharge bund were in the range of 20mm-47mm; this is comparable with the initially predicted magnitude of settlement. Overall, the agreement between actual and predicted settlements was favourable, with observed variations primarily attributed to inherent differences between interpreted and actual ground conditions. It is however, notable that the predicted total settlement was realised within 51 days, considerably sooner than anticipated. Figure 7 illustrates the predicted and actual settlement profiles for RSG 2, illustrating a very close alignment between predicted and observed.

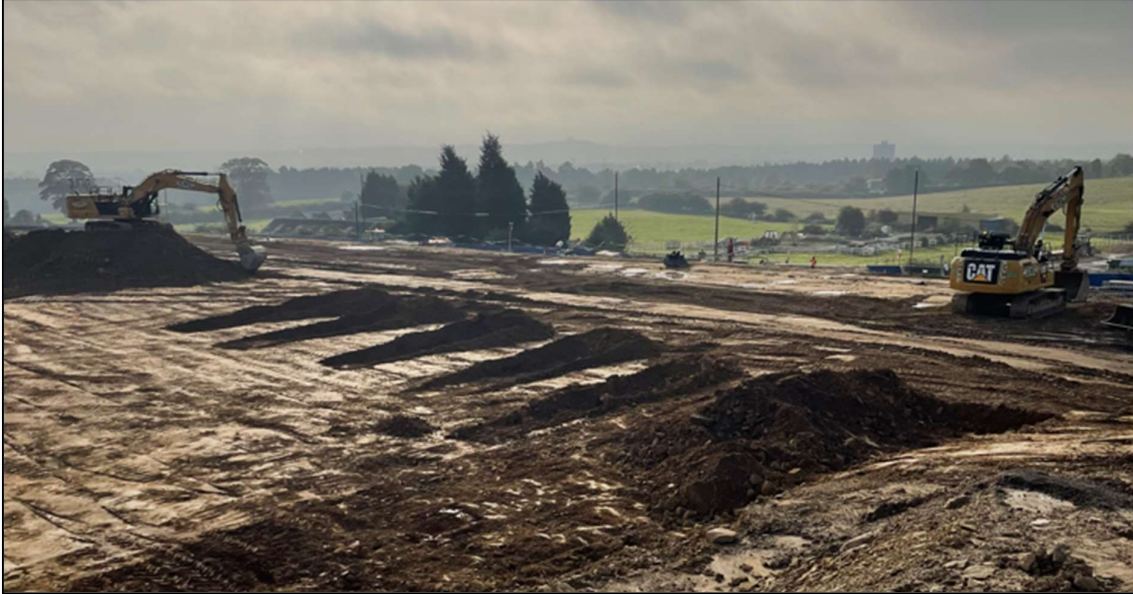
Figure 8: Transition from competent to weathered rock inspection trenches

After the removal of the surcharge bund it was important to accurately locate the transition between competent and weathered rock such that a number of bespoke SR wall panel units could be placed to span this transition. Trial trenches were located based on the 3D ground model and were excavated under supervision of a Geotechnical Engineer. Figure 8 illustrates the inspection trenches employed to pinpoint the actual transition location. On identifying the point of transition this was recorded by site engineers to allow wall panels to be accurately located during future construction.

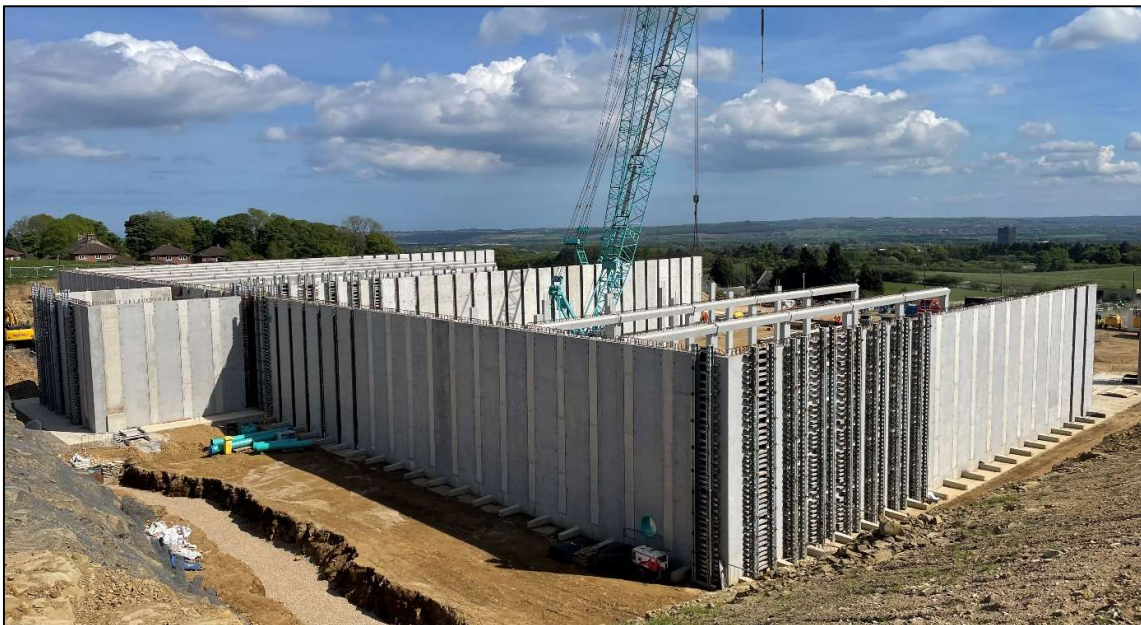
Figure 10: Overview Photo of the Site (taken on 09/05/2024)

Construction to date has largely been over the identified competent rock and only marginally encroaching on the identified weathered zone. Figure 10 illustrates the extent of progress to date (May 2024). Observed settlements from site monitoring have consistently been below that predicted. This alignment between observed settlement and predicted behaviour instils further confidence in the accuracy of the ground model in Settle 3.
