Case studies from challenging pipes and valves works

G CORNELIUS, Mott MacDonald Bentley
M McAREE, Mott MacDonald Bentley

SYNOPSIS With current UK dam stock ageing and infrastructure meeting or surpassing its intended asset life, critical maintenance and replacement of key pipework and valves becomes necessary. The design and construction of historic assets may not have considered aspects such as ease of operation, maintenance and replacement. This paper provides case studies of recent works completed with particularly challenging environments, from projects in Wales.

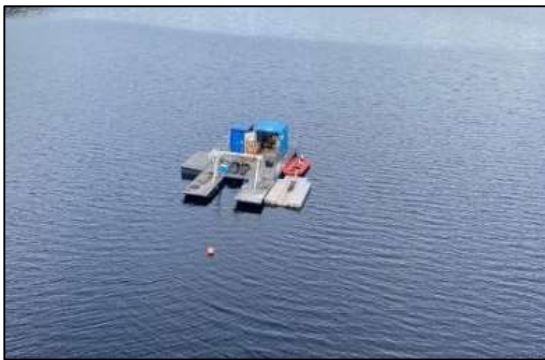
Figure 1. Pontoon

The function of V5 is to act as a burst control valve; shutting down the system should the downstream valves or pipework fail. The asset life of the original mechanically operated butterfly valve had lapsed, and the decision was made to replace this with an electrically actuated gate valve. In order to safely replace the valve, temporary isolations upstream of the 2Nr existing gate valves (S1 and S2) were installed to avoid working under single isolation, following HSE guidance (HSE, 2006) regarding the safe isolation of plant. The works were planned alongside EDS who developed a temporary isolation arrangement using inflatable bungs connected to steel plates. These were installed via a floating pontoon (Figure 1) lowered through a 1.5m diameter diving shaft in sections and re-assembled at depths of approximately 30m. The existing gate valves formed the primary isolation; negligible leakage passed the valves. The temporary bungs formed the secondary isolation, whilst the steel plates (Figure 2) formed a tertiary isolation should failure occur of the bung and gate valve downstream. Schematics of this are shown in Figures 3 and 4.

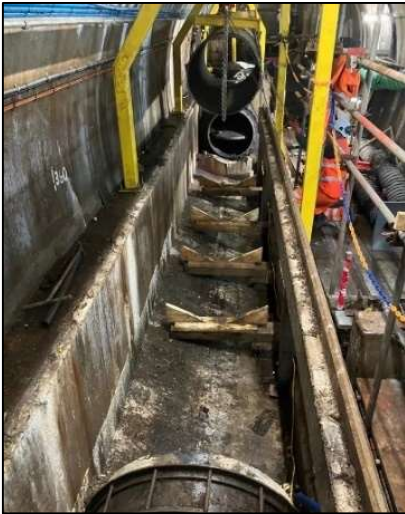
Figure 5. Pipework removal

Due to the location of the valve, additional temporary works and lifting arrangements were needed within the tunnel to facilitate the removal of the existing, and installation of the new valve/pipework arrangement. To facilitate this, a bespoke trolley and lifting gantry (Figure 5) system was installed by Mona Engineering, with the new gate valve weighing approximately 2.3 tonnes. The valve and pipework were lowered into the tunnel via an opening in the roof (Figure 6), transferred to the end of the tunnel on the trolley and lifted by the overhead gantry for the final 20m before being lowered into position and pipework connected (Figures 7 & 8). Given the constraints around isolation and diving, the works were carried out under Welsh Water's 'Gold Command' to monitor progress and resolve any identified issues. Upon completion of the works and the successful pressurisation of the system, divers removed the temporary isolations upstream.

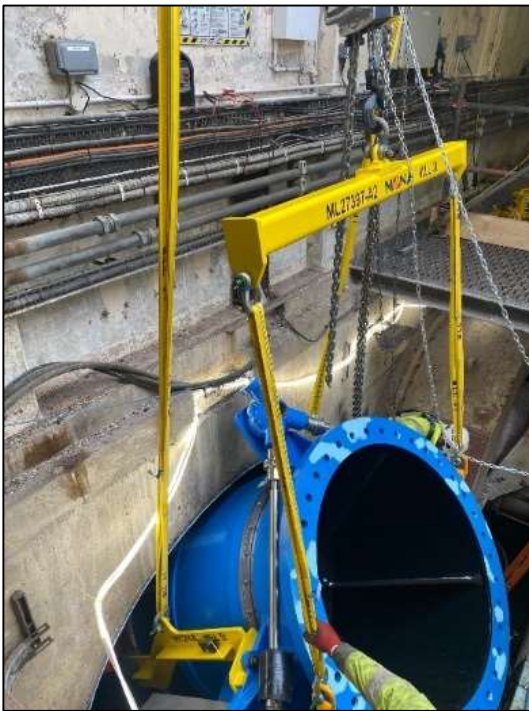
Figure 9. New valve installation

Located at the downstream end of the 66" discharge system, the function of M1 and M2 is to act as terminal discharge valves, allowing flow regulation to the river. Similar to V5, the asset life these valves had expired and required replacing. The new 52-inch fixed cone valves were longer than the original valves and weighed over four tonnes. Given the size of the new valves and existing dimensional constraints, each valve could not be installed in its horizontal position. Installation via the stilling basin would have required emptying the stilling basin along with substantial over pumping, ranging between 1.5 to 16m³/s to maintain statutory releases to the river. The project team worked with Mona Engineering to develop a bespoke lifting frame and methodology to lift and lower each valve into position with limited working room (Figure 9). The lift started with the valve in a horizontal position until it was within the building, transitioned to a 45-degree nosedive (Figure 10), before returning to horizontal as it was fixed to the upstream flange.

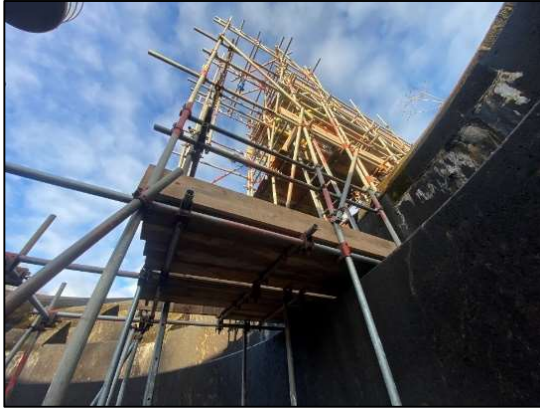
Figure 11. Scaffold installation

To enable the works a 9m high, 10m long scaffold was erected up and over the drop shaft spillway to provide access (Figure 11). With the works being within the reservoir basin, and within the existing spillway, the project team carefully considered the safety of the teams, the reservoir water level with NRW, and managed the risk associated with water resource.

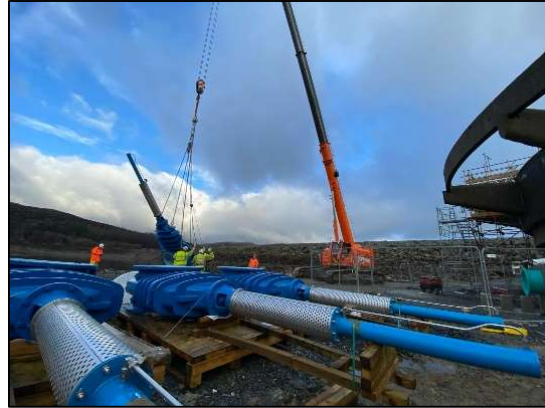
Figure 12. New valves and crane

Two 7m long 1.25m diameter cores were taken through the spillway to facilitate the pipework installation. A 70-tonne (Figure 12) crawler crane was used to lift the valves and lower them between the boat fender and spillway (Figures 13 & 14).

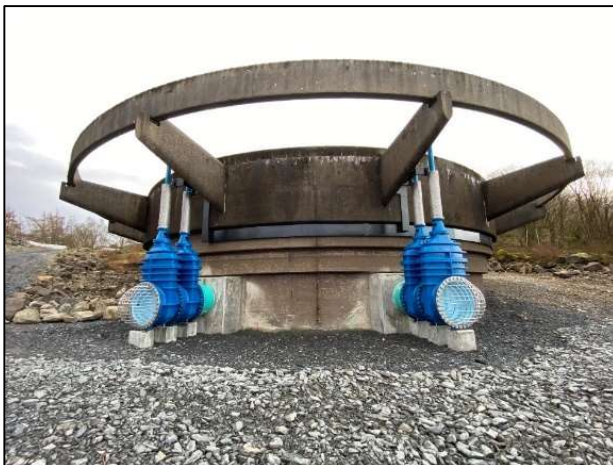
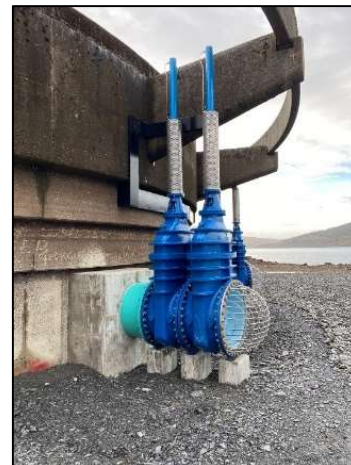
Figure 13. New drawdown facility

In order to enhance the drawdown capacity, two sets of two hydraulically actuated gate valves were installed, connected to new pipework through the primary spillway (drop shaft) wall, with trash screens at the intakes. The valves are fully submerged when the reservoir is at top water level and will be remotely operated by a hydraulic power unit (HPU) using a hand pump or petrol engine. The total discharge capacity of this system is circa 13m³/s.

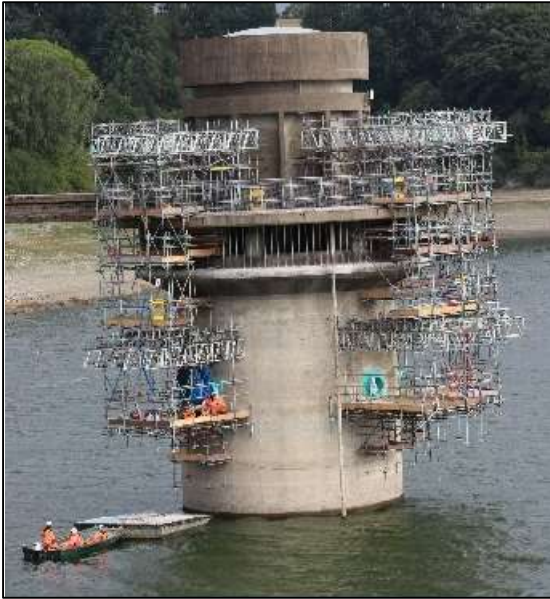
Figure 15. Scaffold arrangement

The project was programmed around the annual drawdown of the reservoir. To facilitate the installation, taking account of a variable water level, a suspended scaffold (Figure 15) with lifting beams was constructed from the top of the valve tower to gain access to the working area. Barges were utilised to transfer the new valves and fittings to the tower.

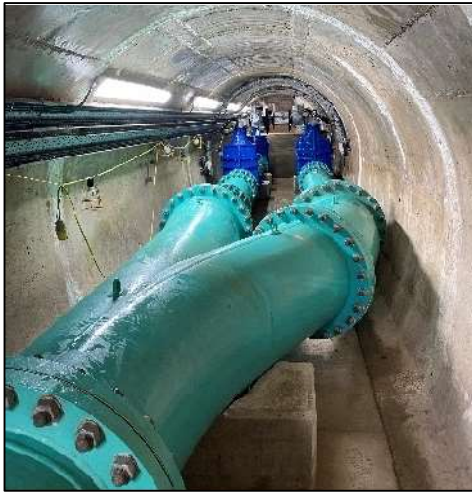
Figure 17. Manifold at bulkhead

A long list of options was developed, with the chosen solution to replace the twin 18-inch pipework with a single larger diameter pipe, offset to one side of the tunnel (Figure 16). This option maximised the outflow from the reservoir and maximised space for access, inspection and maintenance. To merge the two 18-inch pipe sections from the tunnel plug, an asymmetric manifold (Figure 15) was designed to combine the flow, with guard and duty valves upstream of this (Figure 17). Enhanced releases are provided by two flow control valves installed offline to the new drawdown pipework (Figure 18), that could be remotely operated using a telemetry system located in a new control kiosk. The tunnel is circa 190m long and has two 45-degree bends. To facilitate the construction and future maintenance, a screed was applied to the floor of the tunnel. A remote-controlled pipe bogie was utilised to move the pipe sections and valves to their final position.

Following the feasibility stage, the pipework system was further optimised to improve hydraulic efficiency whilst maintaining velocities to a suitable level. The manifold was optimised to achieve balanced flows between both legs, to prevent significantly higher velocities within a single leg. The results of the optimisations enabled the diameter of the larger pipework to be reduced from 900mm to 800mm diameter, leading to a reduction in material costs and embodied carbon by approximate 10%.

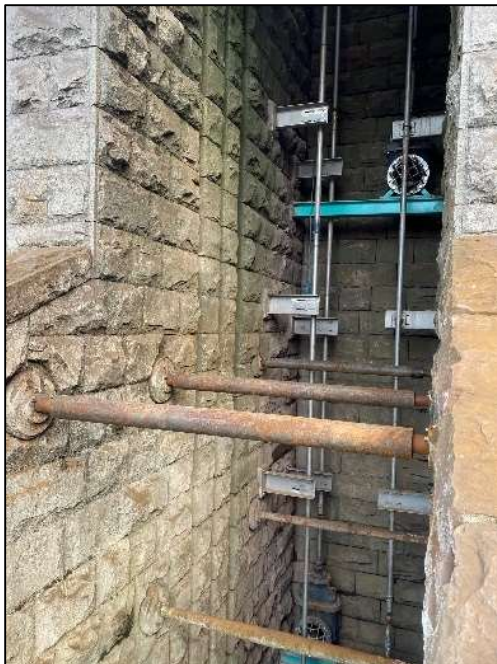
Figure 21. Scour valves and spindles

if required in the future. This included replacing the four gate valves at the interface between the approach channel and wet shaft (Figures 21 and 22), and the valve at the bottom of the wet shaft. The existing pipework through the culvert was maintained, and a 450mm washout provided at the toe of the embankment with a stilling basin prior to discharging to the watercourse.

The original emergency scour system was then discontinued, enabling major environmental benefits in the prevention of large volume of silt removal. The works were undertaken with a partial drawdown of the reservoir utilising a suspended scaffold to replace the top three valves and underwater works using divers to replace the fourth valve.

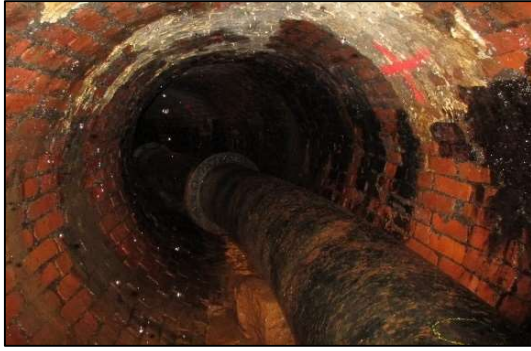
Figure 23. Original tunnel

From the valve tower, water was conveyed through a short section of scour pipeline, where it would discharge directly into the downstream tunnel (Figure 23) when operated. The supply system would convey water through pipework located in the tunnel, until it was beyond the footprint of the embankment, where it would be directly buried to the downstream water treatment works. The tunnel would continue to convey the water from the scour pipeline to the spillway located downstream.

The existing tunnel immediately downstream of the valve tower, under the embankment, was 1.5m diameter and had significant water ingress and had begun to deform in shape (Figure 23). Therefore, it was lined with a 1m diameter pipe, with the annulus infilled with structural grout, which formed part of the new draw-off system. In order to enable the works to the tunnel, and to re-route the new draw-off pipework outside of the dam profile, a 7m diameter tunnel was sunk 11m through the embankment to intercept the tunnel to drive the pipework sections and tunnel the new pipework away from the dam (Figures 24 and 25).

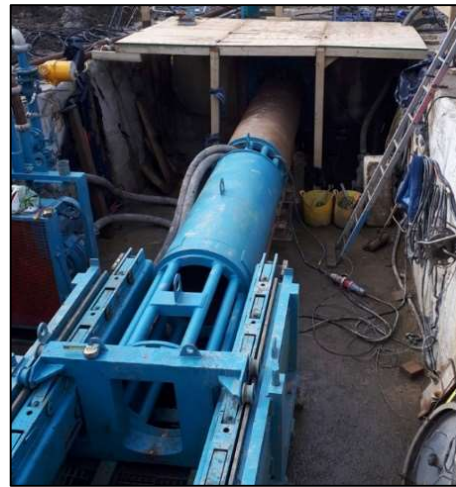
Figure 26. Micro-tunnelling scour main

Downstream of this shaft, a 2.4m diameter tunnel was driven to install the dam draw-off pipework to outside of the dam profile. From this point, the draw-off pipework was micro-tunnelled at 9m depth for 80m (Figure 26) and conventionally open cut for 60m to a submerged discharge valve and chamber adjacent to the receiving watercourse.

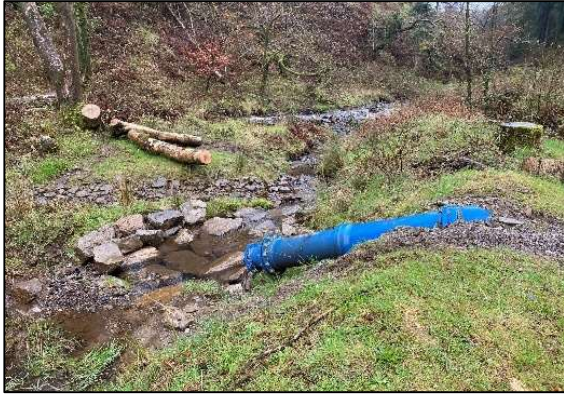
Figure 27. New scour outlet

The scheme to remediate the lack of upstream control, the valve tower and access bridge, and drawdown capacity was planned to be delivered in two phases. The first phase of works consisted of providing a new outlet near the toe (Figure 27) of the embankment to convert the historic supply pipe into a scour pipe, and to provide thrust restraints (Figure 28) to the existing pipework within the unlined rock tunnel. The existing unlined rock tunnel varies in shape and diameter, reducing to around 1.2m high in places.
