Novel geophysical ground imaging technology for the automated long-term monitoring of reservoir dams

SYNOPSIS This paper covers the use of a novel geophysical investigation technique, PRIME, undertaken at two Canal and River Trust reservoirs, Slaithwaite and March Haigh. Due to concerns over seepage the Trust commissioned the surveys to try and establish the cause of the potential seepage pathways. This paper will give an overview of the 4D imagery, its methodology, and the results of which have been interpreted with the use of each of the reservoirs' known geological settings, available ground data and construction information. As with all geophysical techniques, it does have its limitations, however these surveys have provided an insight into the suitability of this technique for identifying seepages within embankment dams through long term monitoring and how it can be further developed for use across the Trust's assets.

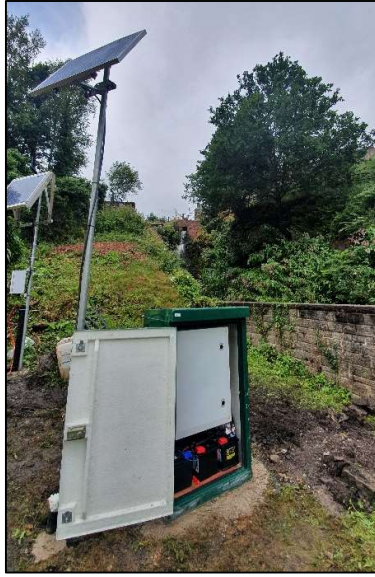
Figure 1. Photo of the PRIME enclosure at Slaithwaite Reservoir (case study 1).

In order to capture changes in electrical resistivity with respect to time we installed PRIME (Proactive Infrastructure Monitoring and Evaluation) resistivity instruments on two earth reservoir dams (see following sections). PRIME is designed to be an automatic resistivity instrument which is left (semi) permanently deployed in field conditions; the instrument can then be interfaced via telemetry and left to automatically collect resistivity measurements at specific times of day. The PRIME instrument uses arrays of electrodes connected via multicore cables, usually routed through shallow trenches/pits. This instrumentation was originally developed as a low cost and low power system to complement already existing monitoring technologies on geotechnical earthwork assets. To generate resistivity images, raw electrical resistance measurements are processed via a 4D smoothness constrained least-squares inversion algorithm described by Loke et al (2022).

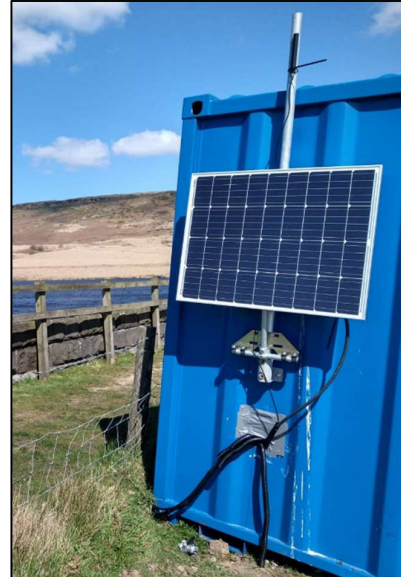
Figure 2. Photo of the PRIME enclosure at March Haigh Reservoir (case study 2).

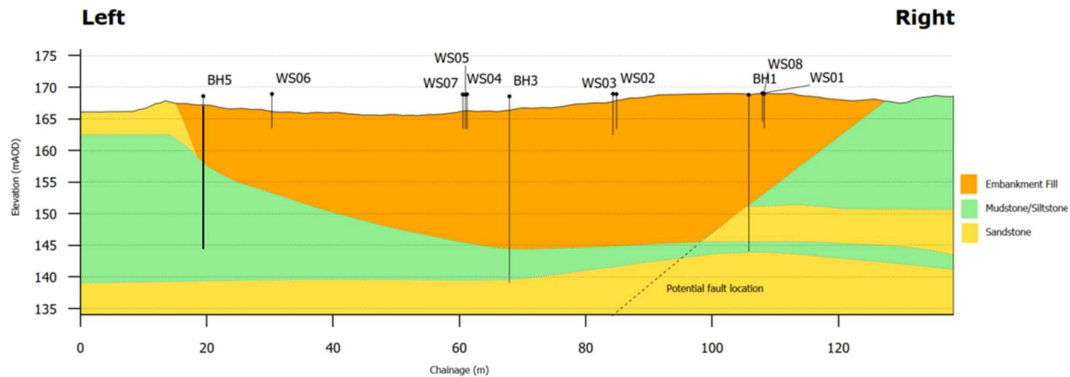
Figure 3. Slaitwaite indicative geological long section.

An indicative longitudinal section through the dam axis is presented in Figure 3 and shows a conceptual model through the embankment and foundation using historic boreholes and rock mapping data. The section identifies sandstone units at lower elevations in the right abutment

which are interbedded with mudstones. The left abutment appears to consist of a single sandstone unit at approximate crest level elevation with the remainder of the abutment formed from mudstone. The geology of the left abutment is confirmed via rock exposures within the spillway chute. The differences between the geological sequences in the left and right abutment suggest the presence of a fault within the valley bottom. In terms of rock mass permeability, mudstones are typically known to have low porosity and low permeabilities with sandstone tending to have relatively higher porosity and permeability.

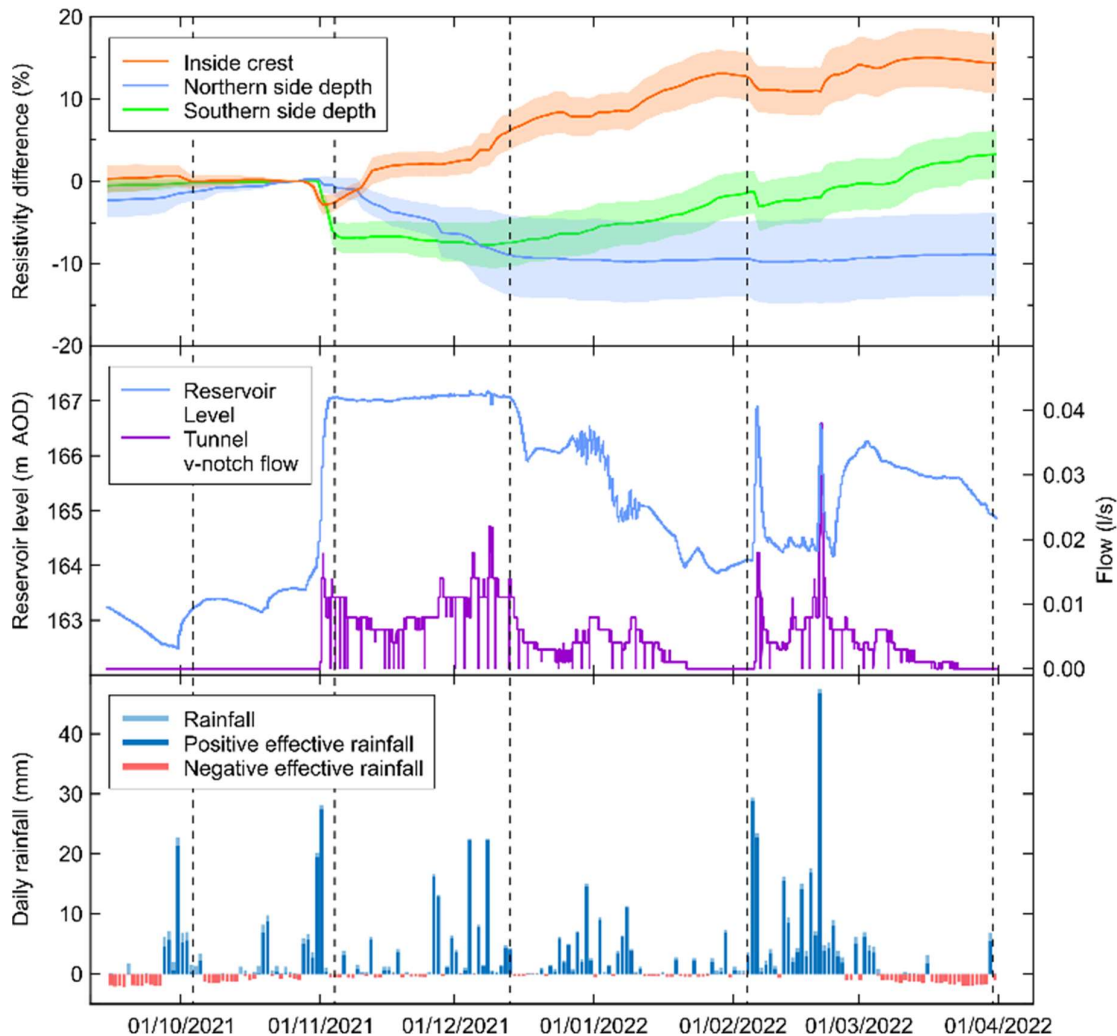
Figure 5. Selected regions of the dam for the period ranging from 15/09/21 to 31/03/22. Resistivity change, rainfall, effective rainfall, seepage flow and reservoir level.

During the raising of the reservoir level, PRIME reported significant changes in resistivity across the length of the outlet tunnel, in the dam crest and in the vicinity of the abutments. Figure 4 presents images from the time-lapse data at various stages of reservoir rise and fall. The most substantial changes in resistivity are concurrent with the rapid rise in level of the reservoir and a period of heavy rainfall in early November 2021. Figure 5 presents this

monitoring period and changes in resistivity in graphical form. Reductions in resistivity during this time are initially concentrated: (1) in a thin layer in the crest region (represented as red); (2) at deeper levels within the right side of the dam (represented as green); and (3) within the left side of the dam (represented as blue).

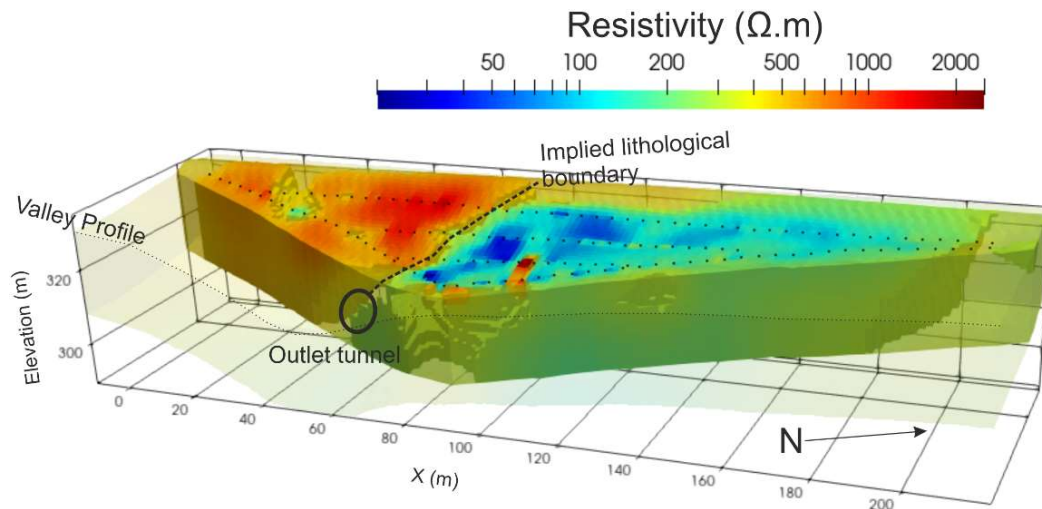
Figure 7. Baseline resistivity image of the downstream side of the March Haigh dam. The boundary between the two dominant resistivities regions of the dam (and by extension lithologies) has been indicated.

Raw electrical measurements were processed in the same manner as for Case Study 1. Figure 7 presents the ERT baseline survey. There are two distinct regions of electrical resistivity in the dam and indicate the embankment-foundation contact is asymmetrical of the left-hand side and right-hand side of the embankment. The left side of the dam is more electrically conductive than the right, both being characterised by resistivities of either less than 100 Ωm or 500 to 2,000 Ωm , respectively. The lower resistivity of the left side of the dam indicates that it is compositionally different to that of the right side. This means it is likely to have a higher clay content in comparison to the right side of the dam. The apparent boundary between the regions of the dam is sharp and represents the construction methodology of the embankment where material is believed to have been sourced from each side of the valley. Weathered shales from the left are likely to contain a higher proportion of silts and clays with the right side of the valley dominated by more sandy material. This boundary also corresponds to the alignment of the outlet culvert indicating that the dam was constructed in two halves.

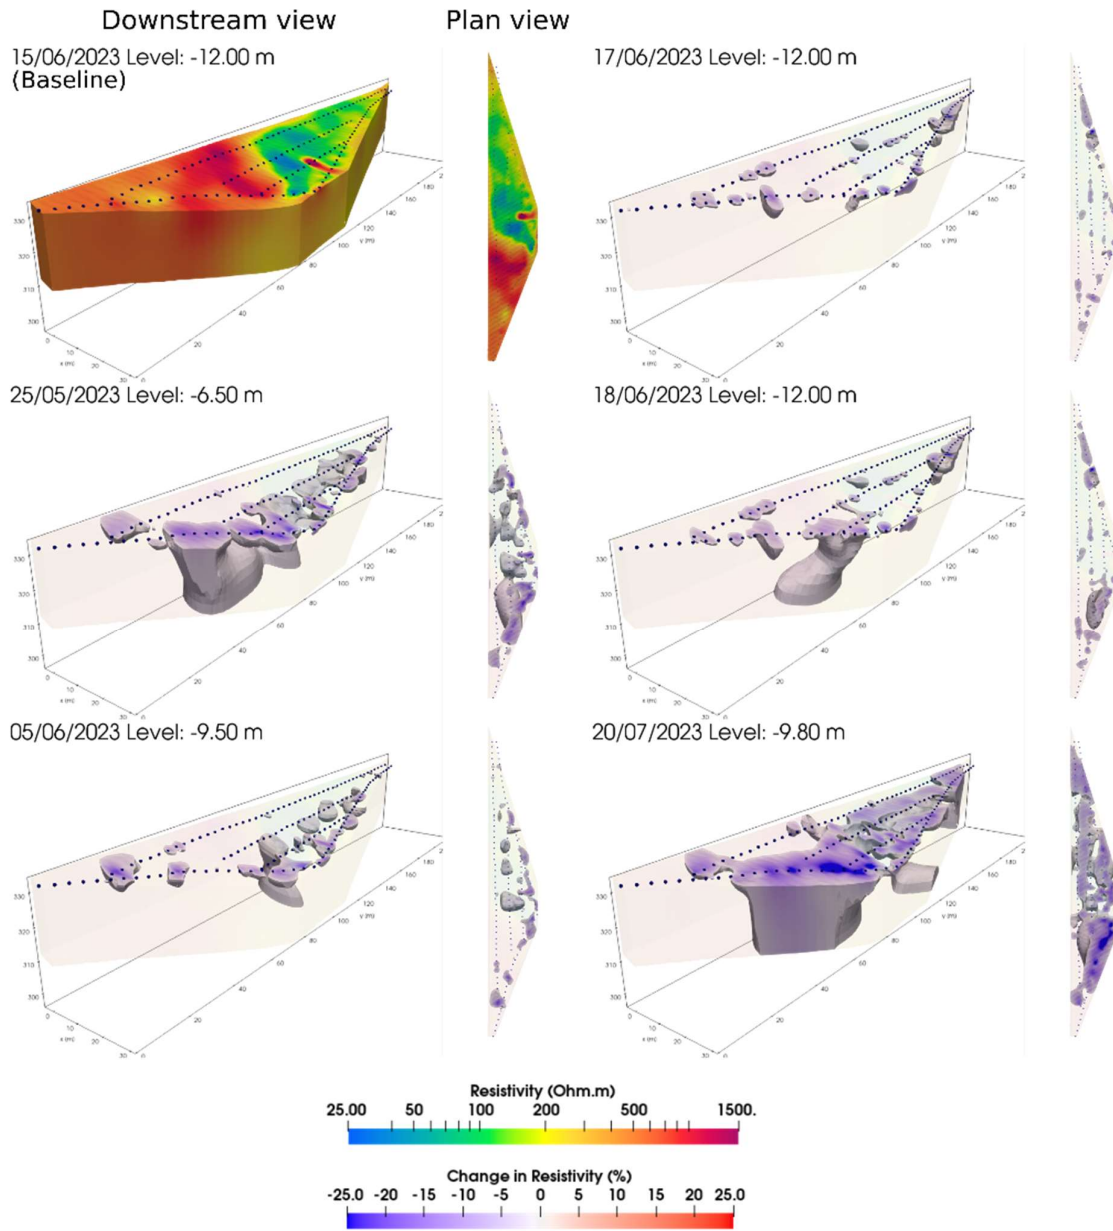
Figure 8. Baseline resistivity images (15/06/23) and a series of change images (% resistivity change) ranging from 25/05/23 to 20/07/23, focussed on the period reservoir level change at March Haigh. Iso-resistivity level in the change images set at -2.5%.

We show negative resistivity anomalies that occur in comparison to when the reservoir was recorded at 12.0m below TWL (14th of June through to 7th of July 2023). During the drawdown of the reservoir level the resistivity of the area surrounding the outlet tunnel increased, indicating this area responds rapidly to changes in reservoir level. Changes in resistivities rapidly became negative after a period of rainfall (18th to 21st of June). This was observed across the surface of the dam face, likely because of near surface moisture contents increasing due to infiltration of rainfall. Figure 8 presents the change in resistivity, noticeably decreasing in resistivity surrounding the outlet tunnel, indicating that this part of the dam has a relatively high hydraulic conductivity. The negative resistivity anomaly surrounding the outlet tunnel does increase in size and magnitude as the reservoir level recovers (7th of July through to 31st of July). However, this period also corresponds to days with elevated levels of recorded rainfall. It is therefore difficult to fully decouple the contribution of rainfall and reservoir level increase to the negative resistivity contrast. On the other hand, the rapid response of this part of the dam to reservoir drawdown and rainfall, and differing resistivities, does indicate this part of the dam has a relatively higher hydraulic conductivity. Ongoing observations of leakage made in the outlet tunnel support this hypothesis. Figure 9 shows the average resistivity (and changes) in the outlet tunnel area (in green) for the duration of the study, alongside effective rainfall and reservoir level records.

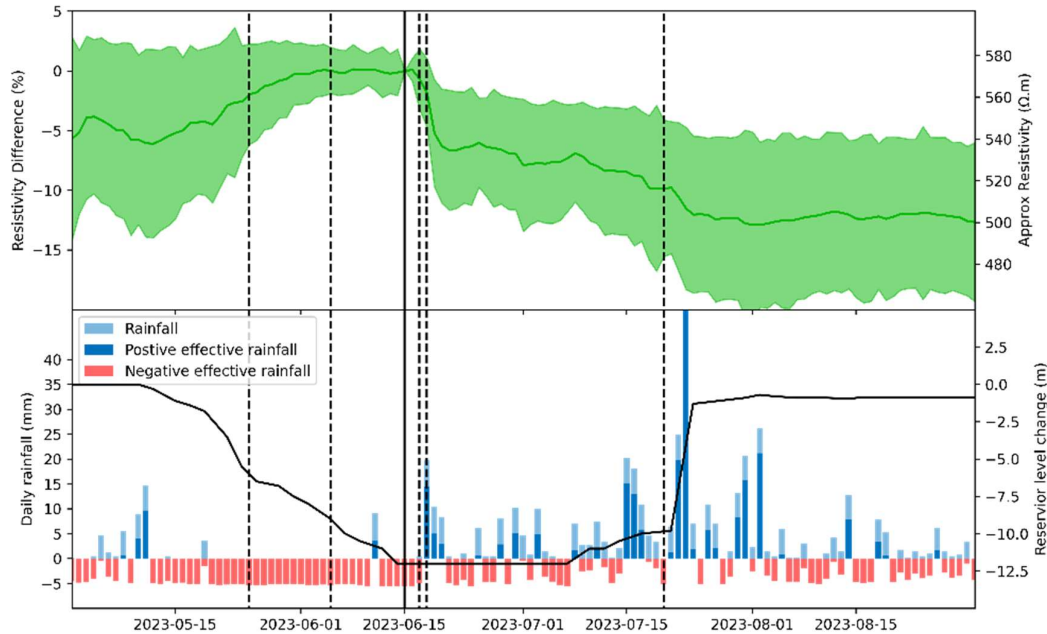
Figure 9. Rainfall, effective rainfall, reservoir level, and resistivity changes (shaded area indicates \pm standard deviation) in material surrounding the outlet tunnel, for the period ranging from 01/05/23 to 31/08/23.
