Design and Construction of an Open Stone Asphalt Spillway for Wychall Flood Storage Reservoir

J G PENMAN, Mott MacDonald
S A HAYWOOD, Environment Agency
A L WILDEE, Mott Macdonald
N A HENDERSON, Environment Agency
R C SMITH, Hesselberg Hydro (UK) Ltd

SYNOPSIS Wychall Flood Storage Reservoir is a Category A flood storage reservoir on the River Rea in the Kings Norton area of Birmingham. A section 10 inspection in 2020 identified shortcomings in the existing spillway provision and recommended measures in the interests of safety. A subsequent flood study identified that the spillway needed to be lengthened and reinforced to withstand overflowing velocities of up to 7.3m/s. The reservoir is located within a local nature reserve and great importance was placed on maintaining biodiversity and minimising the visual impact of any alterations. Opportunities to reduce the carbon footprint of the project was also a priority. Possible options for reinforcing the spillway were a cast in-situ cellular reinforced concrete system, precast concrete blocks, or open stone asphalt (OSA). Following a review of options, OSA was selected as the preferred solution for reinforcement of the spillway. The

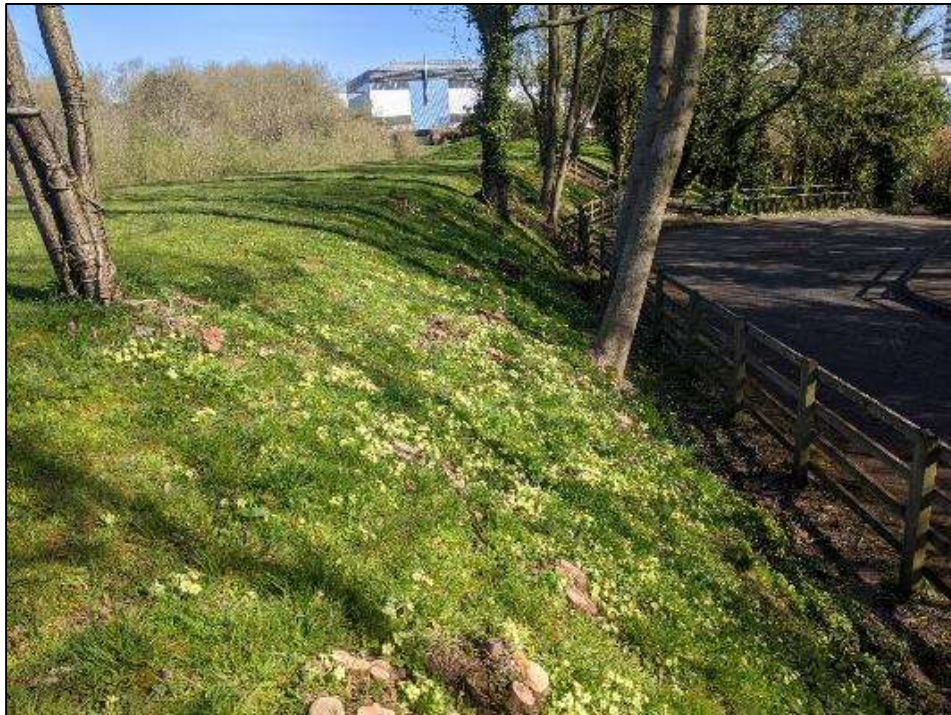
- The emergency spillway had a steep, largely unprotected, downstream face with many trees (Figure 1) in the area between the crest and the access road. It was understood that this has been accepted previously because the line of sheet piles through the centre of the dam meant that the downstream face could be regarded as sacrificial. However, this argument was not considered to be tenable as the sheet piles were too short to be able to support the upstream shoulder on their own.
- Flood modelling suggested that the spillway capacity was inadequate and the main, unprotected, section of the embankment would overtop in the PMF.

Figure 1. Original spillway arrangement

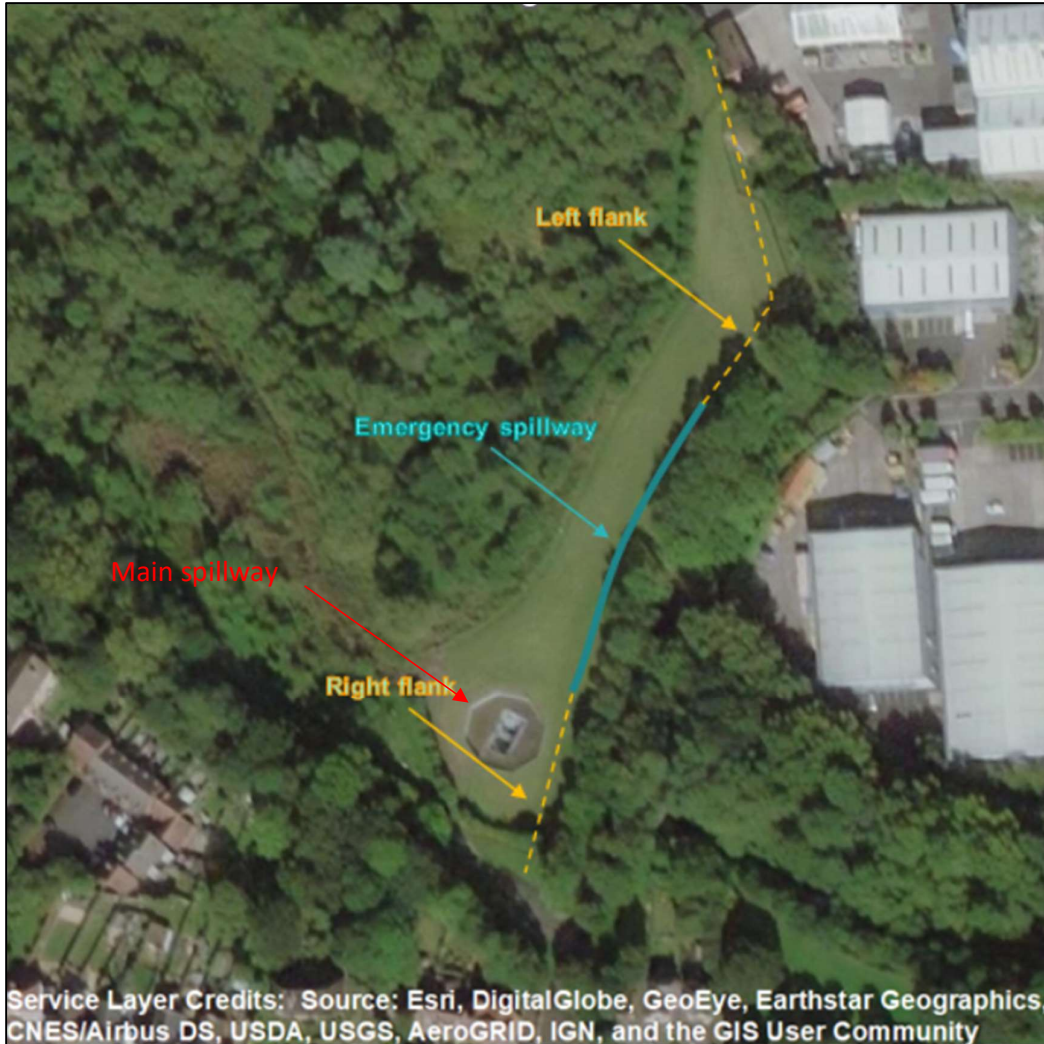
Figure 2. Plan of Wychall Reservoir with indicative spillway layout

It was thereafter determined that to pass the PMF, the length of the spillway needed to be extended by 25m and that the spillway needed to be capable of withstanding velocities of up to 7.3m/s. In addition, the left flank needed to be raised to above PMF level and the right flank made capable of limited overtopping. The layout of the dam is shown in Figure 2.

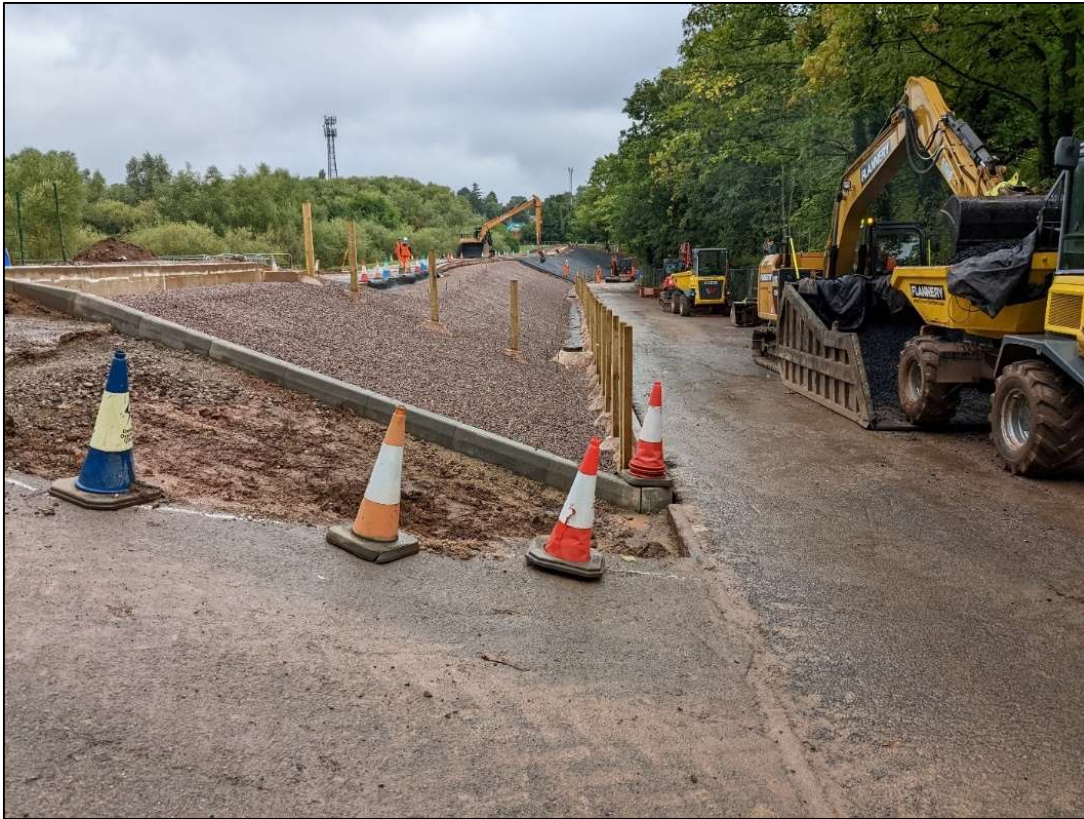
- OSA delivered into a steel delivery skip placed along the toe of the dam.
- Material transferred from delivery skip into a 6T site dumper, taken to the crest of the dam and discharged into a 10T capacity skip on the crest.
- A 13m long-reach excavator placed the material on the slope and profiled it using a travelling shutter to control layer thickness.
- A smaller excavator at the toe completed areas beyond the reach of the crest excavator.
- When the OSA was completed the hot-poured mastic seal was applied to the OSA edges that abutted concrete or steel structures.

Figure 4. Placing OSA (dumper being loaded at downstream toe)

Figures 4 and 5 show the procedure in operation.

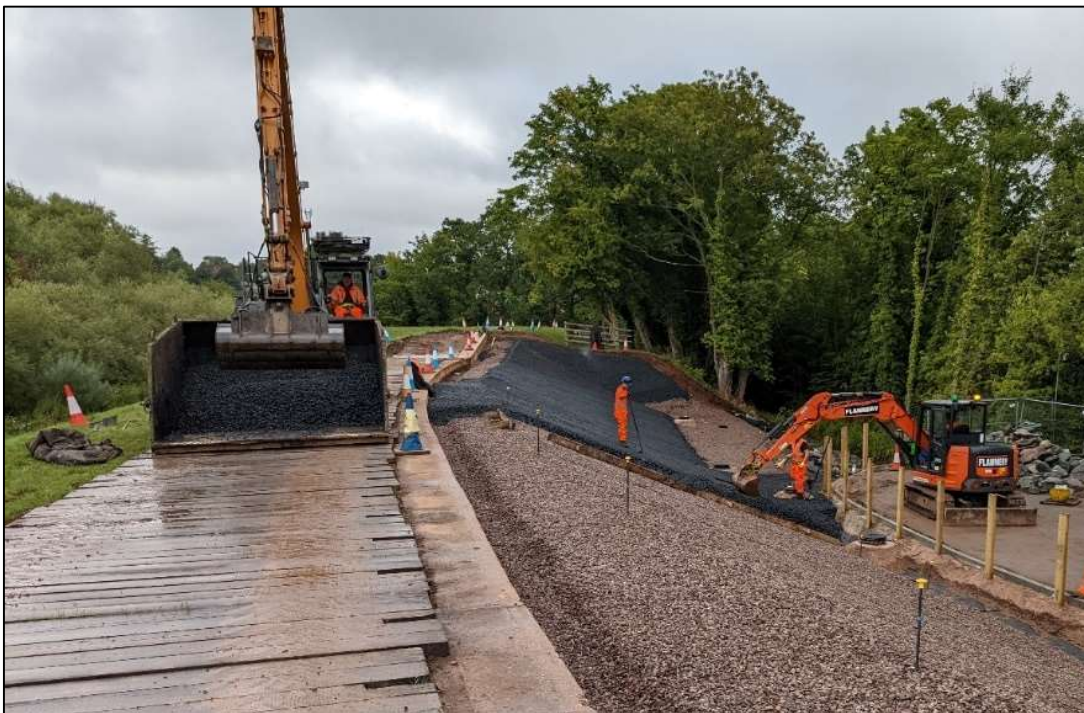
Figure 5. Placing OSA (long reach excavator taking OSA from skip on crest)

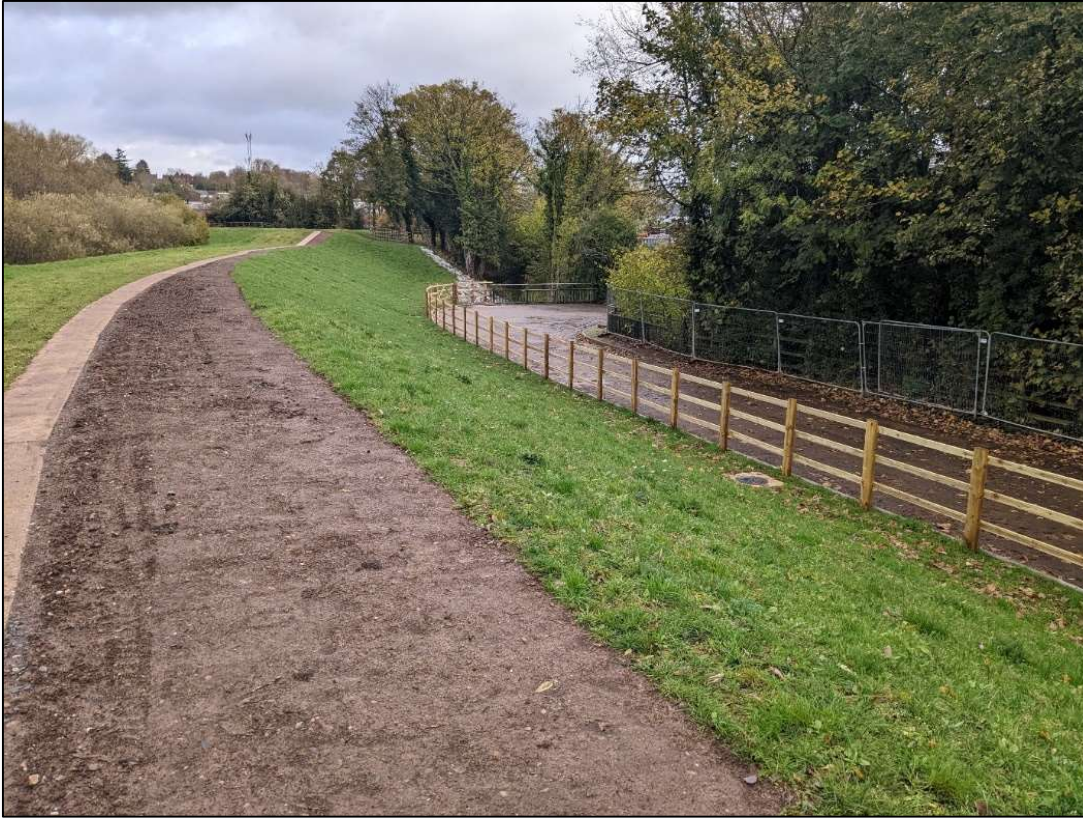
Once the OSA had been placed the spillway was turfed to enhance its aesthetic appearance. To mitigate for the loss in trees and contribute towards biodiversity net gain targets, the client suggested a wildflower turf, instead of a standard grass mix. This was considered acceptable from a technical perspective as the vegetation and soil above the OSA does not contribute to the erosion protection.

A UK low growing native turf consisting of 20% grass and 80% wildflowers was installed. To provide strength and stability the turf incorporates a fine degradable net in its root zone. Additionally, swathes of bulbs were planted to further increase biodiversity. There remains the option to adjust the diversity of the wildflower mix or revert to a traditional grass mix in the future, if required.

Figure 6. Completed spillway with turf installed

Figure 6 shows the final appearance of the completed spillway.
