## Canal & River Trust – Toddbrook & Combs Reservoirs

The group will visit two canal supply reservoir that are close to each other. At Toddbrook we will see the recent spillway works. At Combs we will see the historic stability works. There is a 10-minute drive between the two dams.

### Toddbrook Reservoir

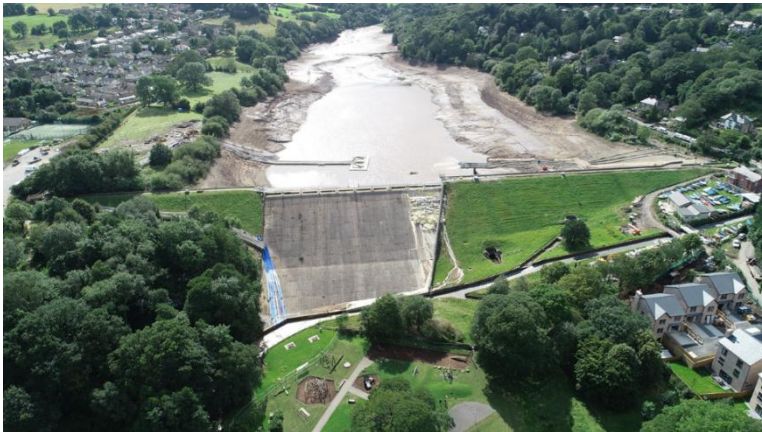
*Figure 1 Toddbrook Reservoir - Post Incident*

In 2019, damage to the spillway led to an emergency drawdown, evacuation of downstream residents and subsequent major rehabilitation works. The site has since undergone significant improvement works to enhance its resilience and safety, including reconstruction of the spillway and upgrades to drainage and monitoring systems.

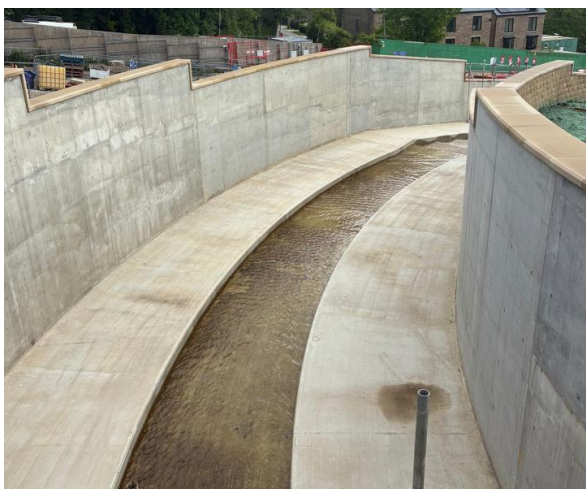
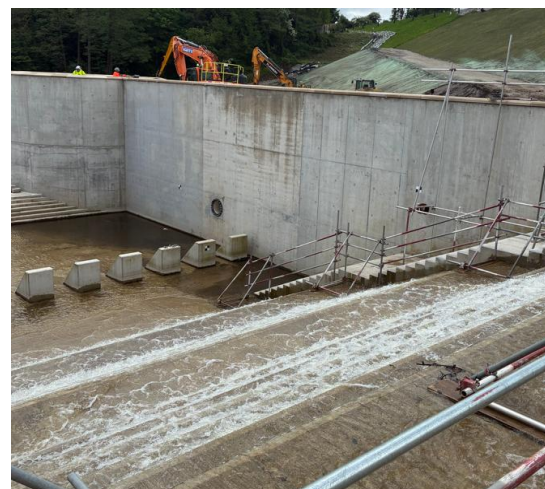
*Figure 2 New Auxiliary Spillway under low flow conditions*

Following the 2019 incident, a new spillway has been constructed to significantly improve the safety and resilience of the dam. The spillway has been designed to be integrated within a public park and wider landscaping. The spillway is of a side-channel configuration located on the left-hand side of the dam, adjacent to the main embankment. It includes a 72m long composite weir, designed to provide increased discharge capacity during extreme rainfall events and to reduce the risk of overtopping.

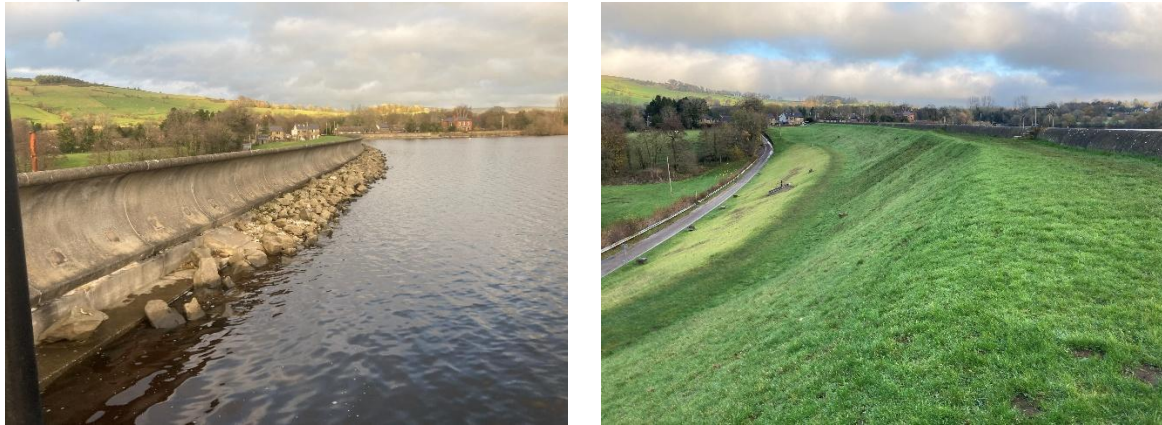
*Figure 4 Combs Reservoir – Concave wave wall and stability berm*

On the 29th January 1976 there was a local failure of the upper part of the downstream slope of the embankment at a point some 15m to the south of the inlet to the swallow hole overflow. Part of the crest dropped as the downstream slope slipped outwards, and as a consequence the slipped material blocked the road known as Tunstead Lane that ran along the toe of the embankment. The slip did not cause a catastrophic breach of the embankment, but emergency measures were put in hand to lower the reservoir water level by around 2m in order to reduce the hydrostatic load on the embankment. Extensive investigations were then undertaken into the cause of the failure and a remedial works project was initiated to increase the stability of the bank. As a result of these studies it was also determined that additional wave protection works were required to the crest. The remedial works were designed by Halcrow in the early 1980s and a contract for their construction was let in the summer of 1982. The works were duly completed in 1983. The main components of these extensive remedial works were as follows:

- Construction of a supporting buttress against the lower part of the downstream face comprising of 16,000m<sup>3</sup> of rockfill.
- Extension of the draw-off and overflow culverts through the embankment in order to accommodate the new buttress.
- Raising of the control gear for the draw-off valve.
- Re-location of Tunstead Lane from the downstream toe of the old embankment so as to run along a berm that was formed on the new buttress.
- Wave protection to the upstream face and crest was improved by the addition of a reinforced concrete wave wall. This was combined with a sheet pile cut-off that extended down through the raised portion of the crest (added in 1826) so as to penetrate the fill of the original embankment beneath.
