Investigation and Rehabilitation of Chardara Dam Spillway

J H Meldrum, Mott MacDonald Limited

SYNOPSIS. A reported vibration problem with 40 year old spillway outlet gates turned out to be a hydraulically poorly designed structure with cavitation and hydraulic impact problems requiring alterations to the structure as well as replacement of the gates. Vibration surveys, hydraulic model testing and diving surveys were all employed successfully to investigate the cause of the problem and to assist with the design of the remedial works. Dewatering of the structure was required to carry out the remedial works and as there were no provisions to do so in the existing structure a caisson gate was designed that could be floated into the site and then positioned by flooding watertight compartments.

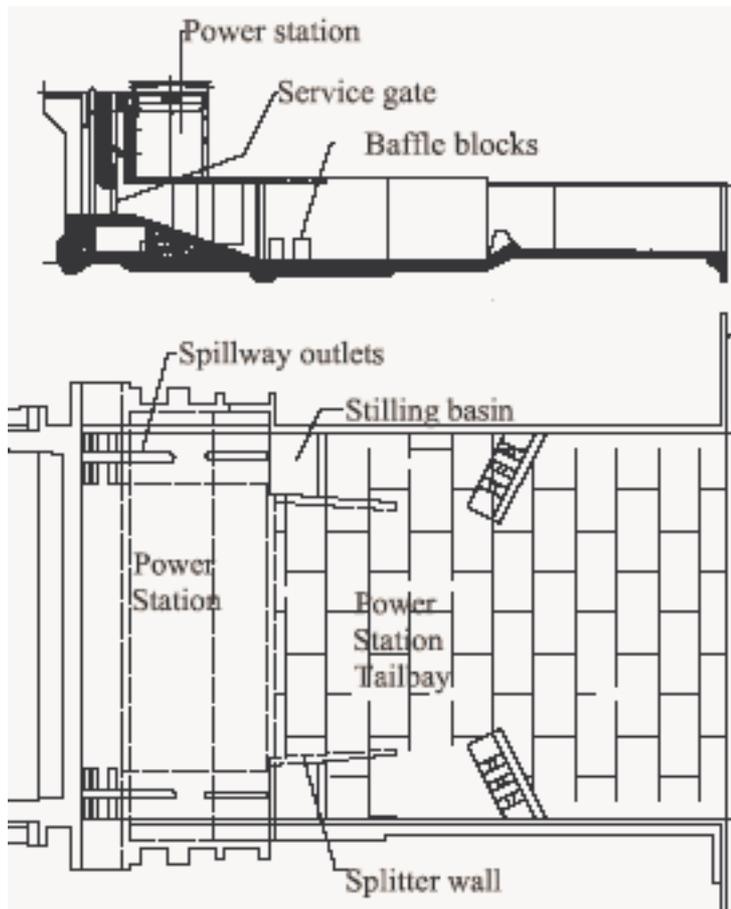
Figure 1: Longitudinal Section and Plan of Outlet Works

Significant aspects of the layout are:

- 5 m downstream of the gates the floor drops 10 m at a constant slope of about 1 on 3 (H:V) into a stilling area;
- there are three 5 m high baffle blocks shared between a pair of outlets immediately downstream of the sloping section;
- there is a partial splitter wall and two columns between the pair of outlets;
- there is a further partial wall between the stilling basins and the turbine outlet channel;
- the sloping section and baffle block parts of the basin are covered by a slab that forms the generator hall service bay and takes the station access road.

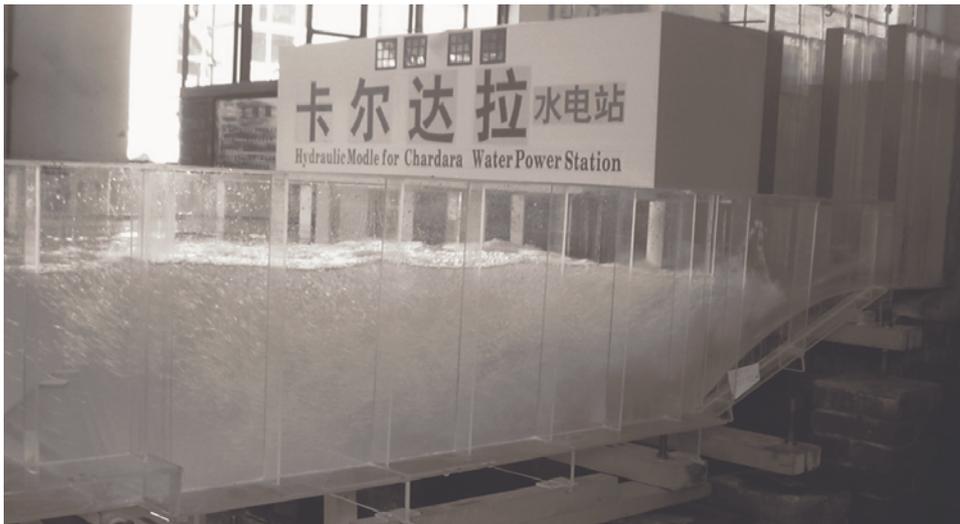
Photograph A: Model Test

- negative pressures occur at the top of the sloping section;
- hydraulic conditions are improved with re-profiling the sloping section and infilling the walls;
- an adequate and less intense jump forms further down the basin with reduced height of the existing blocks;
- the water surface will overtop the side walls of the structure with reduced (future) tailwater levels, if the baffle blocks are not reduced in height.
