Physical Testing of a Stepped Masonry Spillway

P. D. DOWN, Mott MacDonald-Bentley, Leeds, UK

M. WEARING, CRM Rainwater Drainage Consultancy, Bolton, UK

SYNOPSIS Many of the dams that have been constructed in the UK incorporate stepped masonry spillways. In recent years, a number of incidents have highlighted the risk of damage to these types of spillways during flood events resulting in a potential risk to reservoir safety. This was particularly evident during the incidents at the Boltby and Ulley reservoirs.

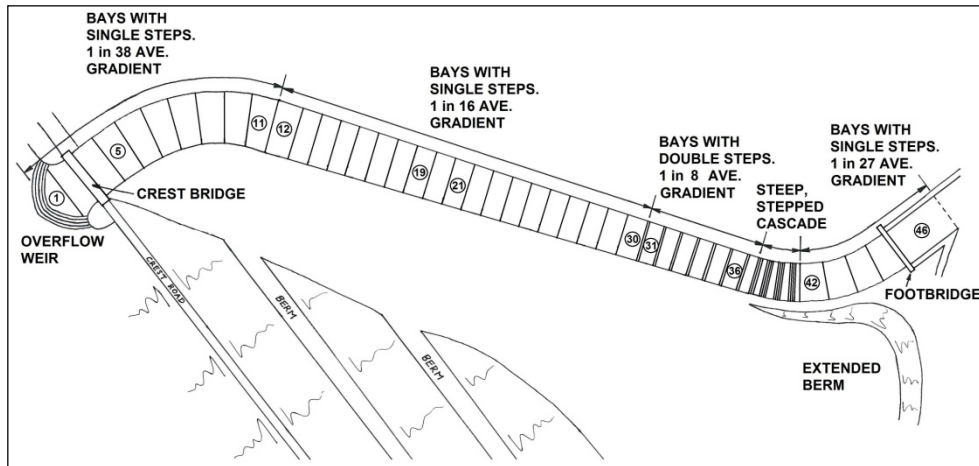
Figure 1. General arrangement of spillway

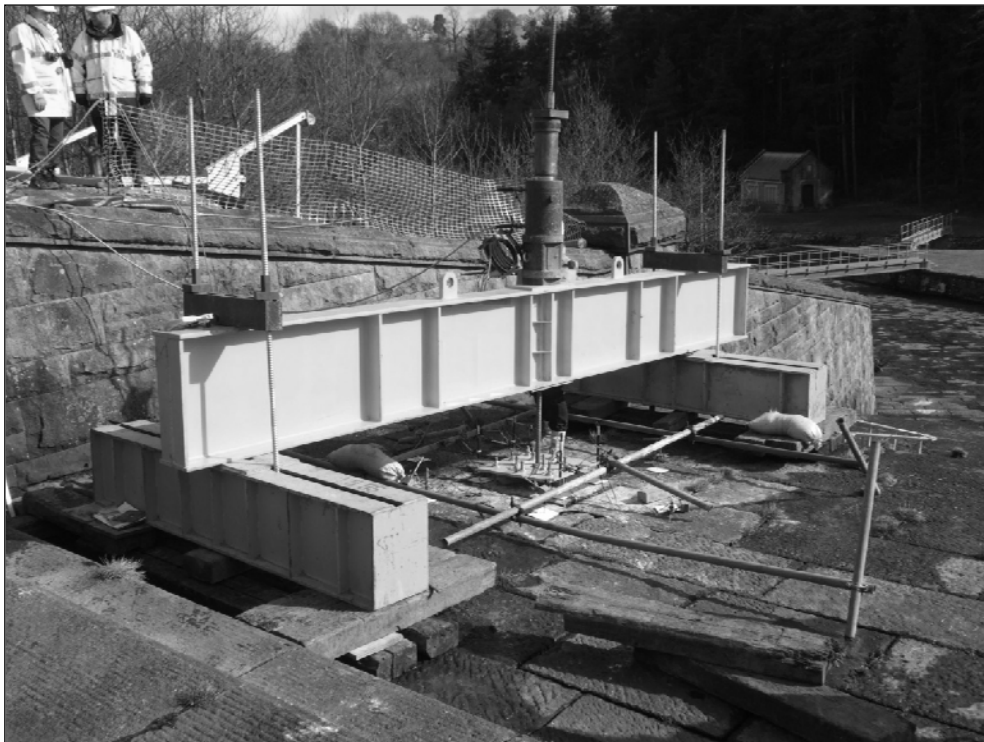
Figure 4 shows the test equipment used. Anchor dowels were fixed into the invert block to be tested and these, in turn, were attached to a load plate and shaft. A hydraulic ram, supported by a beam spanning the test block and adjacent blocks, gradually imposed a load. The applied load and movement of the test block and adjacent blocks was monitored throughout the test.

Figure 4. Equipment for load testing of channel invert blocks
