Recent incidents at canal reservoirs

D. H. BROWN, Canal & River Trust, Warwickshire, UK

SYNOPSIS Two incidents at Cofton reservoir are described; the first relating to leakage of an old dam predominantly made of sand and the second being a problem with the draw-off pipes, which led to internal erosion in the body of the dam.

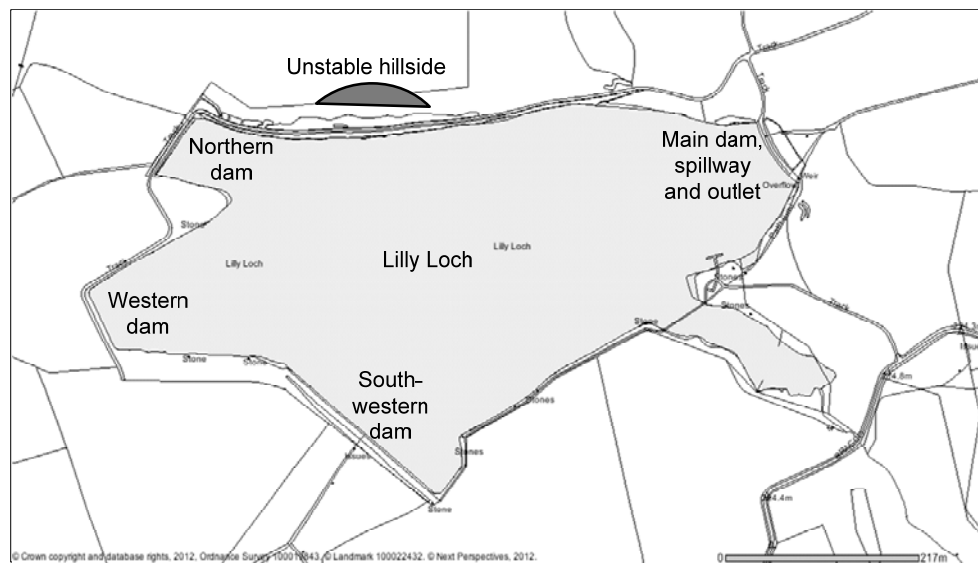
Figure 3. Plan of Lilly Loch.

Along the northern shore of the loch is a steep hillside, some 35m high, rising almost vertically out of the water. A narrow track runs alongside the reservoir and forms a berm to the toe of the slope.

Prior to this visit, the Supervising Engineer, in researching the geology, identified that the hillside had been examined by in-house experts some years before when there had been proposals to extend a nearby quarry and tension cracks had been noted at the top of the slope. The geology was therefore well understood.

The geotechnical engineer who had carried out the earlier investigation was, by the time of the incident, head of Geotechnics. He attended the Supervising Engineer's site visit, which took place on 9 December. Horizontal and vertical displacement of the rock at the top of the steep slope was observed over a distance of some 50m about 25m above the reservoir. The earlier geotechnical study was invaluable in gaining an early understanding of the mechanism of the movement.
