**The consequences of liquefaction on the failure of tailings dams with particular
respect to the upstream construction method**

***- preliminary reflections on the failure of the Brumadinho iron ore tailings dam
in January 2019***

The failure of Brumadinho Barragem No.1 on 25th January 2019

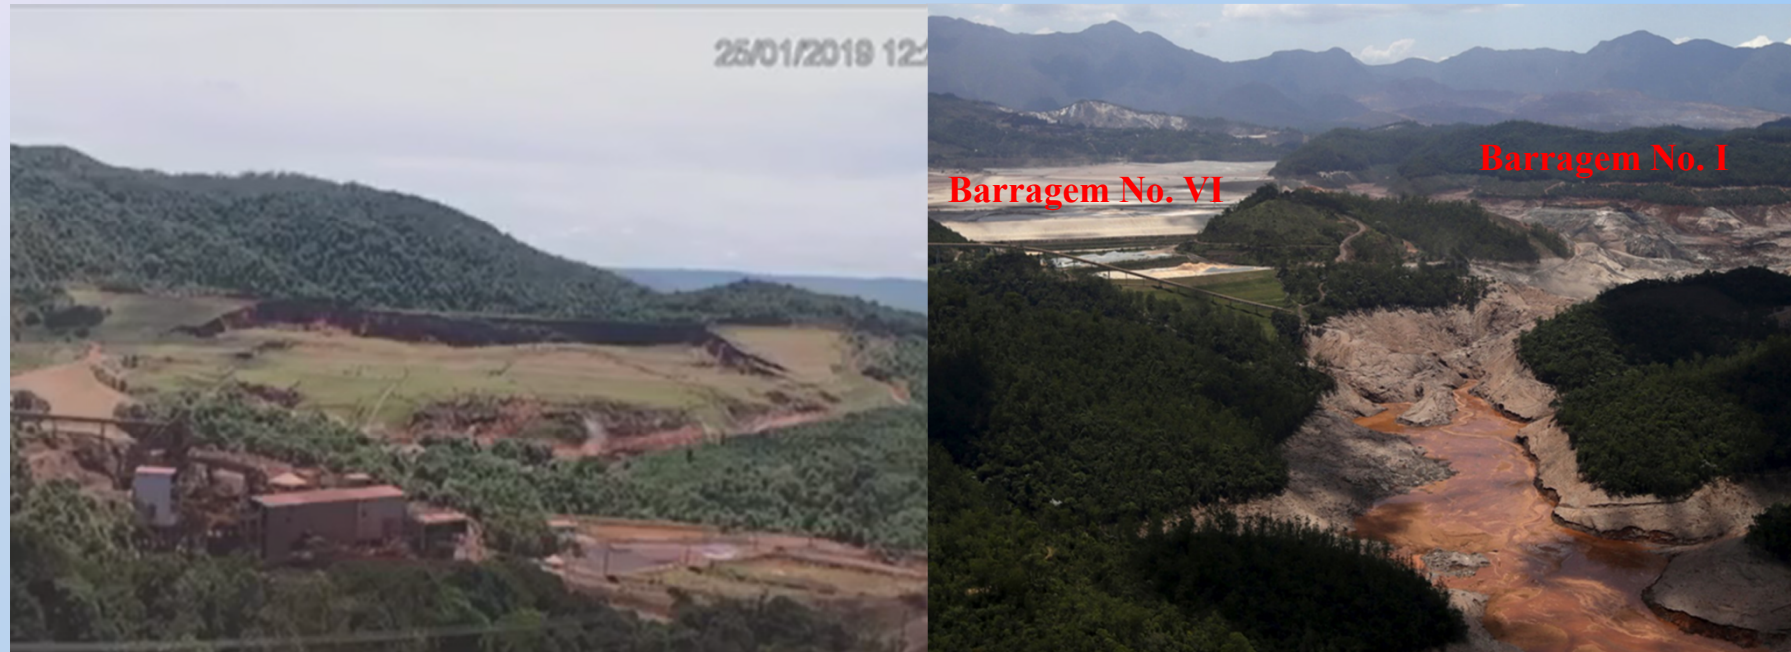
These reflections on the Brumadinho failure are of a preliminary nature as the authors are not party to historical or recent monitoring and investigation data.

The information provided is based on photographic evidence released at the time, on publically available documents and on statements made by Vale (the Owner).

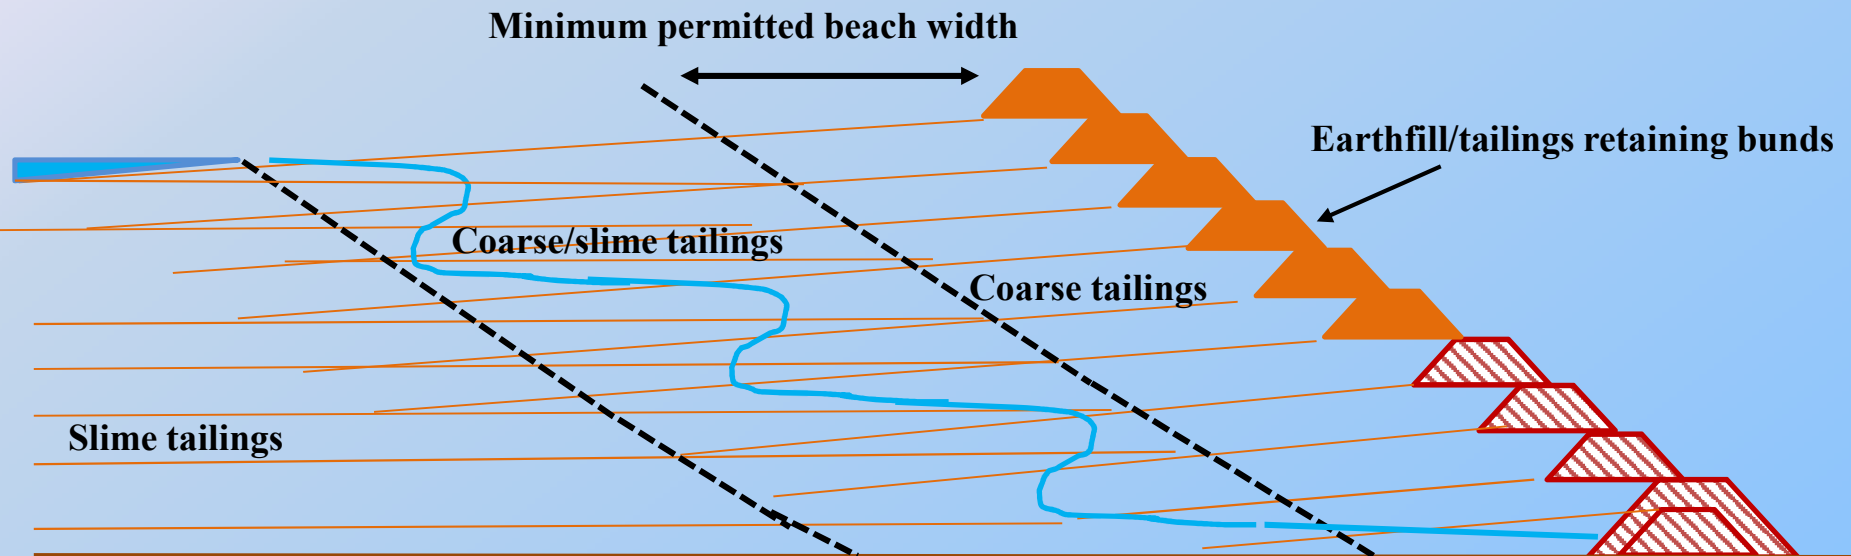
Brumadinho Barragem No.1 - inferred design section

- The final proposed dam height was 87m.
- The storage capacity of was 12Mm³.
- 94 piezometers were installed.
- Mining facilities appear to have been under continuous video surveillance.
- The dam section did not include a rock toe or , it appears, formal internal drainage provisions.
- Construction commenced in 1976 with final crest height achieved in 2010.

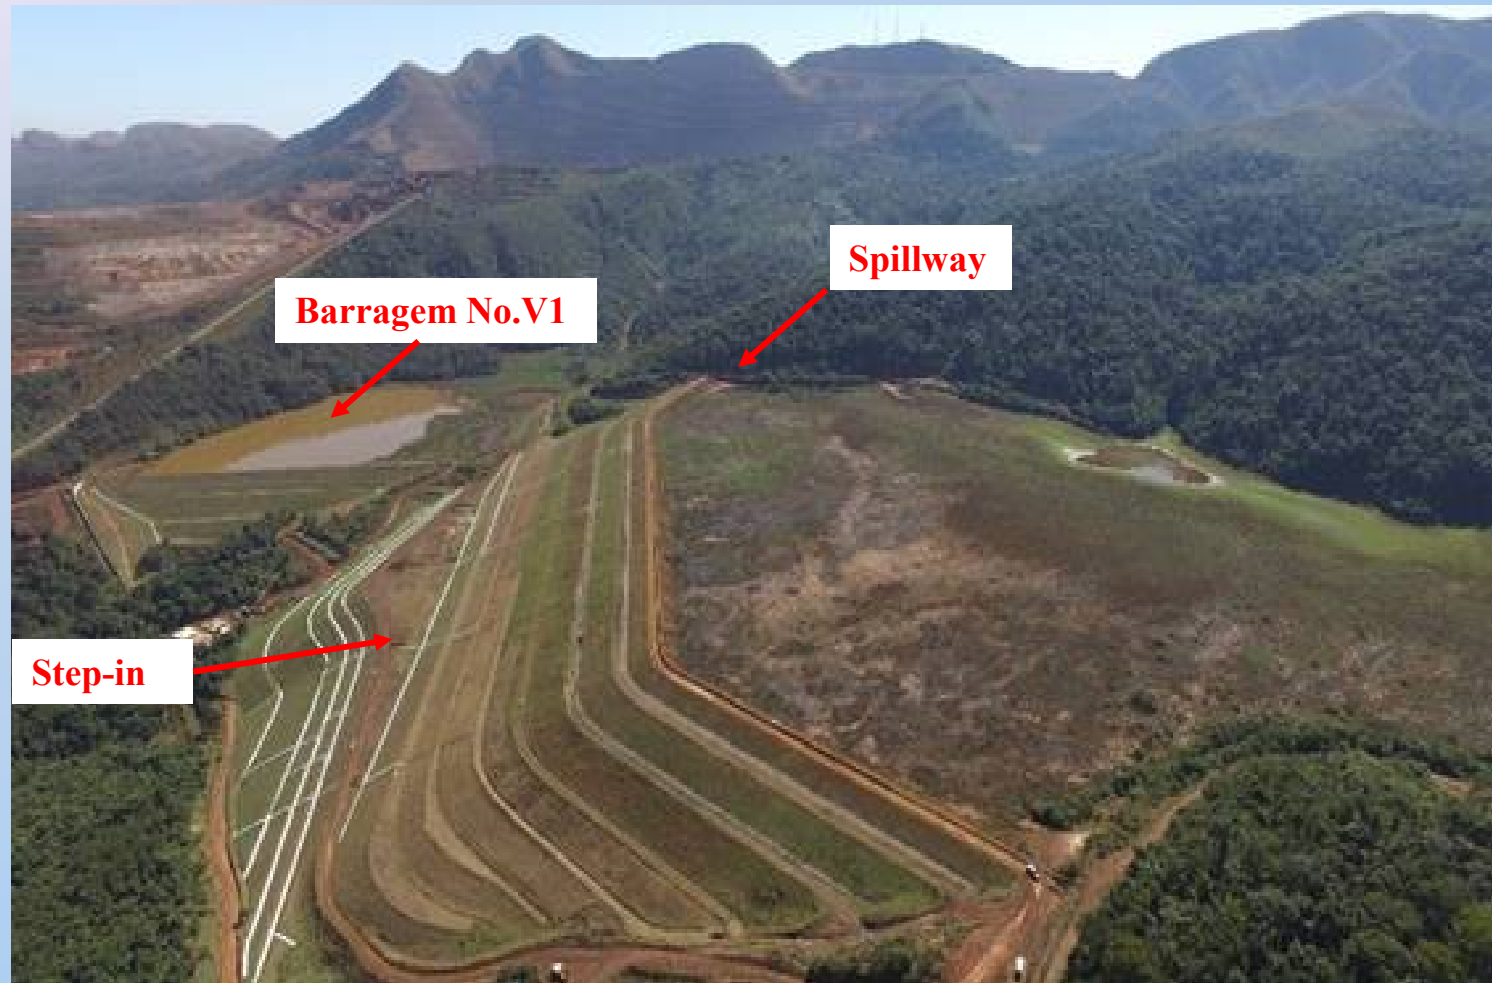
Brumadinho Barragem No.1

Deposition is reported to have ceased in 2015, though this dam may well have subsequently been used for water storage.

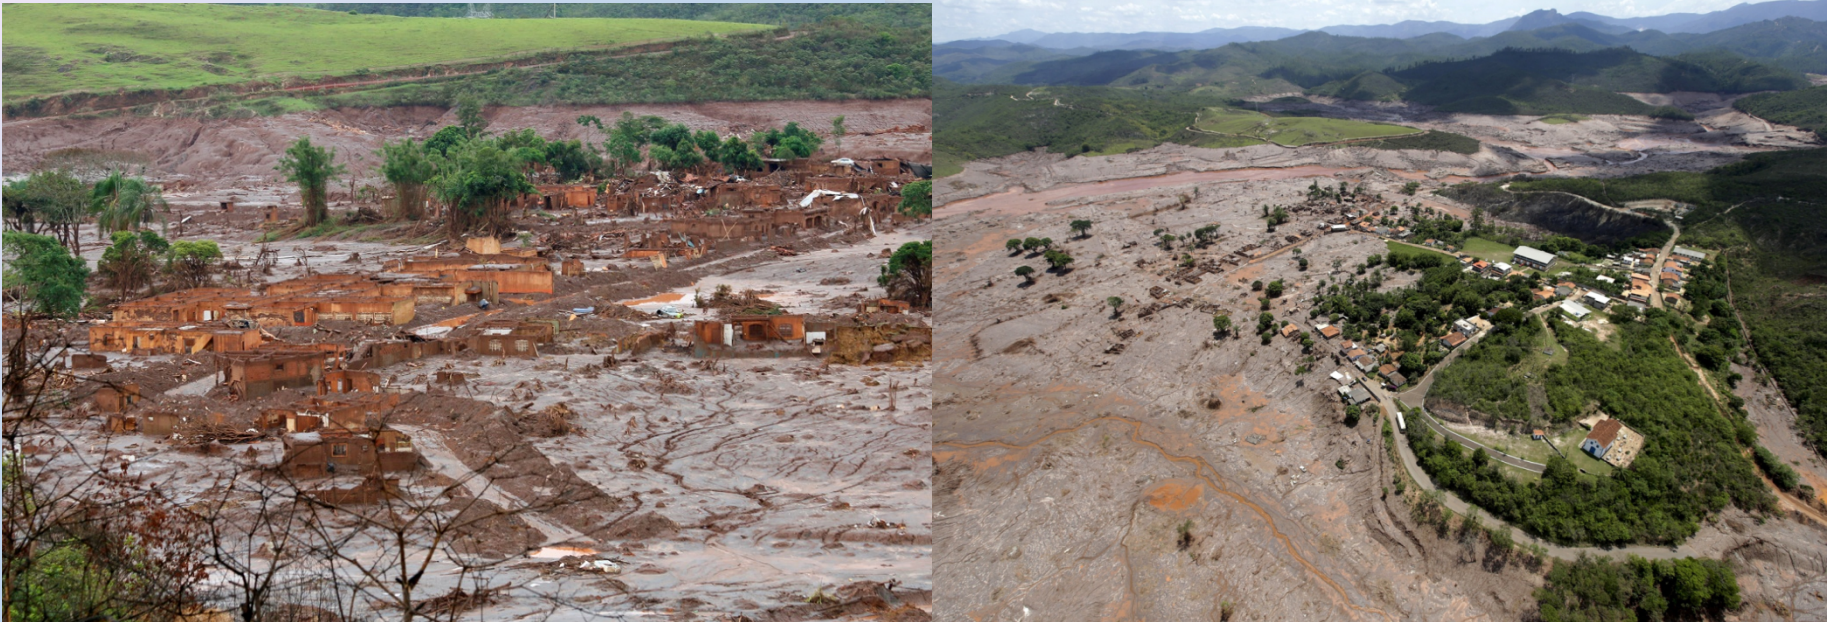
Parallel failures - Samarco Fundão Dam in 2015

- “the failure of the Fundão tailings dam by liquefaction flowsliding was the consequence of a chain of events and conditions
- a change in design brought about an increase in saturation which introduced the potential for liquefaction
- soft slimes encroached into unintended areas on the left abutment of the dam
- this initiated a mechanism of extrusion of the slimes and pulling apart of the sands as the embankment height increased
- with only a small additional increment of loading produced by the earthquakes, the triggering of liquefaction was accelerated and the flow slide initiated”

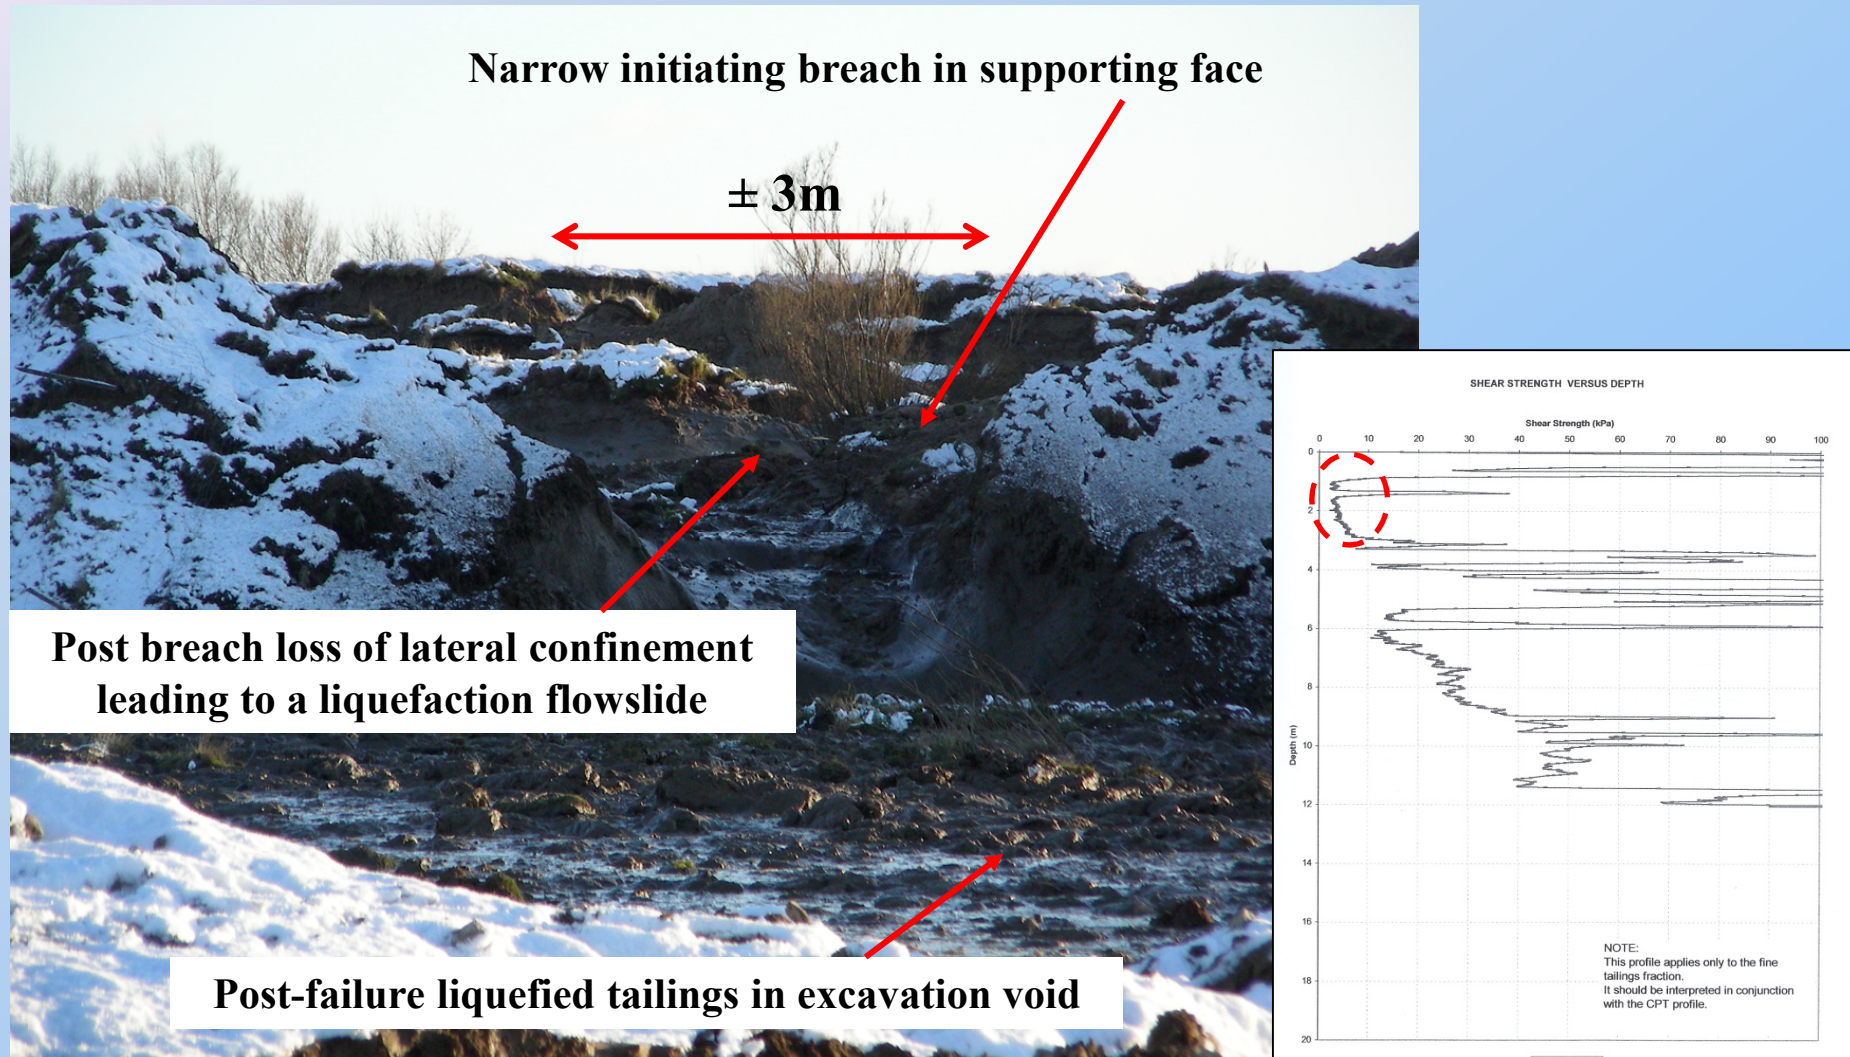
Parallel failures - Cavendish Mill TD1 in 2007

- The removal of lateral confinement via a small localised slope failure precipitated a series of liquefaction/flow slide events.
- Each failure induced further liquefaction events as the flow slide developed.
- 25,000m³ were mobilised through the 3m wide initiating slope failure.

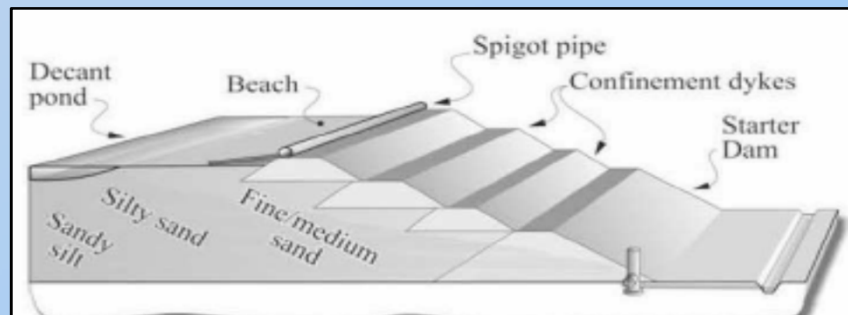
In the case of both Samarco do Fundão and Cavendish Mill, post-failure analyses led to the conclusion that the failures were caused initially by:

- **removal of lateral constraint**
- **subsequent rapid reduction in confining stress**
- **collapse and subsequent liquefaction of the tailings mass**
- **progressive failure as each slide triggered further liquefaction events**
- **the development of a flowslide into the downstream catchment**

The extent of damage was enhanced by the presence of water bodies which aided the flow mechanisms.
