## LONG-TERM BENEFITS AND PERFORMANCE OF DAMS

### Chapter 6. Incidents and rehabilitation case histories

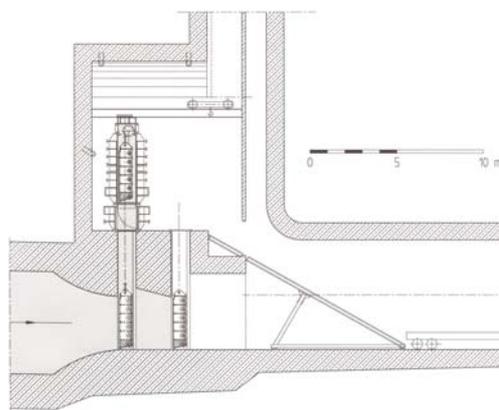
Right after the commissioning of the Mornos Dam it became evident, that the water losses of the upstream bottom outlet gate (considered as emergency gate) amounted up to about 0.5 m<sup>3</sup>/s. A so-called transfer device was built in order to make the upstream gate of Mornos Dam revisable. The basic idea of the use of the transfer device (Figure 4) was to pull the upstream valve under balanced pressure into the top of this pressure chamber, in order to be able to operate with the top of the transfer device separately from the water pressure inside the penstock.

Figure 4. Use of transfer device inside the gate chamber of Mornos Dam

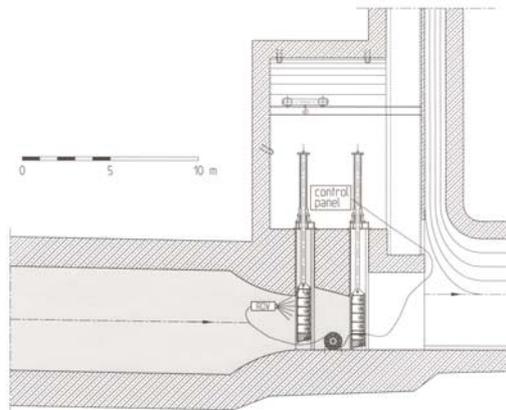
It was examined, if the use of an ROV from downstream offers technical and economical advantages. By using the two gates as a lock it is possible to enter the bottom outlet with an ROV (Figure 5). This procedure requires the penetration of the umbilical through the downstream steel plate, which is no major problem. Then the upstream gate can be raised that much, that the ROV can pass safely underneath.

Figure 5. Inspection of Bottom Outlet with ROV from Downstream

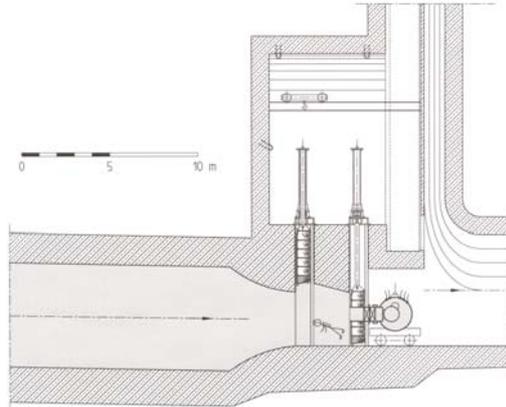
A technique is presented below, which allows diving activities at full reservoir level on the upstream side of the bottom outlet gate. This requires the use of the method of saturated diving. By installing a specific flange in the downstream gate a pressure chamber can be connected to the bottom outlet gate.

Figure 6. Access with Divers from Downstream

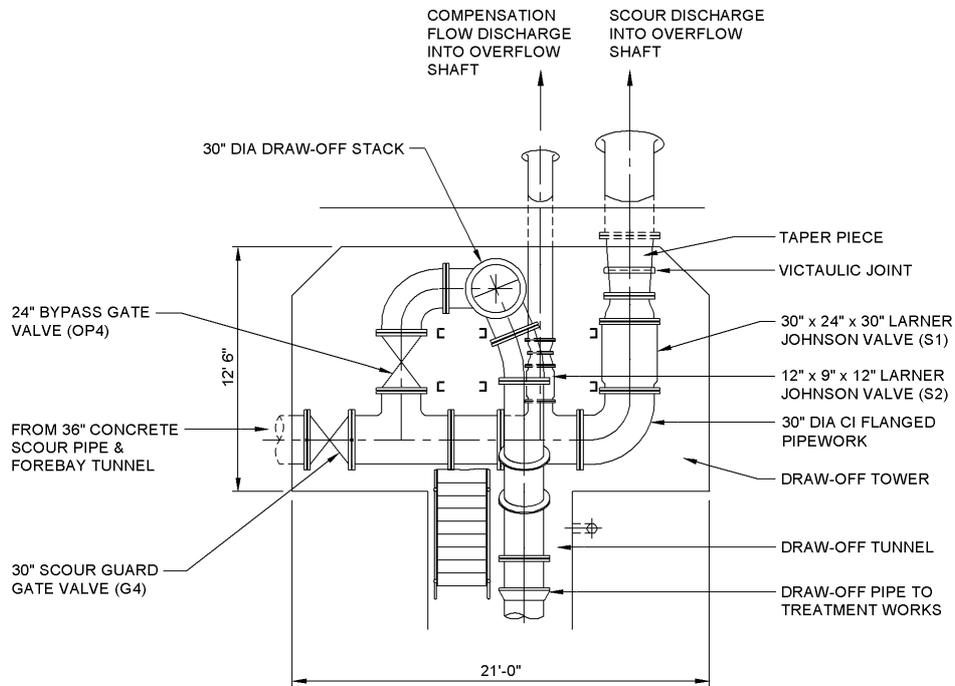
As part of the refurbishment process to return the Larner Johnson to a serviceable condition alternative valve options were considered due to the extent of the refurbishment work that would be required on the original valve. A value engineering exercise was carried out and a 700 mm diameter butterfly valve was chosen to replace the Larner Johnson. A Panel Engineer was not involved in the value engineering exercise, however subsequently one was consulted on the proposal to install a butterfly valve. The Panel Engineer, having carried out some calculations, commented that the velocities appeared to be high and recommended that confirmation be sought from the manufacturer as to the valve's fitness for purpose with respect to the maximum expected velocity and its location within the pipework arrangement. This confirmation was provided and the valve was obtained and installed.

Figure 3: Original scour valve layout in draw-off tower

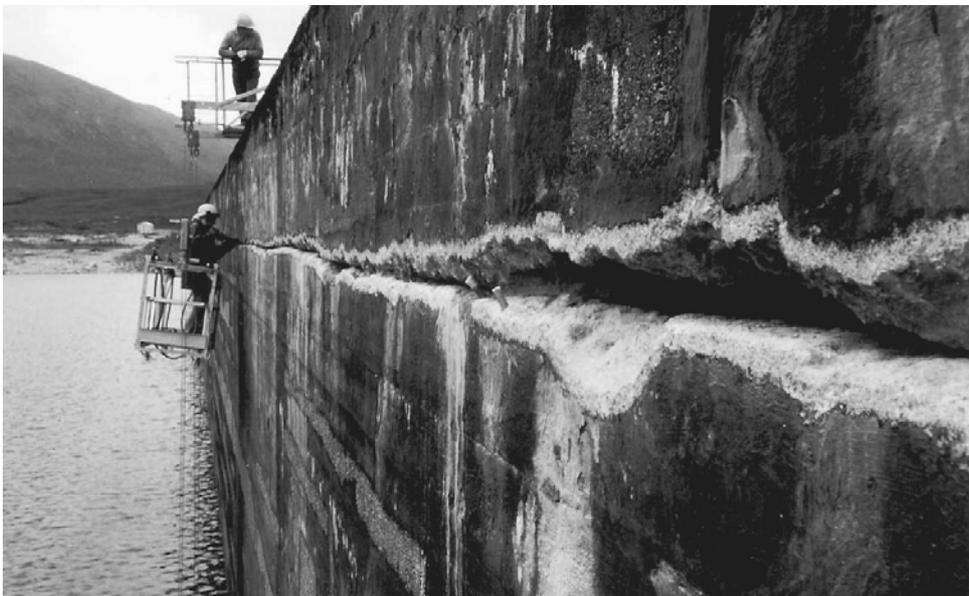
Figure 3 Raked-out joint in upstream face at Blackwater Dam

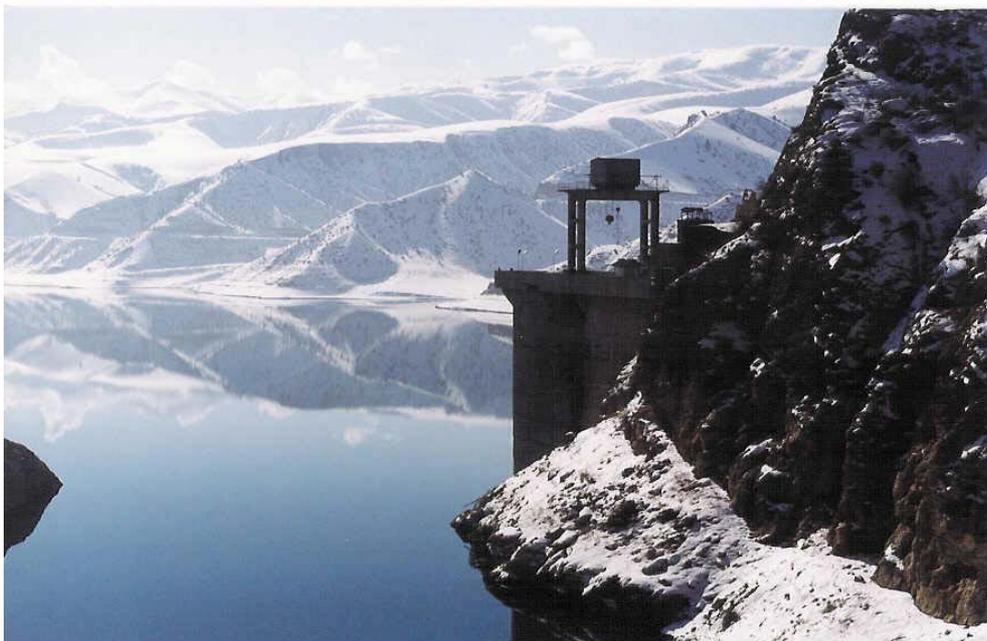
previously been repaired, the gates have vibration and aeration problems, and the tunnel outlet and plunge pool are sub-standard.

Figure 5. Papan dam – Reservoir and Intake Tower

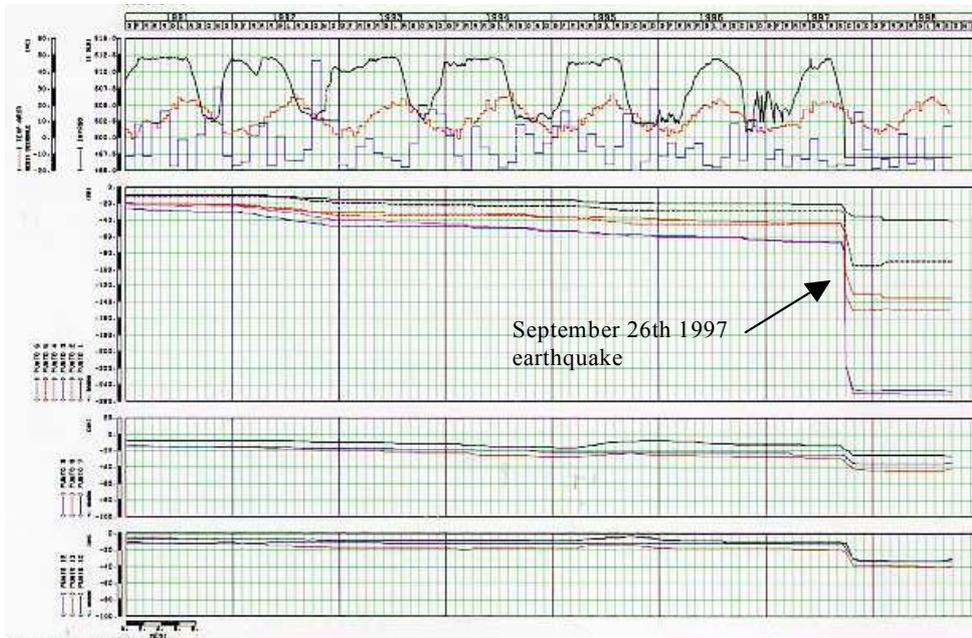
Figure 3. The chronological diagrams of displacements on the crest and berms (Midas® - Ismes Software)

Shortly after the event some wide cracks appeared in the asphalt paving of the crest: two longitudinal cracks, close to the crest edges, and two transverse ones, near the extreme ends of the dam, were observed (Fig.4). The upstream crack appeared the most significant and spanned the entire crest. Settlements up to 15 cm of the rigid reinforced concrete edges of the crest road were measured in the main cross section, where also a lateral spreading of about 10 cm was also found. The downstream lower berm settled about 2 cm. In the following month, settlements of the dam increased by only a small percentage, mainly due to the dissipation of the excess pore pressure in the foundation soil (a 0.05 MPa increase was measured in the alluvium shortly after the event). The following Figure 3 shows the chronological measurements of displacements on the crest and on the two berms.

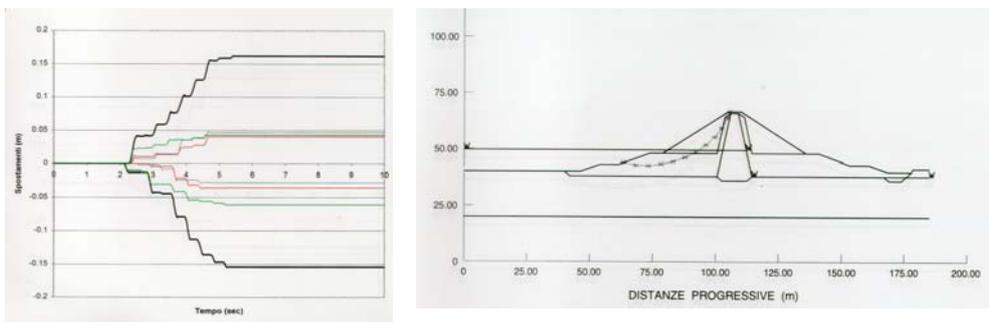
Figure 9. Residual displacements and a potential failure surface

The residual displacement reaches 15 cm, for the most vulnerable surface (Fig. 9) while, for most cases, such displacement is lower than 6 cm.

The values obtained are modest if compared with threshold suggested in the literature (Lambe and Whitman for earth dams, NIT report), which are metric.

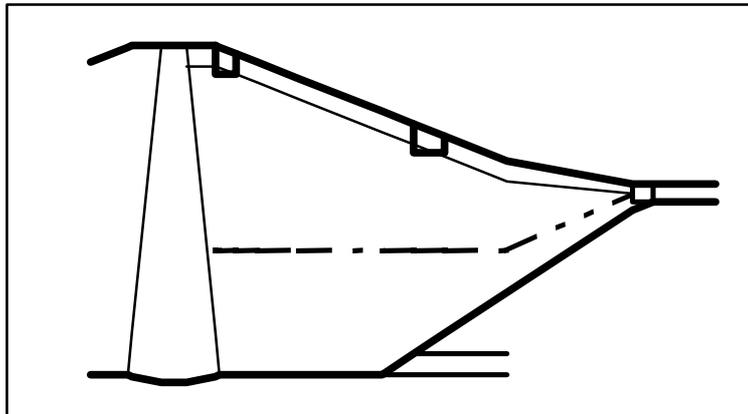
Figure 3 Cross section

The incident had a happy ending, the dam did not fail, the reservoir was refilled and has performed satisfactorily since. As indicated on Figures 3 and 4 below, I concluded that the hole had formed following deformation brought on by a combination of circumstances associated with new drains and wet weather. The heavy rainfall discharged from the (temporarily) slotted toe drain and wetted the stony fill, which had been kept dry by the deep layer of clayey fill on the surface of the downstream slope. The wetting caused some movement of the fill as points were wetted and collapsed. The clayey surface fill had been cut through at top and bottom of the slope for new drains, and may have stretched a little. There was some evidence in a trial pit of soil movement into voids in the stony fill, local internal erosion.

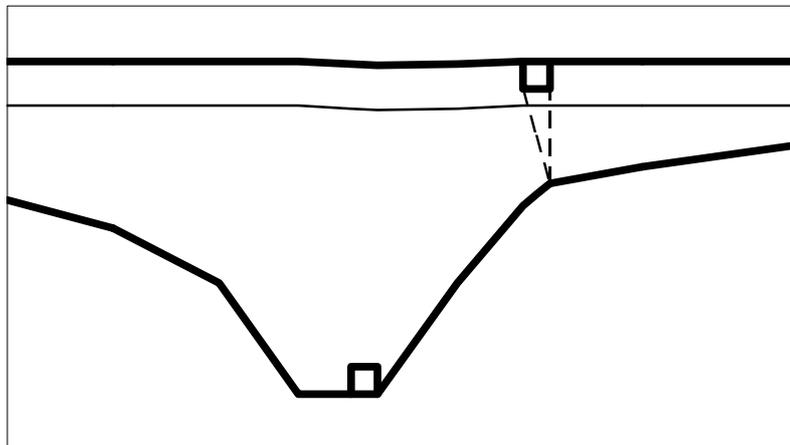
Figure 4 Longitudinal section

Figures 3 & 4 Conjectured mode of hole formation. Figure 3, cross-section, toe drain released water into stony fill, which may have settled slightly. Toe drain and crest drain cut through clayey surface fill, made slope less stable, allowed water in, surface fill moved. Figure 4, longitudinal section, foundation profile at hole position created differential settlement and adjustments in stony and clayey fill increased stress on clayey surface fill.

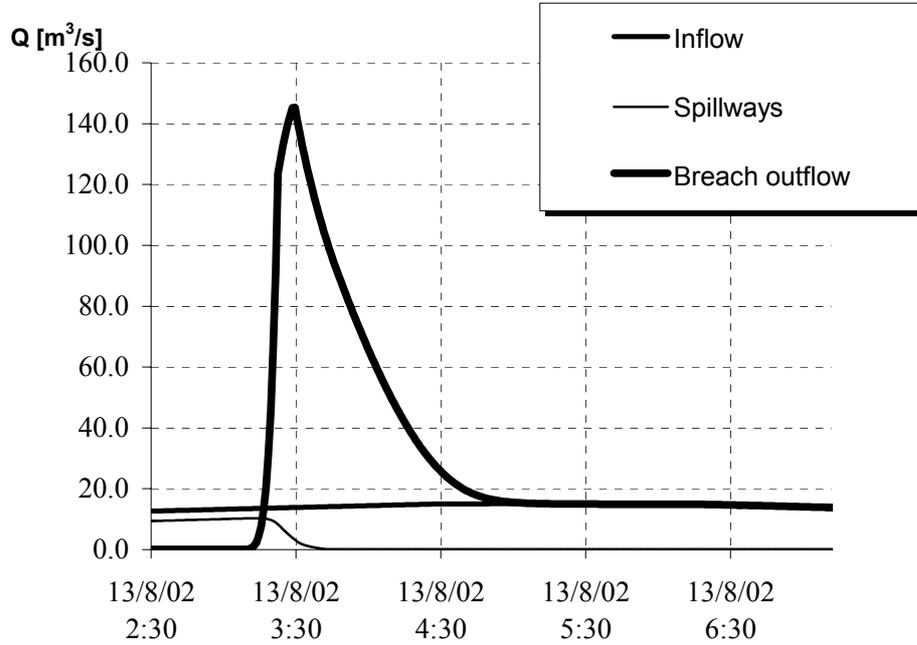
Figure 7: Melin reservoir - inflow and outflow

The results of hydrological and runoff modelling indicated a rapid increase in the inflow discharge to the pond on the evening of 12 August 2002 with the peak discharge approximately  $15 \text{ m}^3/\text{s}$  (Fig. 7), which corresponds with 50 year flood (Table 2). The flood routing through Melin reservoir showed a transformed flood peak discharge  $13.5 \text{ m}^3/\text{s}$  and shift of the peak by 2.5 hours. At the same time, the spillway capacity was about  $10 \text{ m}^3/\text{s}$  at the water level at the dam crest.

The Melin dam failure was caused by combined action of leakage through the upper portion of the dam below the dam crest and the wind waves overtopping the dam crest. These factors caused the dam failure in the section of the lowest crest, where its subsidence was probably caused by suffosion of the sandy material into the damaged wooden pipe. The process of breaching was accelerated by slides of the relatively steep downstream face of the dam. The dam break peak discharge at the dam site was estimated to be  $150 \text{ m}^3/\text{s}$  and this was verified by the calibrated flood routing model in the valley downstream of the pond. The resulting dam breach opening was of almost rectangular shape with the 5 m depth and 15 m width.

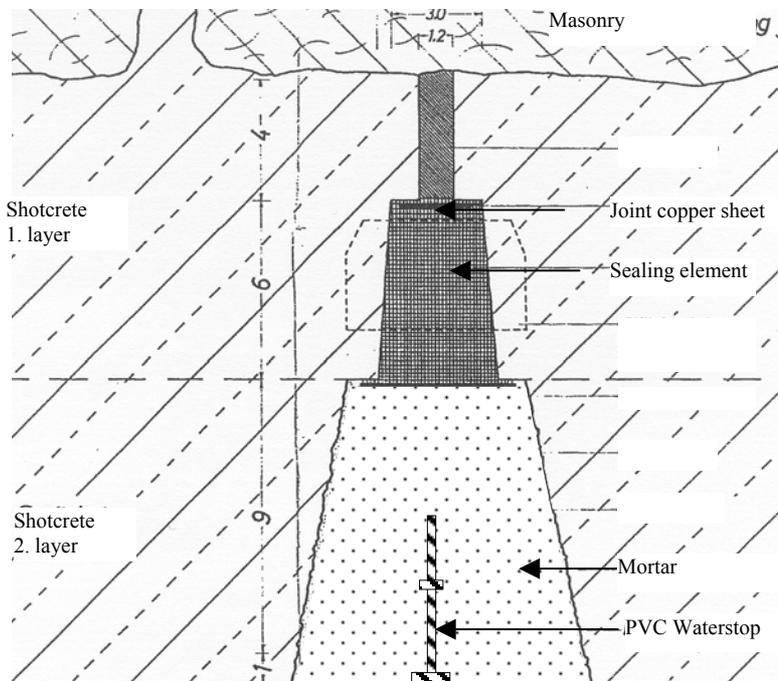
Figure 1. Cross section through joints of shotcrete layer

Each panel was anchored into the dam by 16 anchors with a diameter of 20 mm and a length of 2.50 m. The shotcrete was applied directly onto the masonry in two layers, each 10 cm deep. The joints between these shotcrete panels were formed with a sealing element and mortar, see figure 1.

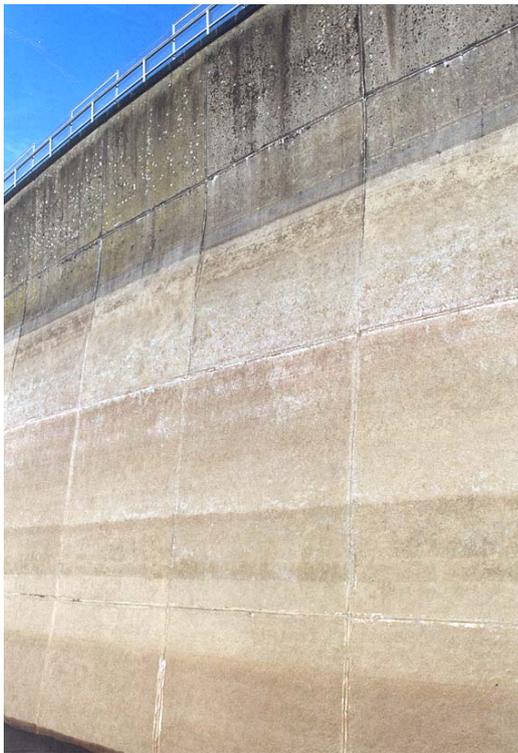
Figure 2: photo of existing shotcrete lining

Despite these complex rehabilitations the sintering process deterioration was only slowed down slightly. As the joints were not really flexible joints the joints were disturbed due to thermal movement in the dam. Hence the water could leak through these joints into the dam.

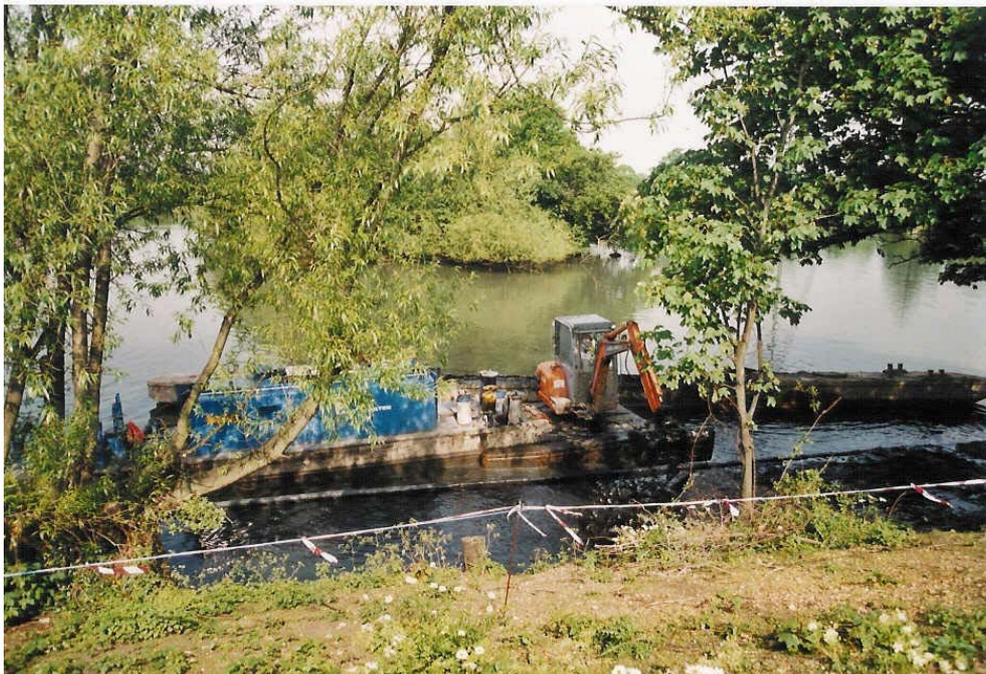
As there have been minor slips along the external embankments of Reservoirs Nos. 2 and 3 in the past, there was a need to avoid moving any heavy plant along the top or on the embankments, to reduce the risk of causing any further slips. The Contractor was able to carry out all the works from the water using floating craft/machinery (see Fig. 4), with only Land Rovers and small vans being used along the top of the embankments when carrying out the planting of the reed beds.

Fig. 4 Placing of “silt” shelf using machinery on floating craft

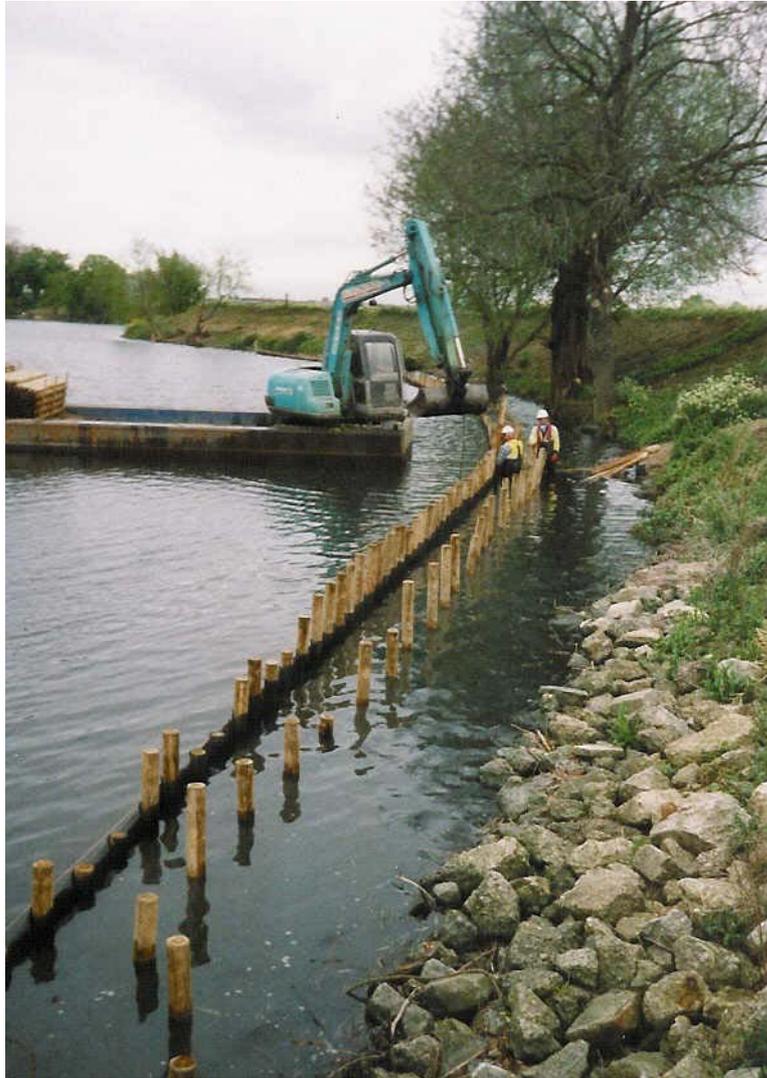
Fig. 5 View of revetment system being placed

The posts for the “nicospan” revetment were driven in using a small piling hammer, converted for 100mm posts, mounted on an excavator. The posts were driven, at 500mm centres, into individual pockets of the “nicospan” to progressively “tighten” the revetment. The line of the revetment was agreed with Thames Water’s site staff to offer maximum toe restraint to the embankment, but also offer the most ecological benefit. Anchor poles were

driven to the rear of the “nicospan” at 100mm centres and, wired to the “nicospan” using galvanized fencing wire. The excavator, used to install the retaining system, was secured to a floating pontoon (Fig. 5).

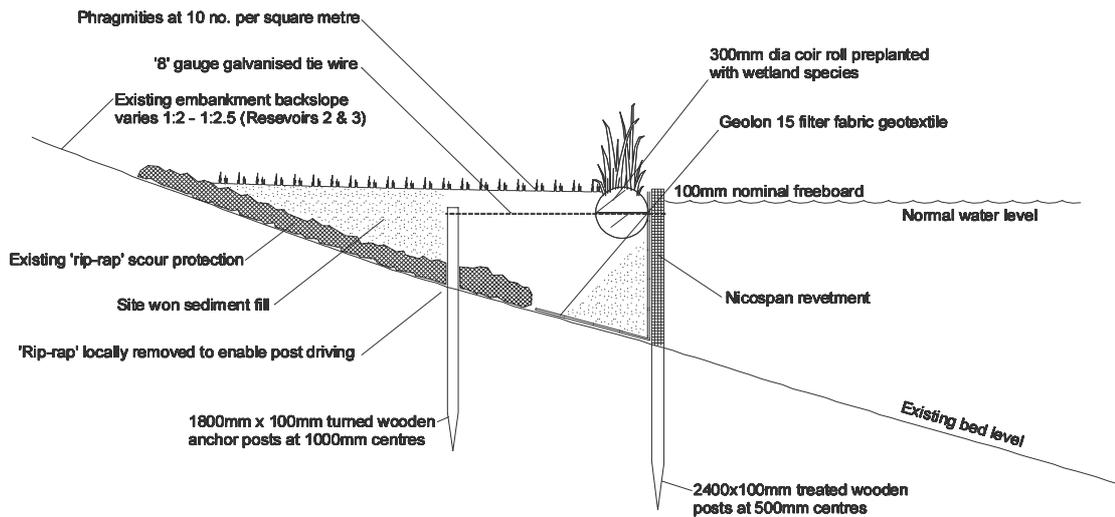
The conclusion was that the effect of the “silt” shelf on FOS was minimal and that even with the most onerous combination of a steeper slope and with the failure surface entirely in the London Clay, an acceptable FOS was obtained.

Fig. 6 – Section of “silt” shelf

The Contractor designed the form and retaining system for the “silt” shelf (see Fig. 6) and Thames Water’s Geotechnics Group checked whether the new shelf would affect the stability of the reservoir embankments. The analyses were undertaken for slope angles of 1 in 2 and 1 in 3 using the methodology suggested by Morgenstern and Price (1965) and conservative soil parameters ( $c' = 0\text{kPa}$  and  $\phi = 37$  degrees for the gravels and  $c' = 3\text{kPa}$  and  $\phi = 20$  degrees for the London Clay). The results for failure surfaces

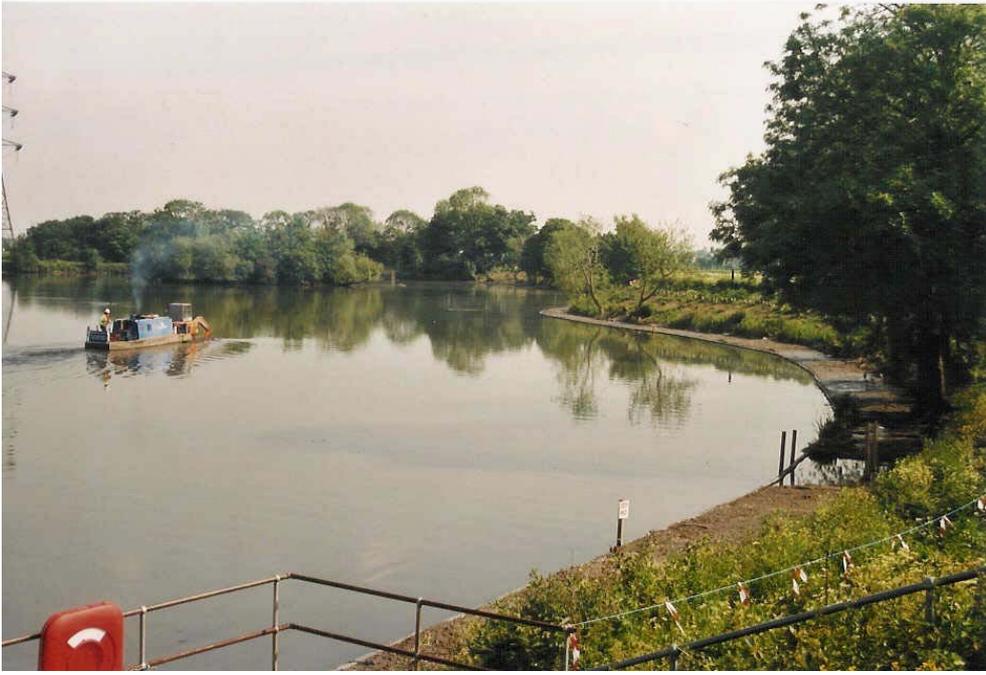
Fig. 7 View of placed “silt” shelf

After the “silt” shelf was completed (see Fig. 7), reed beds were planted during late spring 2000, which was the best time of the year for their establishment. The reed beds were planted in the “silt” to consolidate the protection and enhance the environment. Timber platforms were constructed at intervals to provide “swims” for the anglers that use the reservoirs.

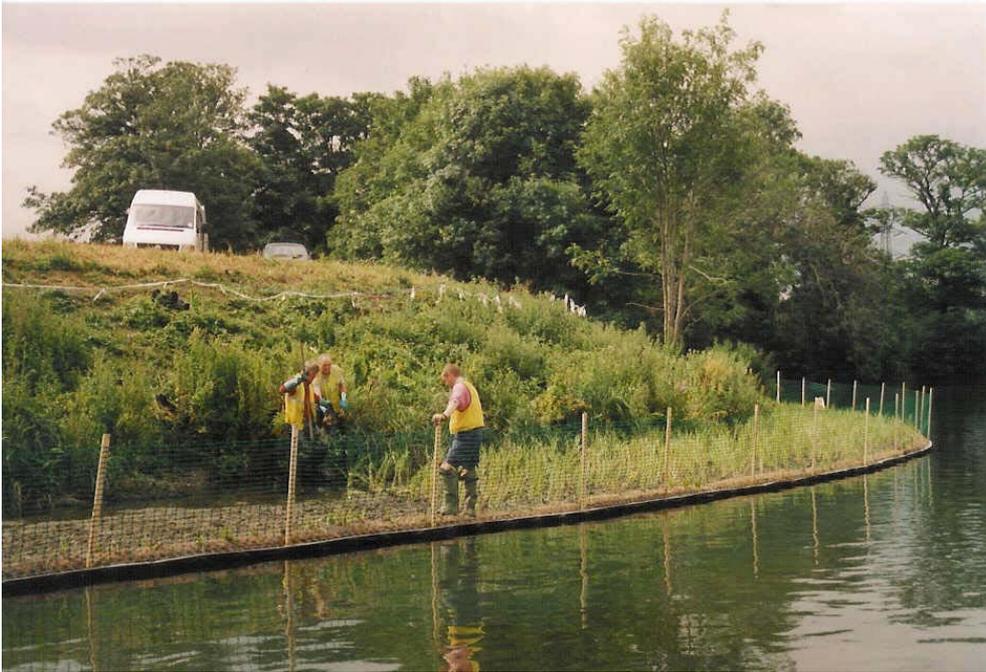
Fig. 8 Planting of reed beds

The depth that the reed beds sit in the water was important to their surviving and maturing, and the Contractor formed the “silt” shelf to a level of 8.00m AOD, which allowed for 0.20m settlement of the “silt” shelf. This level ensured that the roots of the plants were always submerged. The finished level of the “nicospan” revetment was 50mm above the top water level. The density of the reed beds planted was ten plants per square metre. The reed beds were planted during May, which was the best time of year for their establishment (Fig. 8). Also the Contractor’s design included the use of pre-planted reed “coir” rolls and mattresses, which minimised the chances of die back or natural waste of the reeds.

As these rolls were placed at the front of the shelf and the reeds in the rolls were established, they prevented erosion of the “silt” shelf whilst it consolidated and the planted reeds behind established themselves.

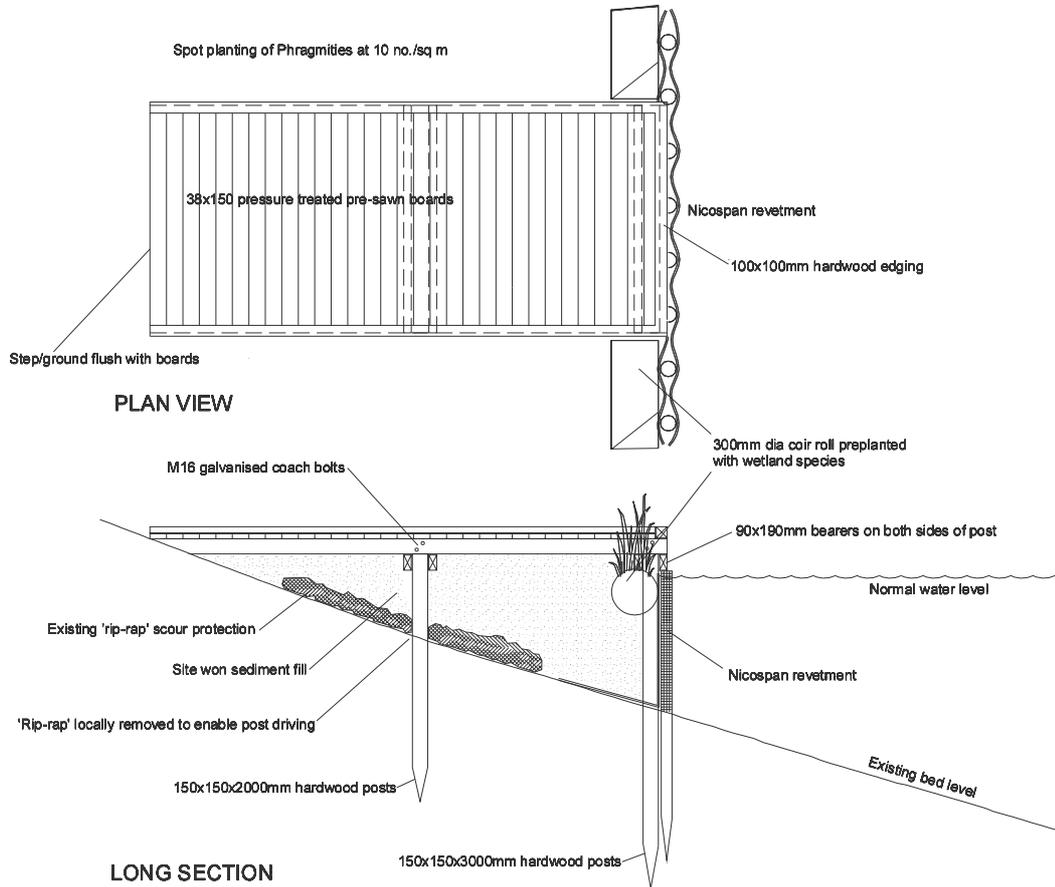
Fig. 9 Section of fishing platform

There were ten wooden platforms built out into Reservoirs Nos. 2 and 3 along the 800m of the “silt” shelf and they were approximately 2m long by 3m wide. The swims provided a new safer access to the waterside, and the reed beds either side helped to conceal the outline of the fishermen to the fish. A plan and section of a platform is shown in Fig. 9.
