Bewl Water spillway remedial works

I DAVISON, MWH
K SHAVE, Babcie

SYNOPSIS. Bewl Water is a major impounding reservoir in South East England, UK. In the mid-1990's an external inspection confirmed that the crest of the spillway shaft was suffering from severe cracking. A paper, by one of the authors, presented at the British Dam Society Conference in Bangor in 1998 described the investigation that was carried out to determine the cause of the cracking. This paper describes the remedial works contract that was undertaken to replace the pre-cast concrete crest blocks that were suffering from Alkali Silica Reaction, and describes the extensive temporary works over the top of the spillway shaft, the methods used to remove the existing pre-cast units and the design of the new units. The new crest units have been designed to allow the crest to be raised by 350 mm without the need for further major temporary works over the top of the shaft.

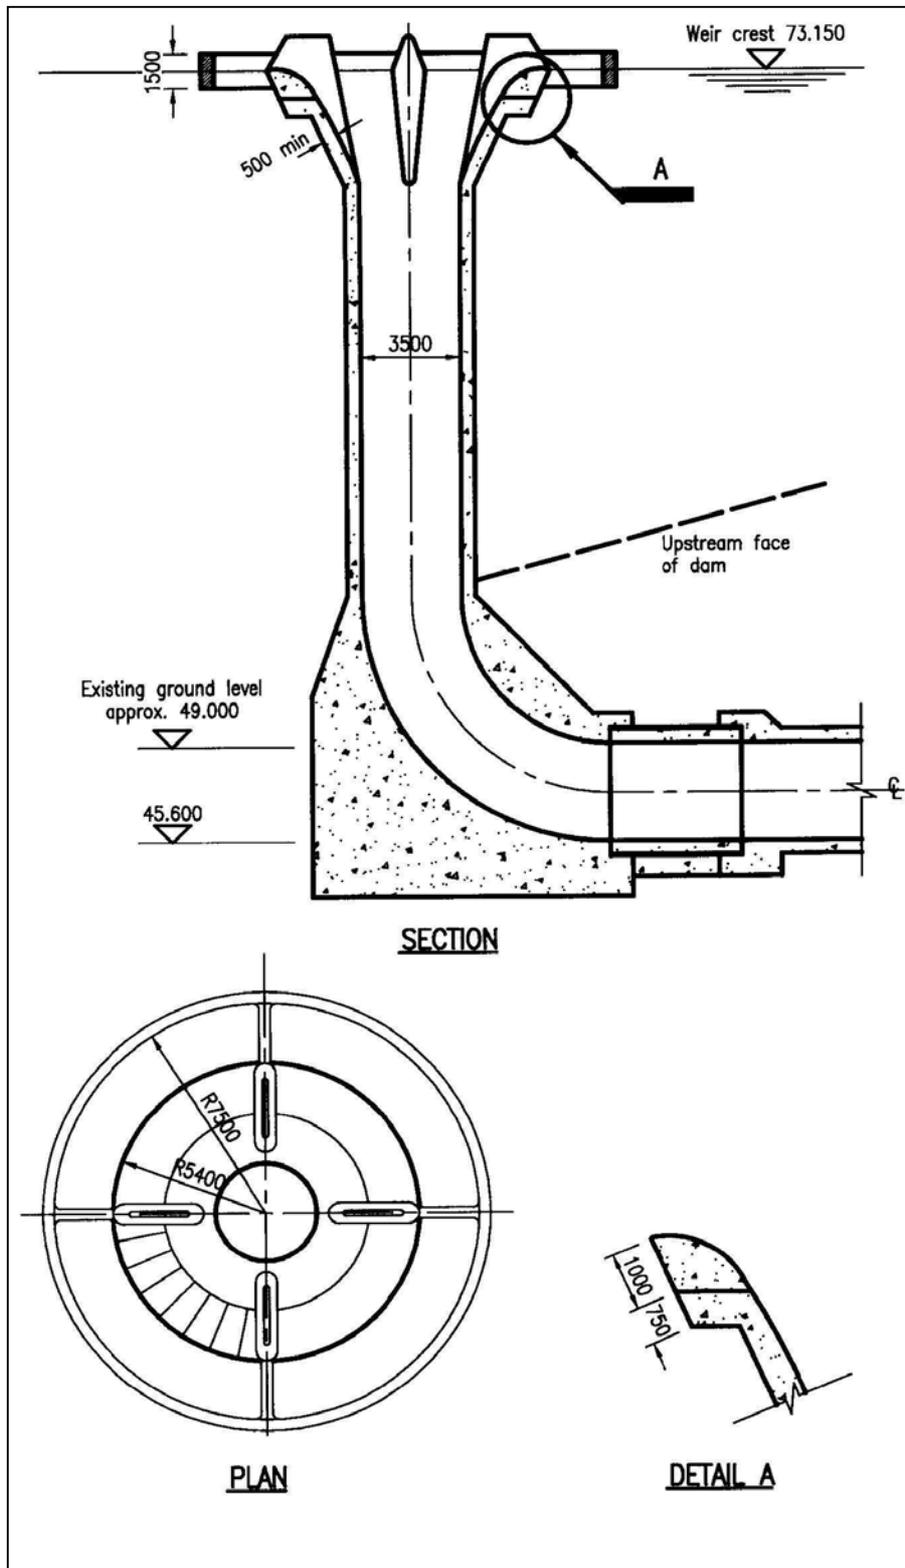
Figure 1 - Detail of the Overflow Structure

The overflow structure, as shown in Figure 1, consists of a vertical shaft from the reservoir bed up to the full supply level of the reservoir. The lower

At the base of the tower the shaft turns through a 90° bend into the discharge tunnel which passes under the dam before discharging into the river downstream. The tunnel is a horseshoe in section and is approximately 3.3 m in diameter.
