An Incident at Ogston Reservoir

A.K. HUGHES, KBR, UK

S.D.R. HARWOOD, Severn Trent Water, UK

SYNOPSIS. In the autumn of 2001 an incident occurred at Ogston Reservoir which led to the catastrophic failure of the pipework in the draw-off shaft. An uncontrolled release of water commenced which was only prevented by the quick actions of two operatives in the shaft. This paper describes the investigations carried out to establish the cause of failure, the remedial works which were carried out and the lessons learnt.

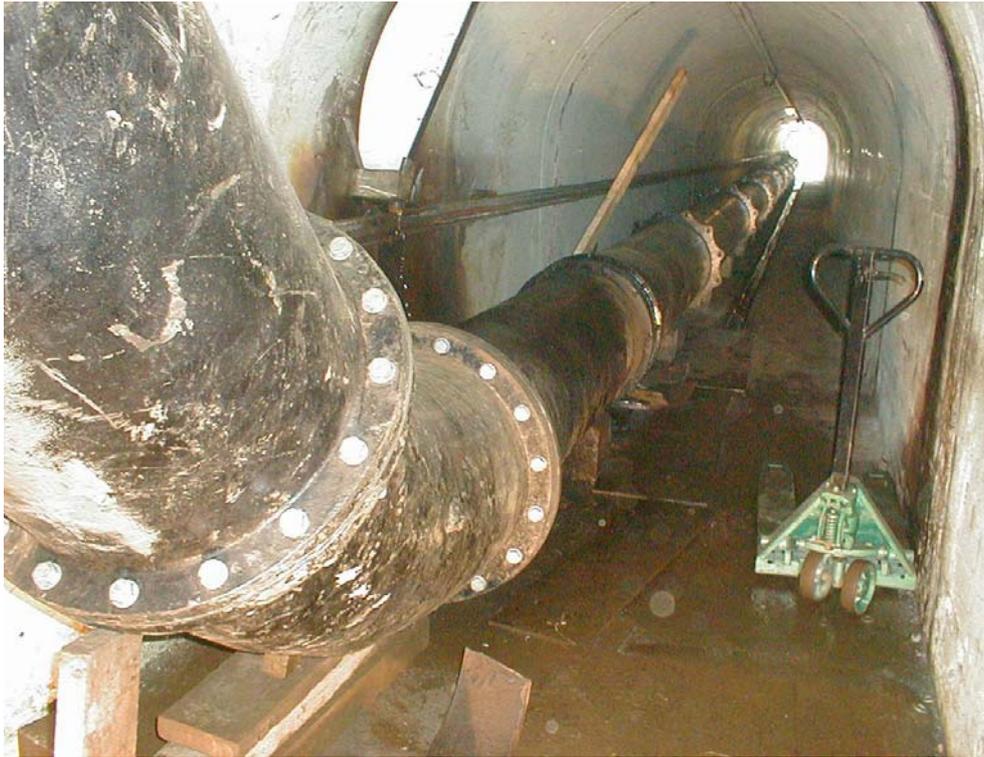
Plate 4: Draw-off main within the draw-off tunnel

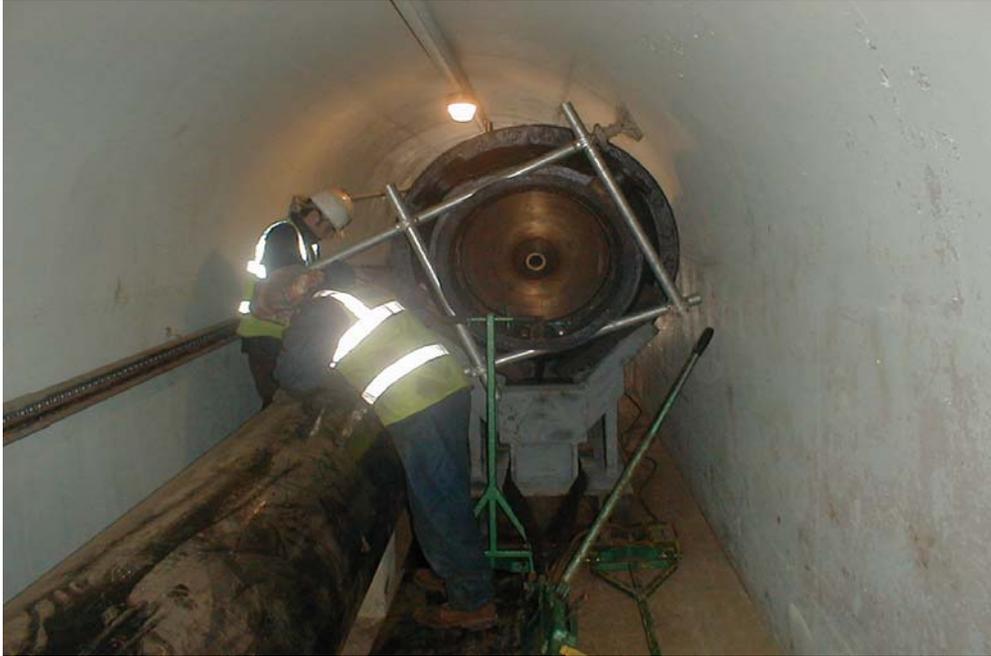
Plate 5: Transporting the Larner Johnson Valve

dismantle the Larner Johnson scour valve once it had been factory refurbished. Following delivery to the site a specially designed trolley enabled the valve to be moved along the tunnel and then positioned in the base of the shaft.
