Detailed investigation of an old masonry dam

Dr.-Ing. ACHIM JAUP, Lahmeyer International GmbH, Bad Vilbel,
Germany

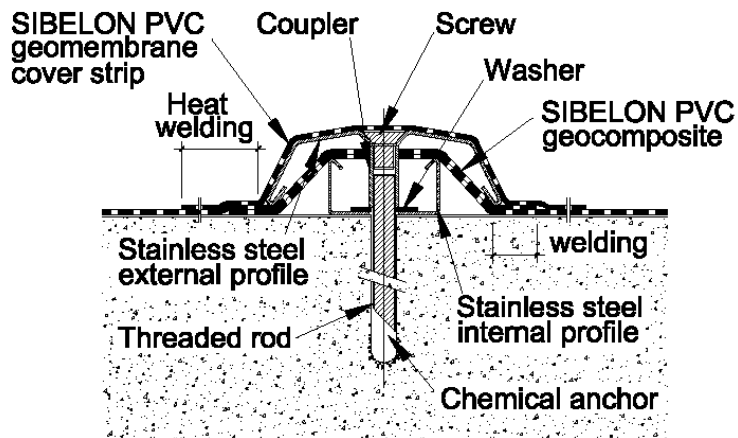
Figure 3: Cross section through pretensioning profiles.

The Carpi PVC geocomposite is anchored by tensioning profiles on the shotcrete. The tensioning profiles belong to the patented Carpi-System, see figure 3. They are made of two parts, the inner and outer profile. The inner profile is anchored to the concrete structure by anchors. The outer profile is connected to the inner profile by means of a special adjustable threaded device. The connection of the two profiles creates a clamping effect to the geocomposite. Pre-tensioning gives the geocomposite best adhesion to the existing concrete surface.
