Raising of the Ajaure embankment dam by extending the moraine core with a geomembrane

Å. NILSSON, SwedPower AB, Stockholm, Sweden

I. EKSTRÖM, SwedPower AB, Stockholm, Sweden

SYNOPSIS. The Swedish Ajaure embankment dam is a high consequence dam which is 46 m high and was constructed between 1964 and 1966 with commissioning in 1967.

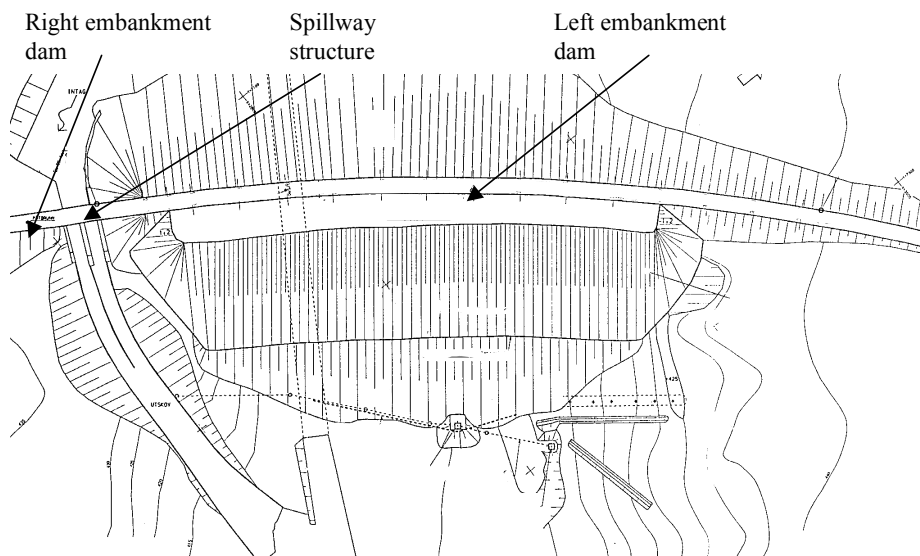
Figure 1. Plan of Ajaure after the placing of the second berm (marked B).

Stability analyses also indicated low stability and a stabilising berm of blasted rock was placed against the lower half of the downstream side of the left embankment dam to increase the stability margin in 1990. The berm was 18 m wide and 20 m high, with a total volume of approximately 50,000 m³. The fill material was placed with the slope inclination 1 vertical to 2 horizontal. The berm was also intended to increase the erosion resistance at the downstream toe in the dam. No decrease in deformation was however noted after the lower berm had been placed.

The horizontal downstream movement of the central part of the left dam increased dramatically after the placement of the second berm, and on examination in August 1993, longitudinal fissures on the crest of the dam outside the guardrail were observed.
