## **Remedial grouting works to two dams in Hong Kong**

D. GALLACHER, AECOM, Edinburgh, UK

**SYNOPSIS.** Tai Tam Upper and West Col Dams in Hong Kong had experienced substantial leakage over an extended period. Recommendations were made in the interests of safety for both dams to investigate and carry out remedial grouting works to reduce leakage to acceptable levels. Reference is made to their history and earlier unsuccessful attempts to reduce and control leakage.

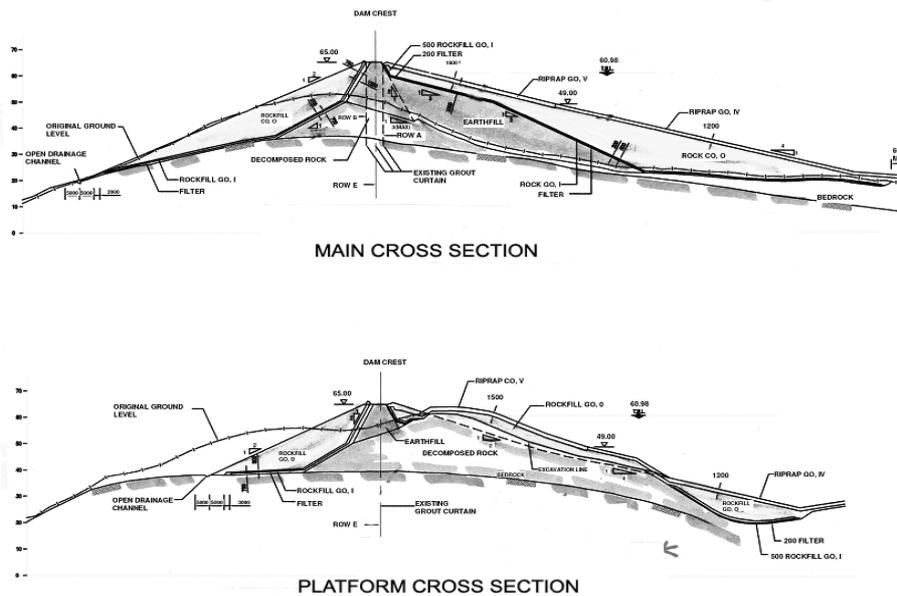
Figure 7. West Col Dam Cross Sections

West Col Dam is a rock fill dam completed in 1979 with a clay core, curved upstream in plan, Figures 5 & 6. It is about 300 m long and 45 m high, and it is understood to be founded on residual soil overlying bedrock, Figure 7. The upstream face incorporates a knoll at the left abutment which forms a promontory with a helicopter pad. The downstream face incorporates a knoll or platform also at the left abutment which is of mainly agglomerate rock.

Leakage appeared over the dam section at the platform at the left abutment during first impoundment with the reservoir level about 8 m below top water level. The foundation of the dam including at the platform had been grouted using Ordinary Portland Cement (OPC) during construction prior to impoundment. Further investigation and grouting works were carried out in this area under the original construction contract in 1981 again using OPC to try to ensure that no zones or channels of high permeability remained in areas of erodible decomposed rock. Leakage was not reduced by the latter works but the dam and its foundation were considered to be safe.
