Stability issues at Intake UD

A. ROWLAND, Black & Veatch, Redhill, UK
Dr C.F. WAN, Black & Veatch, Hong Kong

SYNOPSIS. Intake UD in the New Territories of Hong Kong diverts water from a rocky stream into a tunnel system feeding into High Island Reservoir. The majority of the diversion structure is a siphon weir with a height of 9m above downstream ground level. The structure is constructed predominantly of mass concrete with reinforcement provided only in the siphon inlets and hood.

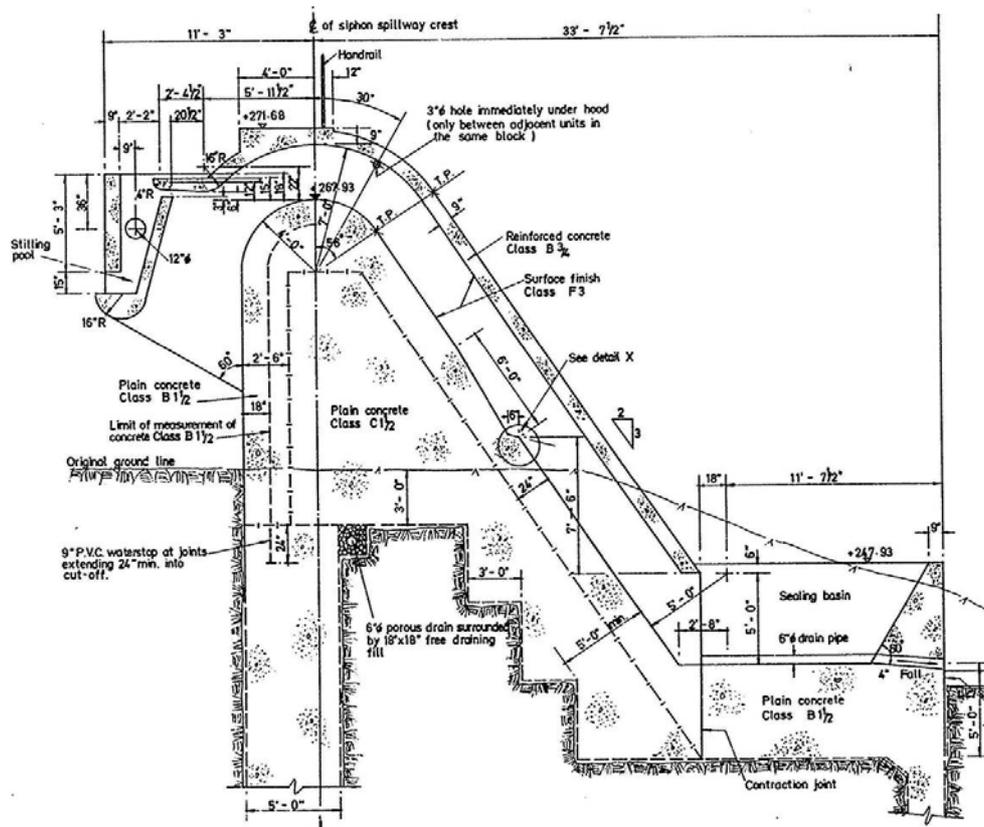
Figure 2. Cross section of Intake UD siphons

The section in Figure 2, reproduced from record drawings, shows a hearting of Class C1½ concrete and a 0.75 m thick skin of Class B1½ concrete. However, it is by no means certain that the contractor would have chosen this form of construction and he may have constructed the whole gravity structure in Class B1½ concrete. Unless proven otherwise by further investigations, it will be assumed that there are two zones of concrete of different strengths.
