Leakage Remediation Works at the Hampton Distributing Reservoir

S QI, AtkinsRéalis

SYNOPSIS Hampton Distributing Reservoir is a non-impounding reservoir built in 1900s and located in Hampton, southwest London. The reservoir, formed by a typical puddle clay core embankment, has a total perimeter of 800m and a storage capacity of 32,000m³.

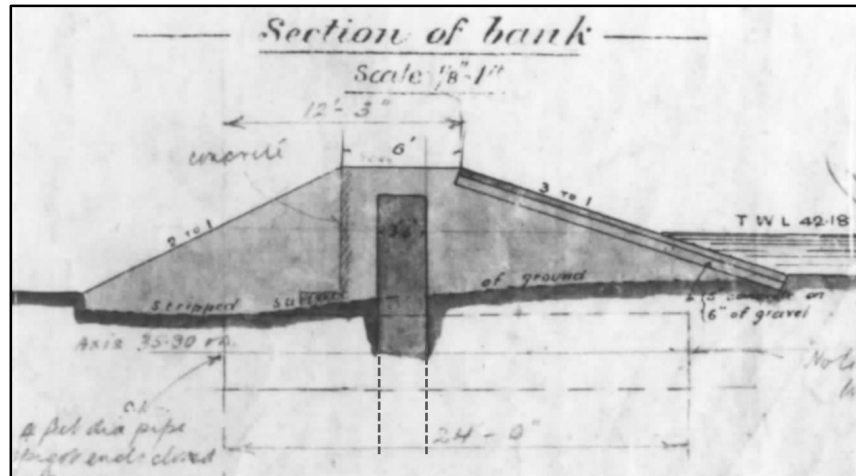
- Embankment shoulders are formed by clayey sandy Gravel on a stripped surface of original ground level over Kempton Park Gravel Formation.
- A 0.9m wide puddle clay core that passes in a trench through the Kempton Park Gravel Formation and is keyed into the underlying London Clay Formation with a 1.2m deep embedment which results in a total height of 8.5m for the puddle clay core/trench (not fully shown in the cross section below).

Figure 1. Extract of record drawing showing a typical section of the embankment, with a clay core extending to the London Clay Formation at depth.
