Megget Reservoir: Investigation into potential internal erosion in an asphaltic concrete core rockfill dam

SYNOPSIS Megget Reservoir is an impounding reservoir in the Megget valley of the Scottish Borders, which is used to supply water to Edinburgh and the Lothians. The dam retaining the reservoir is a 56m high asphaltic core rockfill dam constructed in 1982, believed to be the only one of its type in the UK.

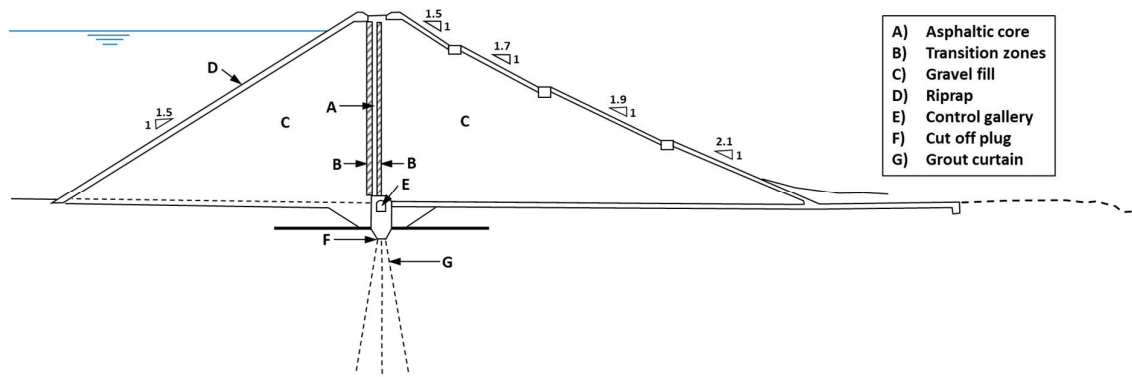
The dam has two shoulders of gravel fill and a central vertical asphaltic core. The core is located under the crest of the dam and slightly offset to the upstream side. Adjacent to the core are transition zones extending 1.5m upstream and downstream of the core. Beyond the transition zones the embankment consists of a gravel fill material. The crest and downstream berm are protected with grass and concrete blocks, with the upstream berm and embankment slope being covered in riprap above a filter layer to separate it from the main gravel fill (Figure 1).

Figure 1. Cross section through Megget dam

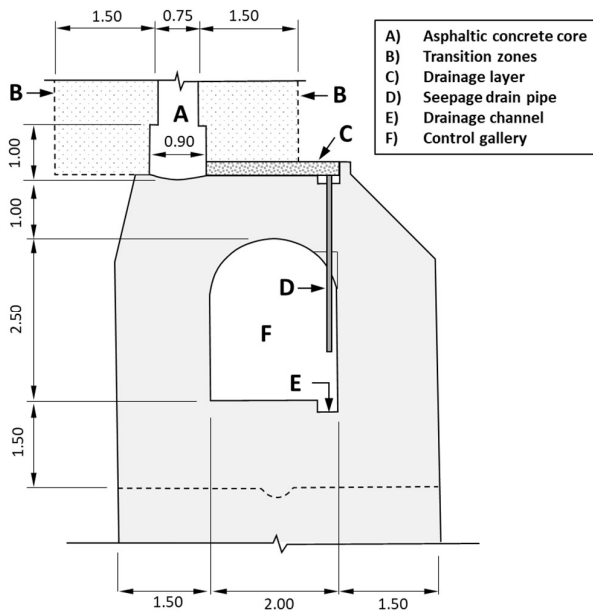
A concrete inspection gallery runs along the length of the dam at the base of the asphaltic core. Drainage channels run along the length of the gallery, with drainage pipes from the above drainage material (immediately below the transition zone) discharging into the drainage channels (Figure 2 and Figure 3).

Figure 2. Cross-section through gallery

The transition zones on the either side of the core use the same material as that used in the shoulder (with an upper size limit of 100mm and a restriction of 5% - 10% fines passing 2mm), allowing for any seepage through the core to be directed to the control gallery channels, via the drainage layer and seepage drain pipes (Figure 2, notes C and D).
