## Re-establishing and Improving Scour Capacity at Daer Reservoir

R McHUGH, Mott MacDonald

K MURRAY, Scottish Water

**SYNOPSIS** Daer Reservoir was formed in the 1950s by the construction of a 43m high, 790m long earthfill embankment dam with a concrete corewall.

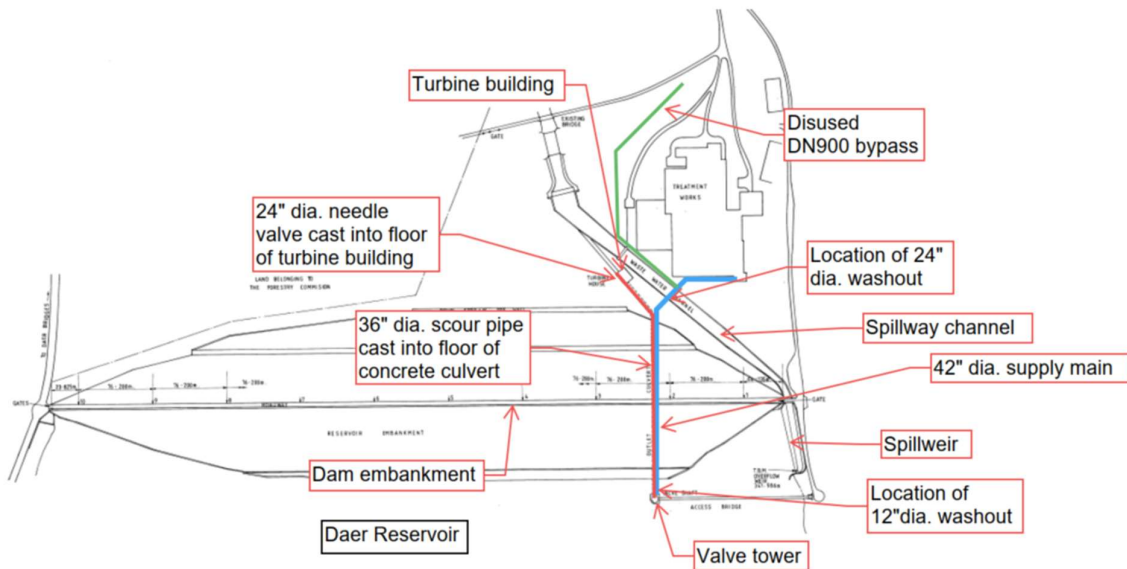
The outlet (Figure 1) comprises a 42" supply main with three draw-offs connecting to a 42" diameter stack pipe in a dry valve tower. The supply main passes through a culvert below the

There are two washouts off the supply main; a 12" washout at the head of the tunnel controlled by a 24" butterfly and a 12" fixed cone discharge valve, and a 24" washout at the left-hand end of the spillway bridge controlled by a gate valve. There is also a disused 900mm diameter bypass on the right-hand side of the spillway bridge with a 600mm diameter branch at the toe of the dam. This bypass had not been operated in some time and there were few records of this available.

The scour comprises a 36" pipe which is encased in the concrete floor of the culvert with a branch off to a compensation turbine and a branch off to a spill turbine, both located within the turbine building at the downstream end. The compensation flow at the reservoir is discharged through the compensation turbine and, when the reservoir is (or close to) spilling, the spill turbine operates to generate energy from what would have otherwise been wasted water. The scour discharges through a 24" diameter needle valve, the body of which is encased within the concrete foundation of the turbine building.

**Figure 1.** Outlet Pipework at Daer Reservoir

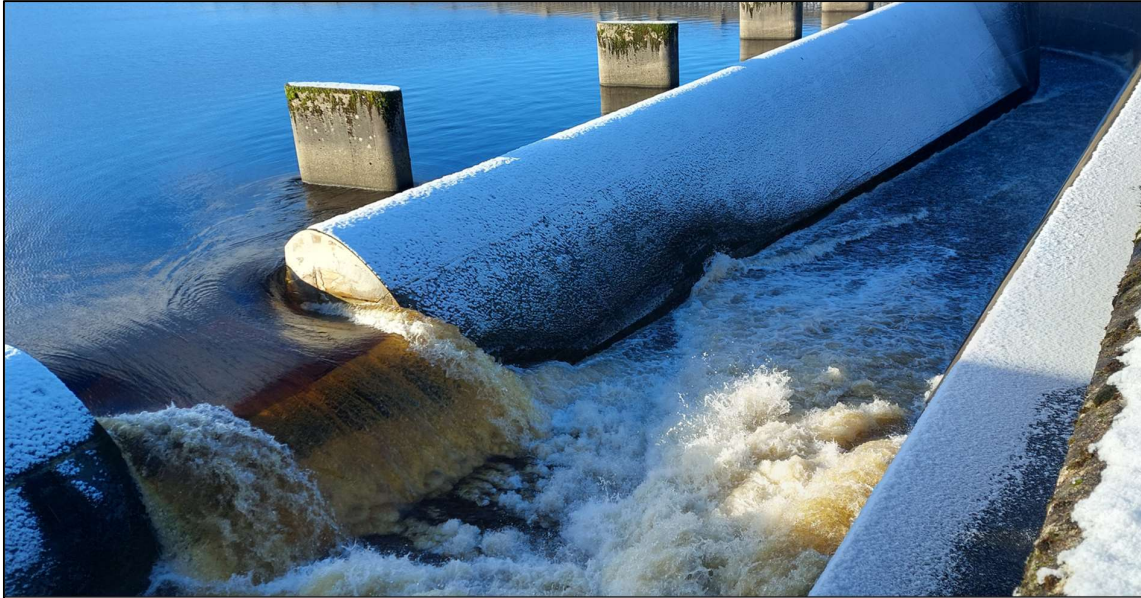
The reservoir has a side channel overflow (Figure 2) which is formed of precast concrete crest blocks on an in-situ base, discharging into a concrete channel down the left-hand mitre of the dam.

**Figure 2.** Overflow Weir

While the scour was being cleared, a notch was cut in the spillweir to aid control of the reservoir level. During this time, a 24" diameter washout off the supply main was used to control the reservoir level. Due to this frequent operation, the washout valve became damaged. Repair of the valve would have required shutdown of flow to the works.
