Managing risks associated with the infilling of the adit at Tunstall Reservoir

B AGUILAR, Stantec
N ASHCROFT, Stantec
I CARTER, Stantec

SYNOPSIS Significant leakage was observed on the left flank of Tunstall Dam upon first filling of the reservoir. A concrete-filled cut-off wall was extended into the abutment in 1879, which significantly reduced the flow but did not resolve the problem. In a further attempt to manage leakage, the adit and shaft that had been used to form the cut-off wall was repurposed and extended with additional drifts cut into the hillside to capture and transfer leakage flow.

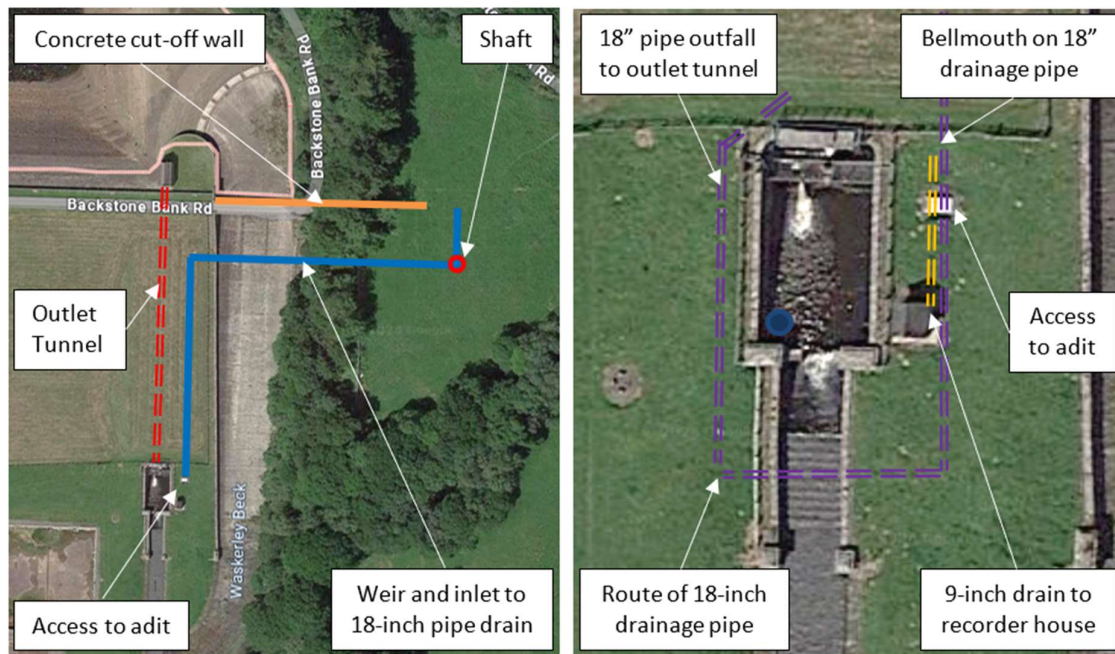
Some 120m of the 200m long adit lies below the footprint of the dam and spillway, with the rest lying within the hillside. Water passing through the left flank is intercepted by the tunnels and flows into the adit, where a low brick wall transfers the water into an 18-inch cast-iron pipe. Figure 1 illustrates the layout of the adit and associated features.

Figure 1. Extent of the adit and key features (Google Maps).

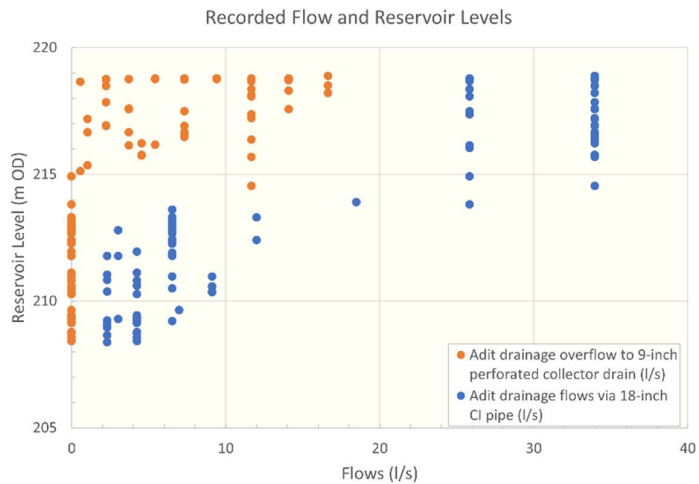
Figure 4 shows the leakage entering the adit predominantly through the shaft near its eastern end. Flows in the adit are closely related to reservoir water level. They decrease significantly when the water level falls 6m below the top water level (TWL). Figure 5 shows the correlation between reservoir levels and recorded flows in both the 18-inch drainage pipe and the 9-inch perforated collector drain, collecting flows from the bellmouth overflow.

Figure 5. Relationship between reservoir level and flows recorded in both pipes systems.

Regular readings of flows both in the 18-inch and 9-inch pipes began in October 2019. Prior to the works, the maximum recorded leakage flow was 51 l/s with the reservoir water level standing at TWL for a prolonged spell. Leakage flows have historically dropped to 2 l/s with the water level 10m below TWL. It was therefore decided that flow into the adit should be stemmed during the construction phase by lowering the reservoir level and maintaining it around 6m below TWL. In view of the nature of the cut-off wall and its very good condition, no additional works were required to improve its watertightness.
