# Lessons from incidents and geotechnical investigations at embankment dams

Andrew Charles (BRE)  
Paul Tedd (BRE)  
Alan Warren (Motts)

# **Investigation hydraulic fracture at Greenbooth dam: 2001/09**

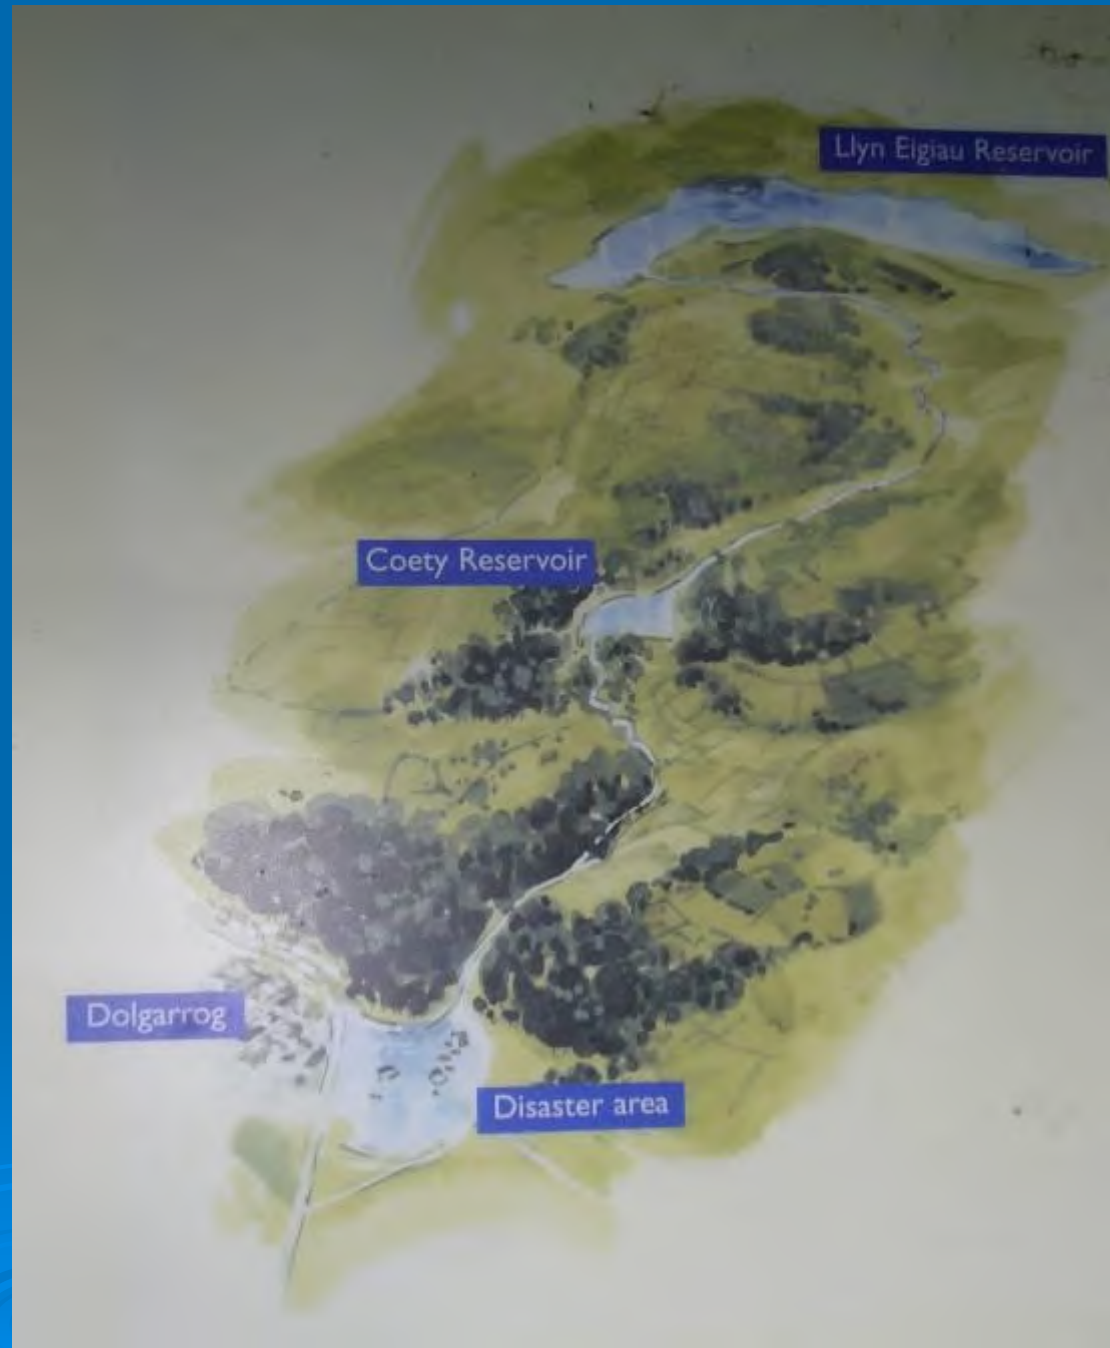
- Concrete gravity
- Completed 1911
- Height 5m at breach
- Shallow foundation on clay
- Poor concrete
- Remote location
- 16 killed, power station destroyed

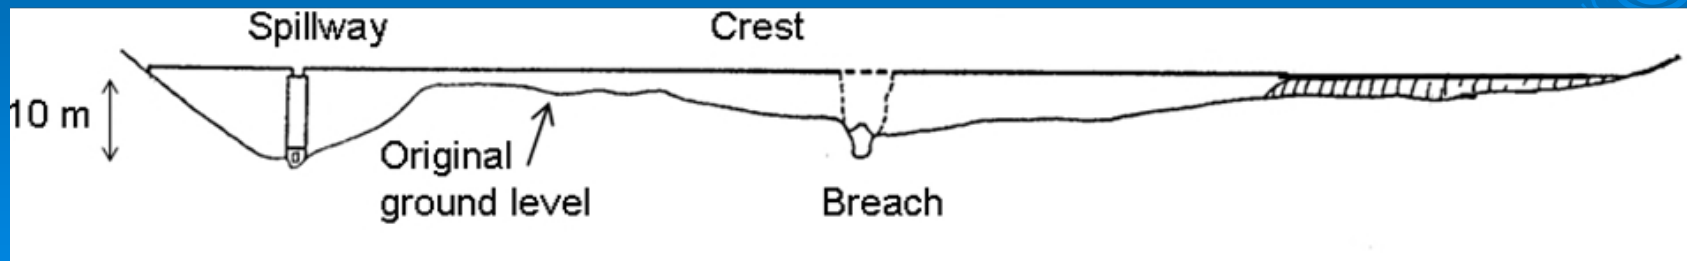
Longitudinal section

Foundation: glacial deposit of hard blue clay containing granite boulders, overlain by peat up to 1.5m.

Foundations were specified to be 1.8m below clay surface but were only 0.46m.

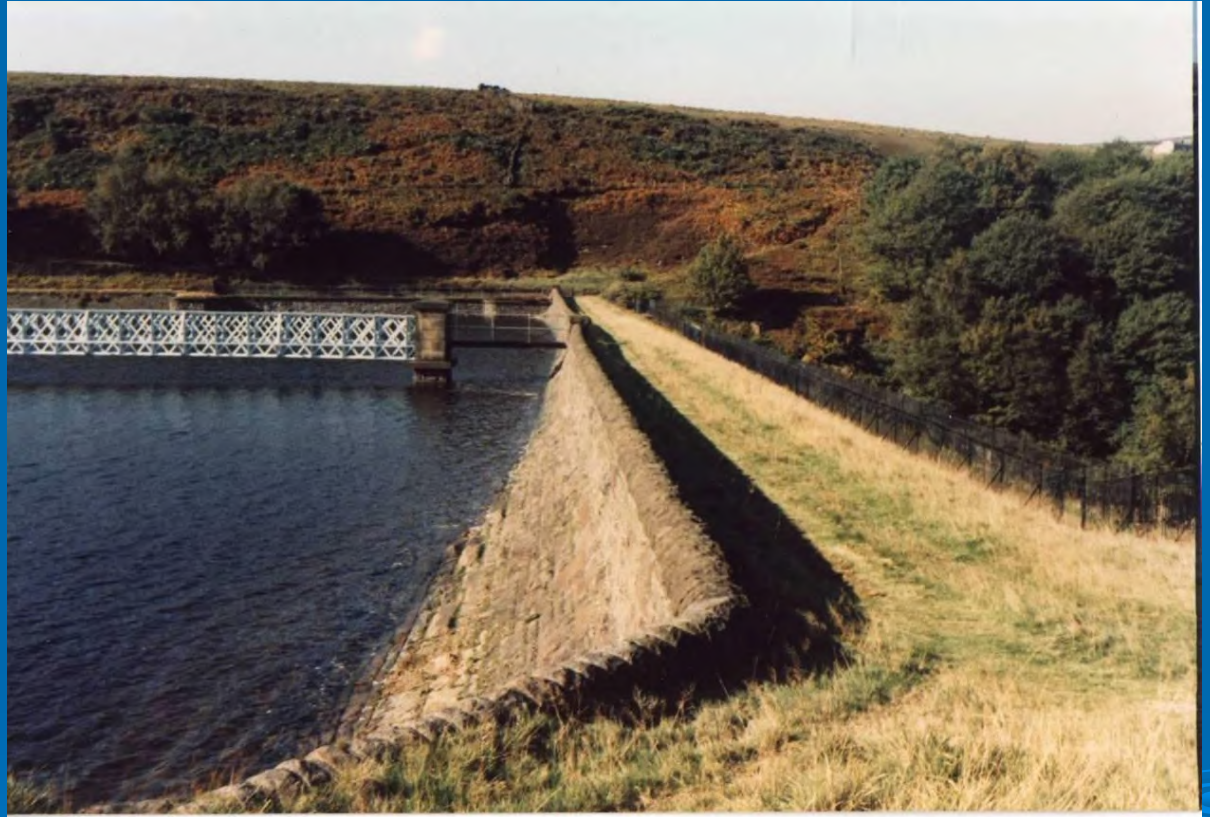
Height: 25 m

Settlement: 1m  
(4% vertical  
settlement) since  
construction

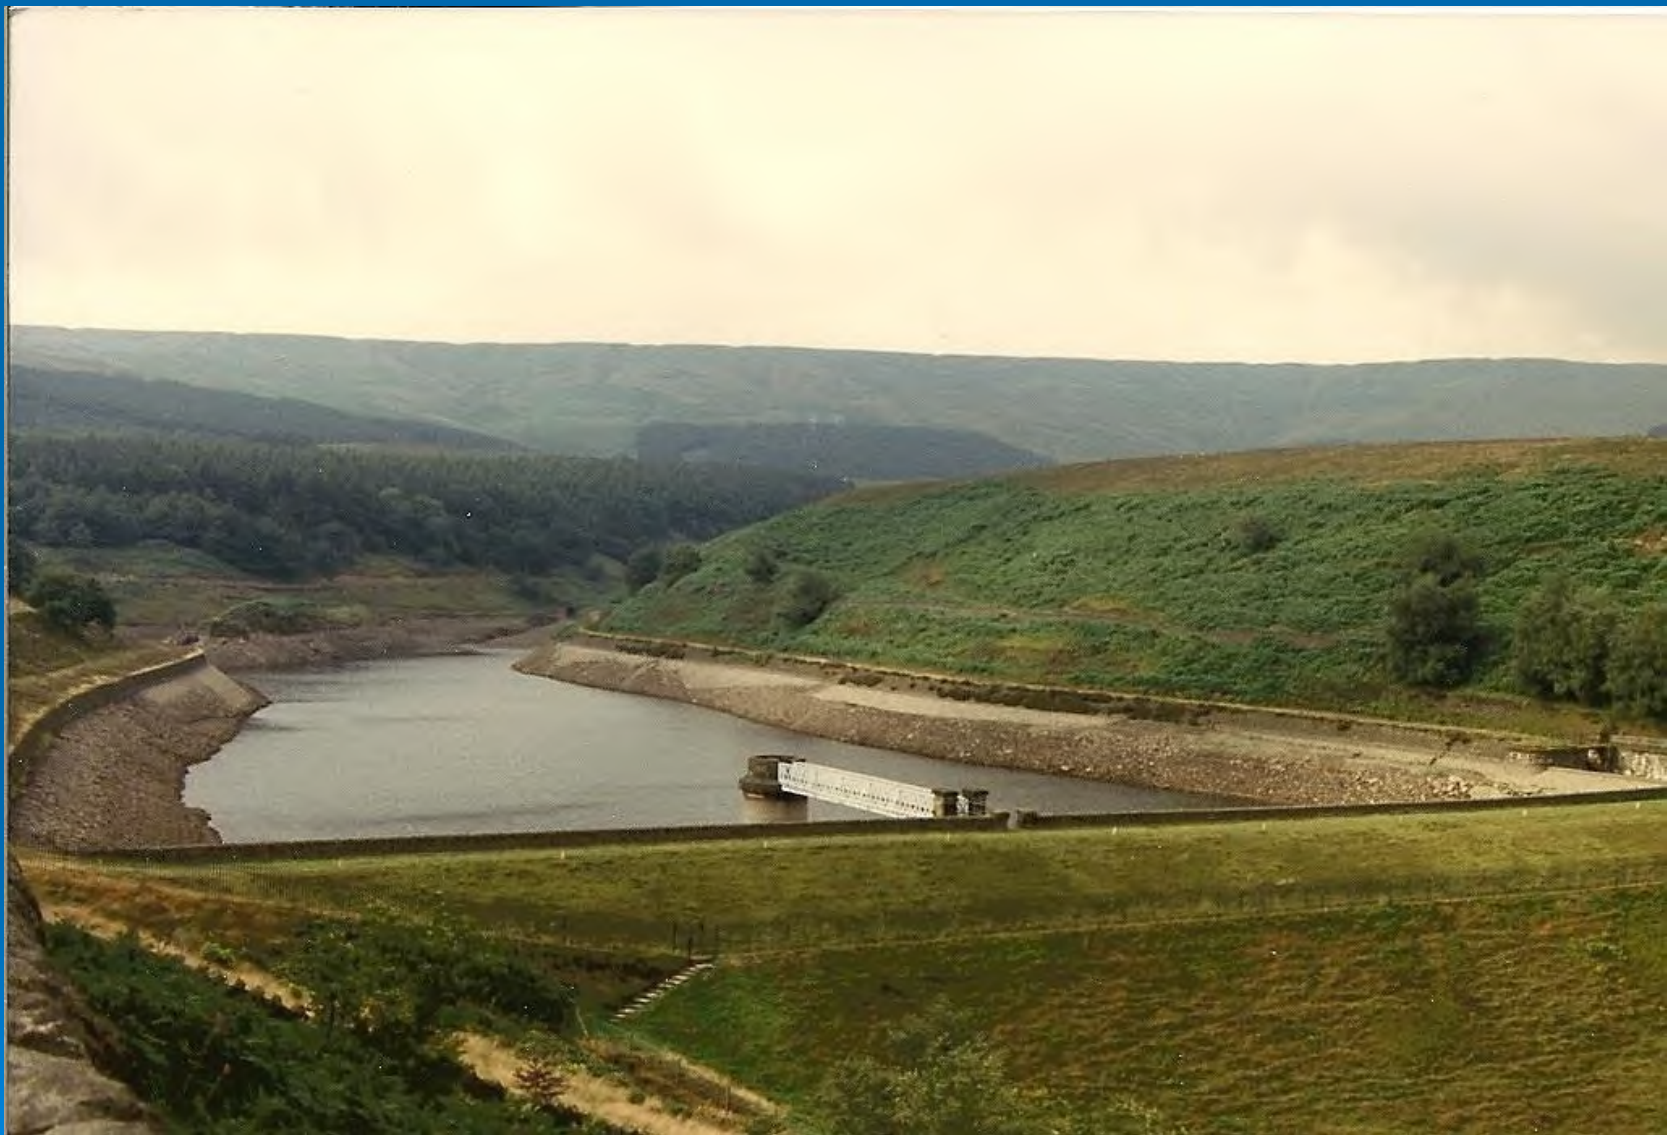
Measurements by Yorkshire Water showed that settlements were related to reservoir drawdown. Concerns were expressed about slope instability and internal erosion

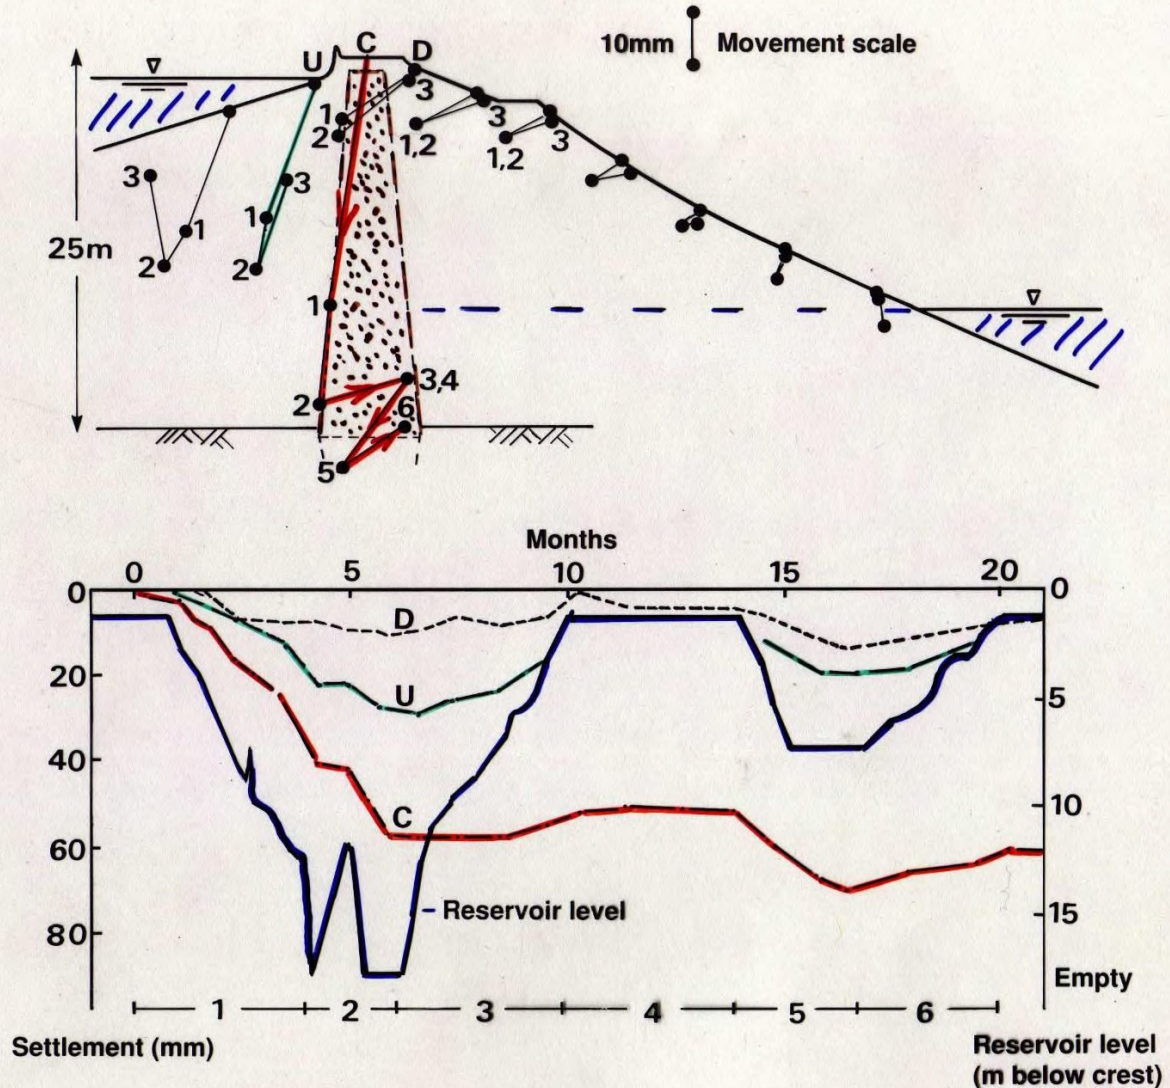
# Ramsden – surface movements due to reservoir changes

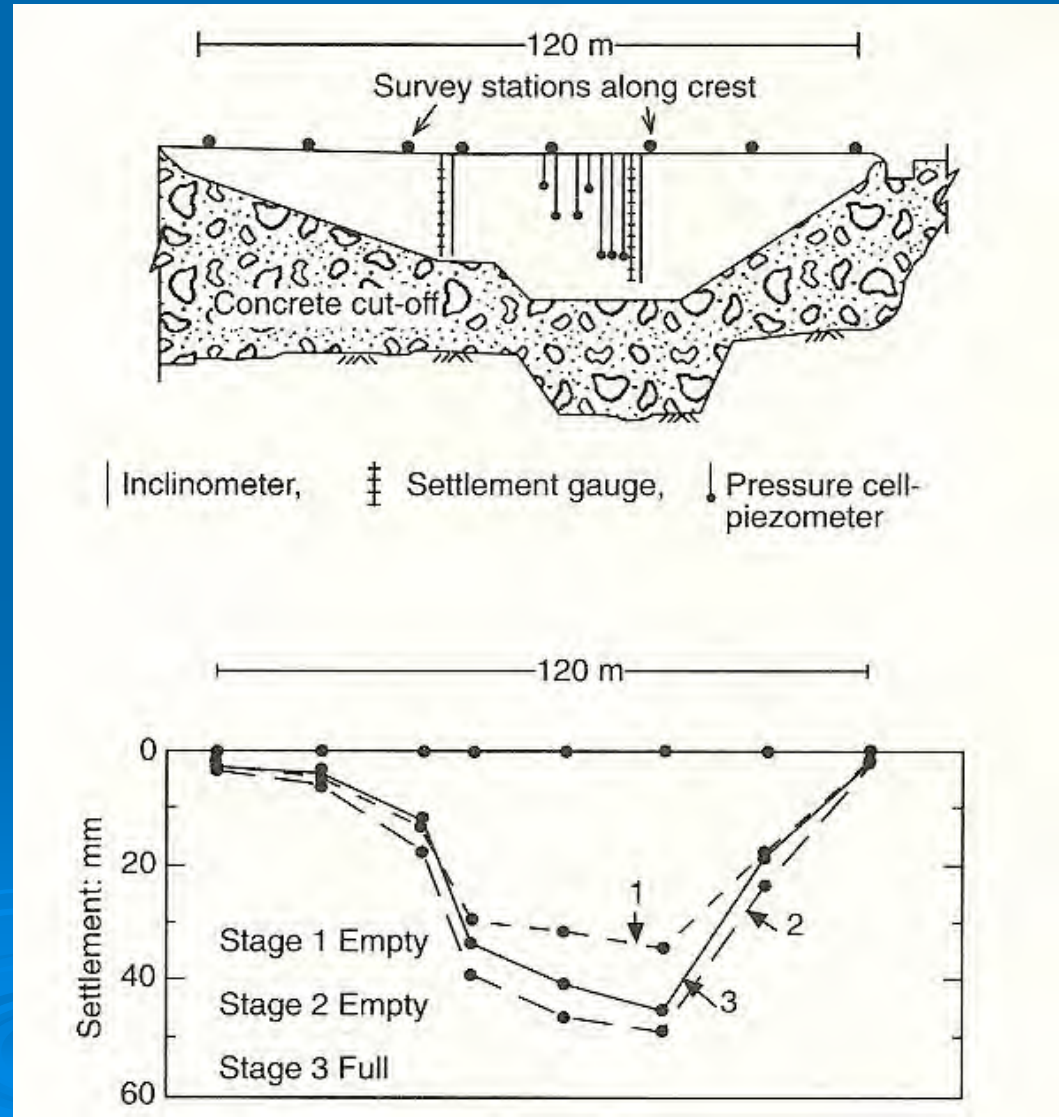
# Settlement along crest

- Depth of fill
- Duration of drawdown
- Depth of drawdown
- History of drawdown

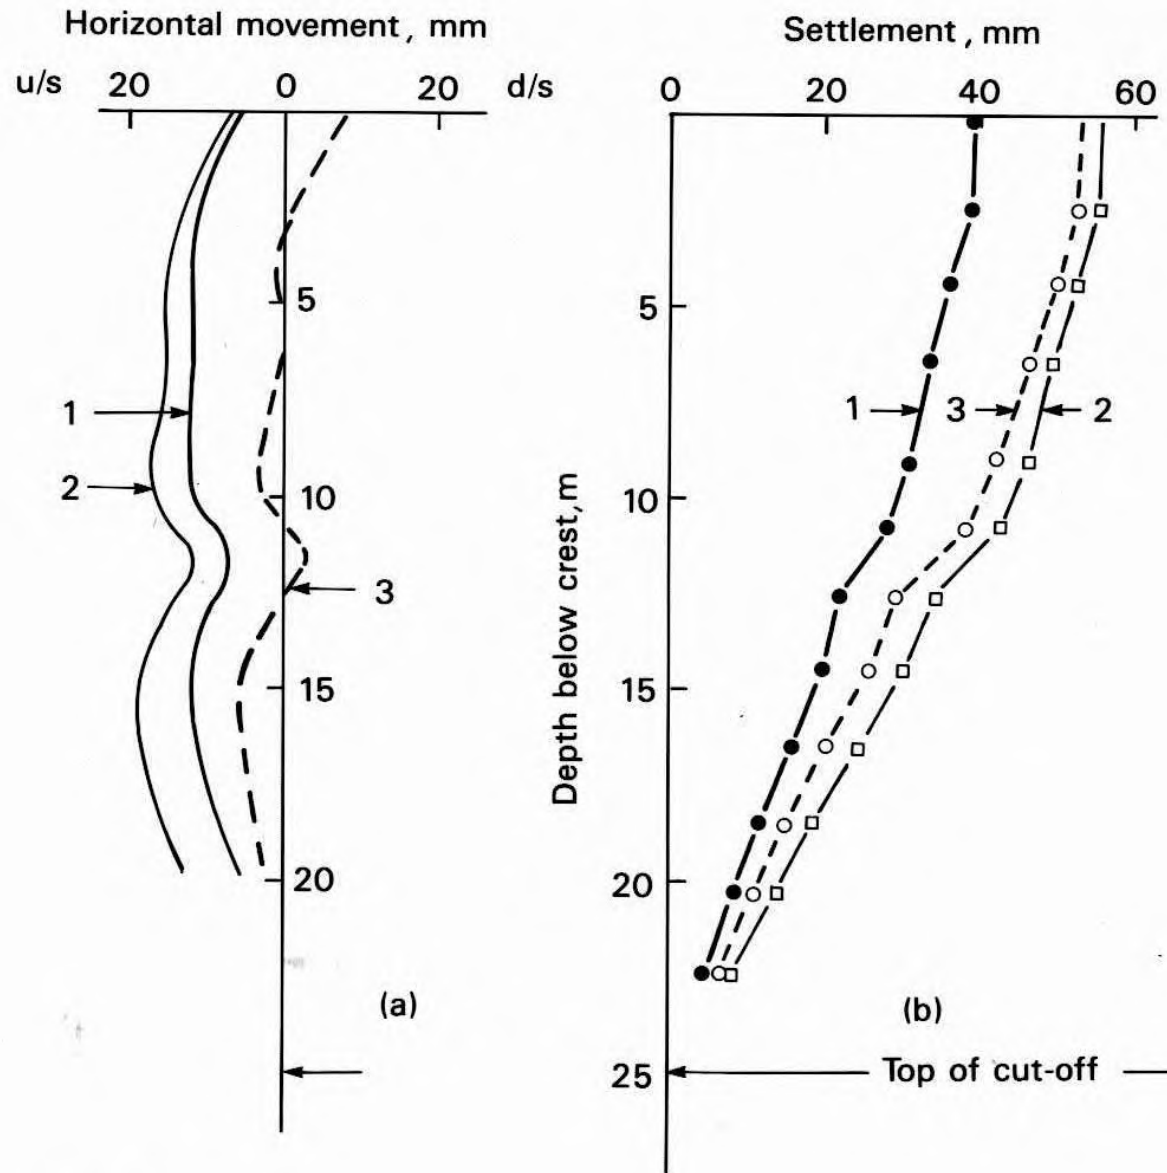
Figure 4

# Settlement and horizontal movement with depth

Stage 1: Empty  
Stage 2: Empty  
Stage 3: Full

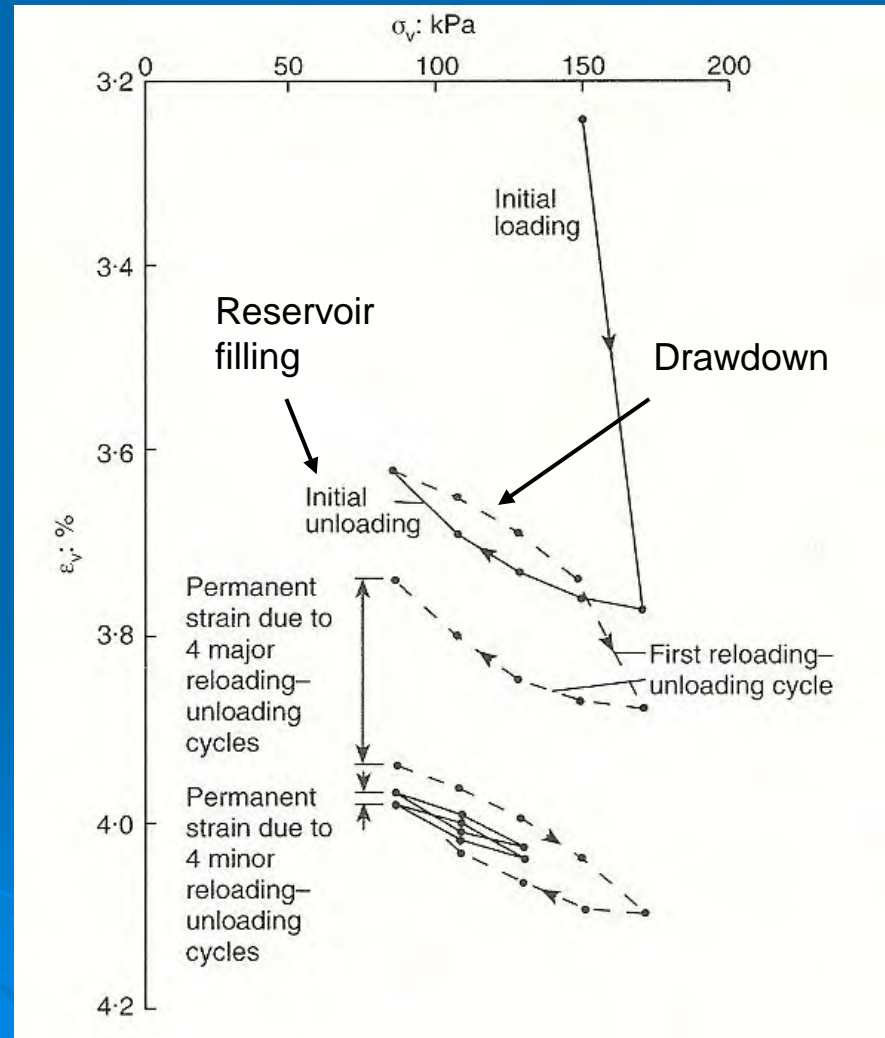
Stress-strain behaviour is not linear. Constrained modulus values decrease with increasing reloading (reservoir drawdown) 113 MPa to 31 MPa.

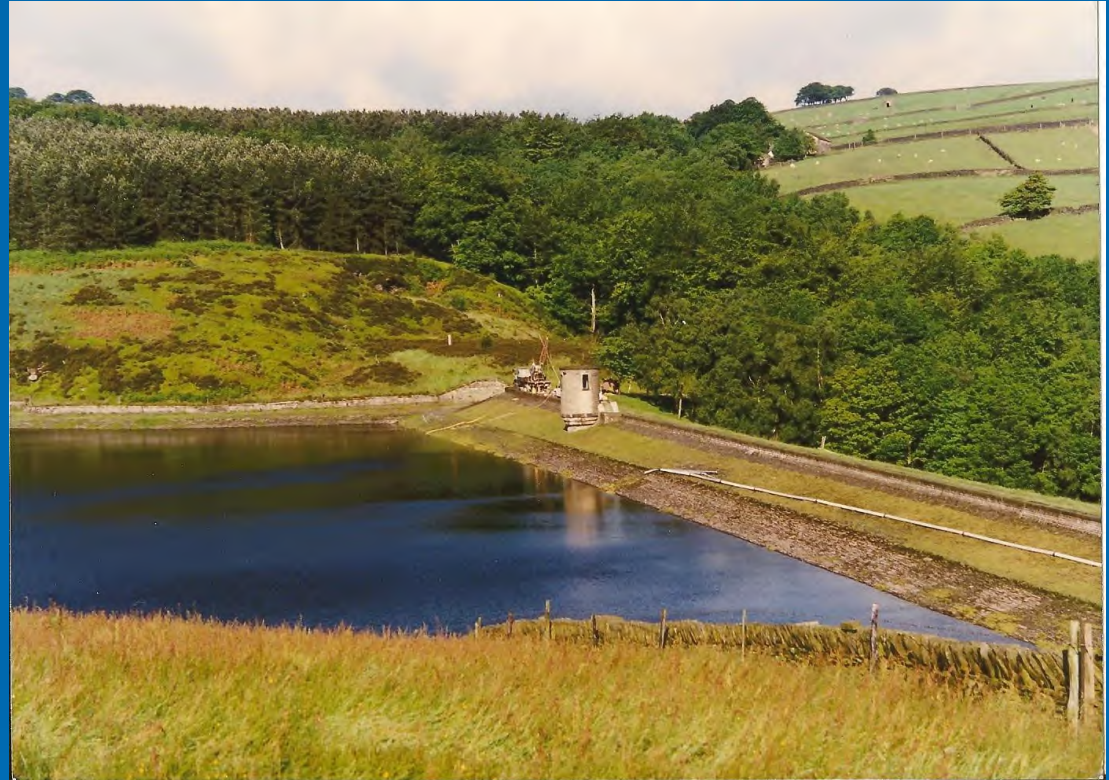
- Built 1840, design by George Leather for the Holme Reservoirs Commissioners
- 24m high with puddle clay core and shallow cut-off.
- Valve shaft immediately upstream of the core
- Captain Moody, government inspector for the failure of Bilberry dam, reported that “leakage into the valve pit was running considerably muddy”
- Bateman placed an upstream clay blanket on the dam and adjacent sides in 1857

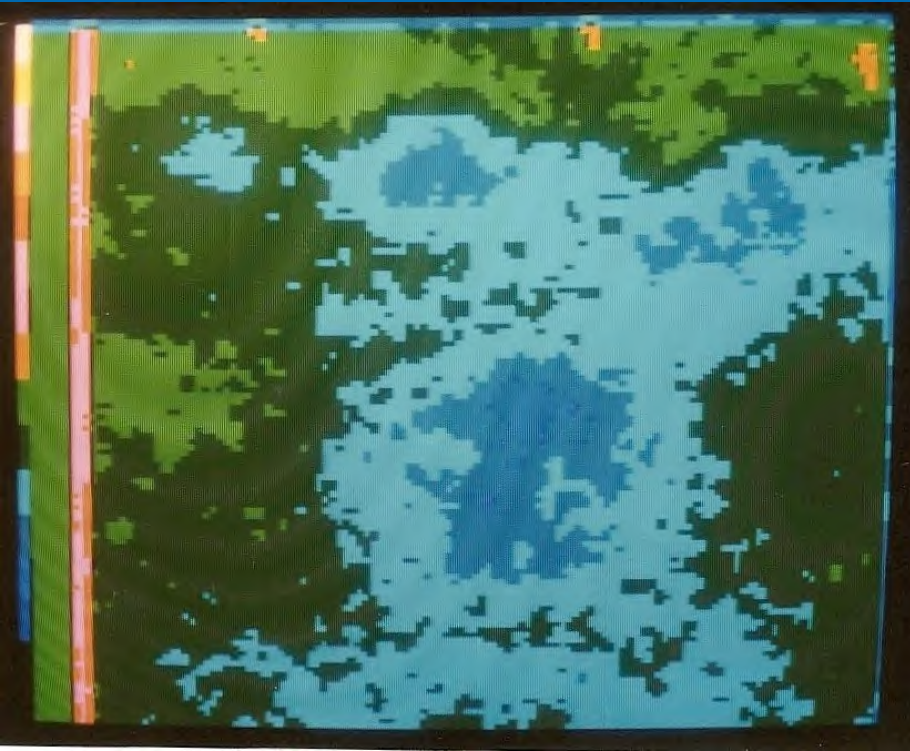
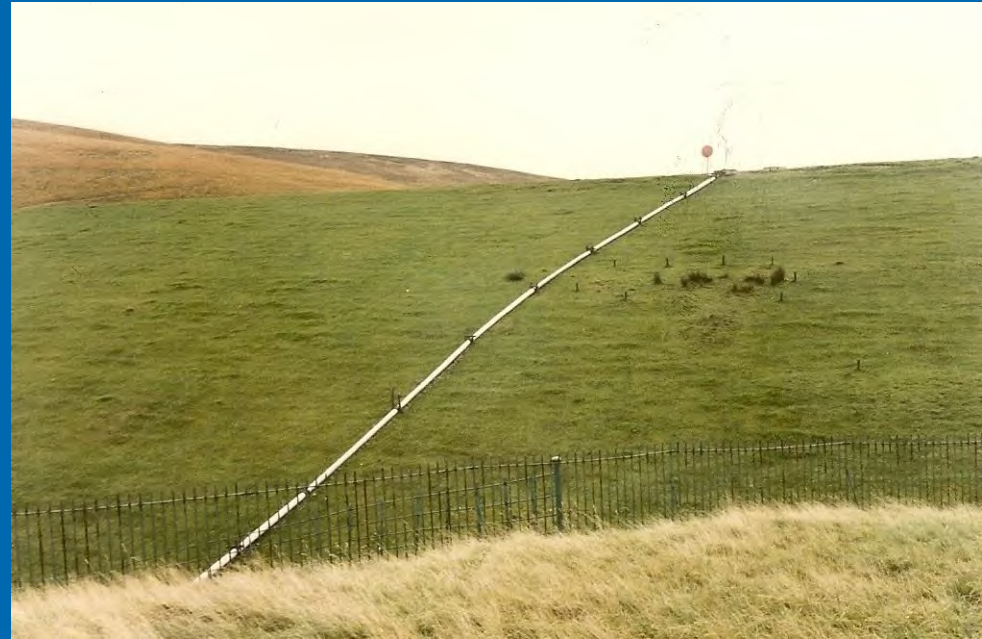
Infra-red thermography study 1984 at Gorpley dam

Showed the wet areas (blue) to be cold compared with surrounding ground (green)

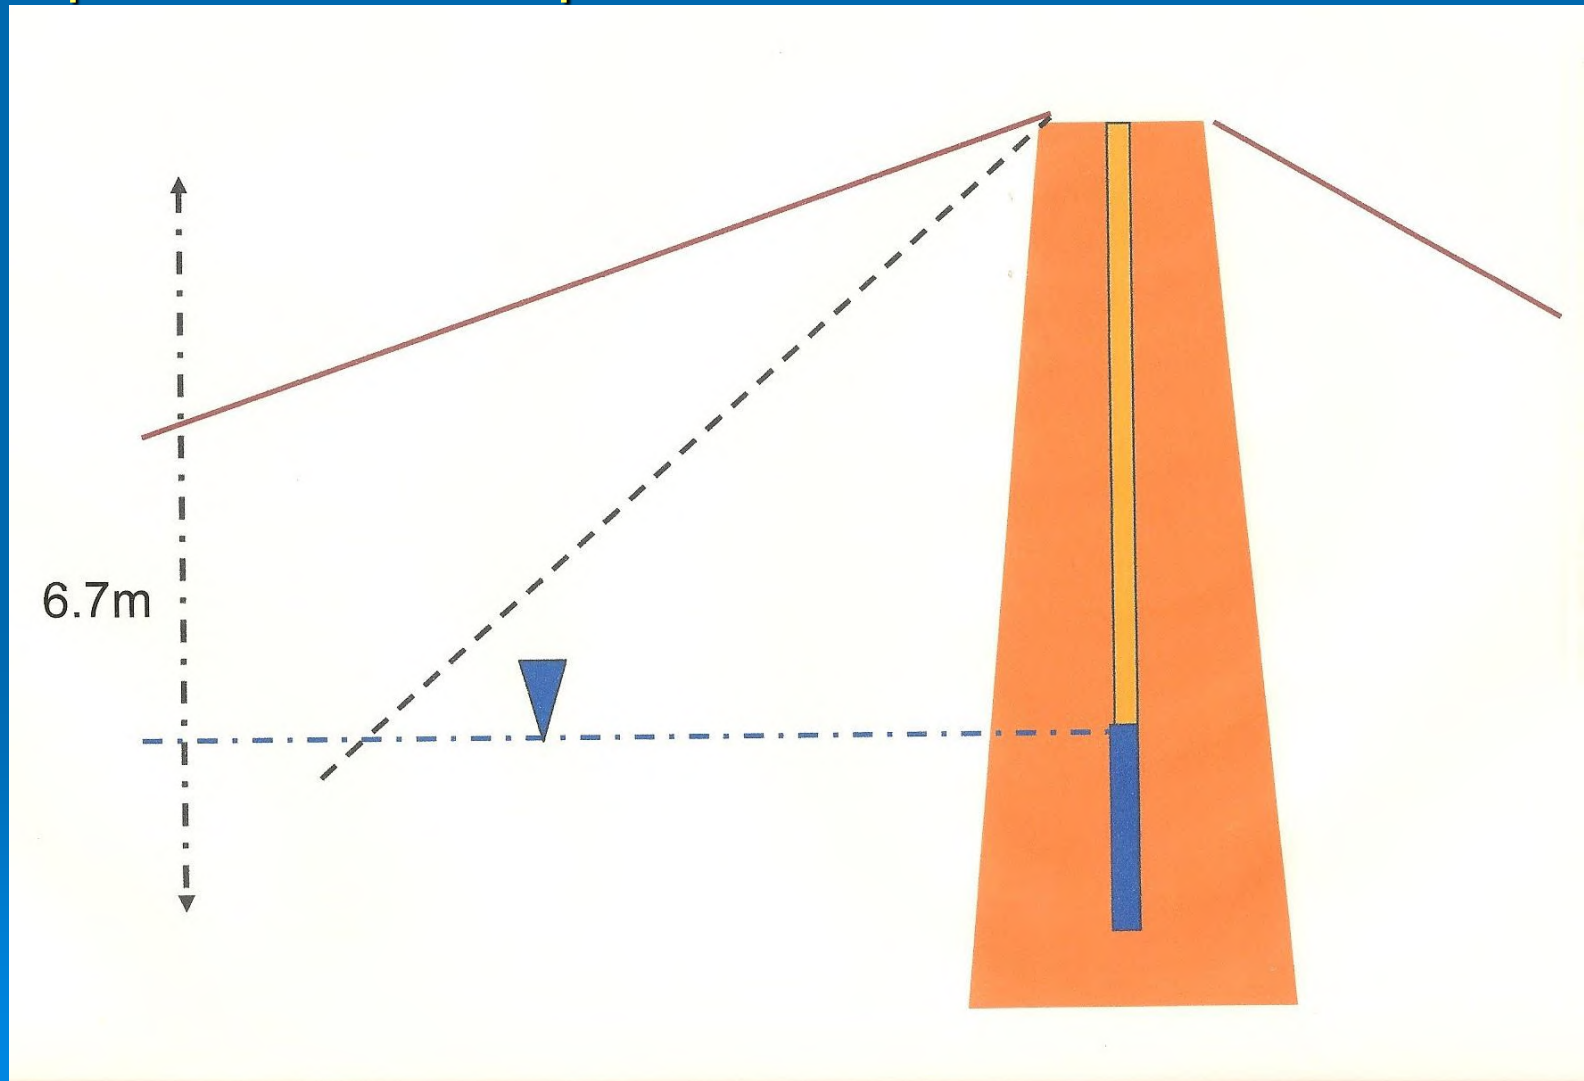
2001 – Borehole investigation for seismic assessment reveals connection between core and reservoir at 6.7m depth in the central part of the dam.

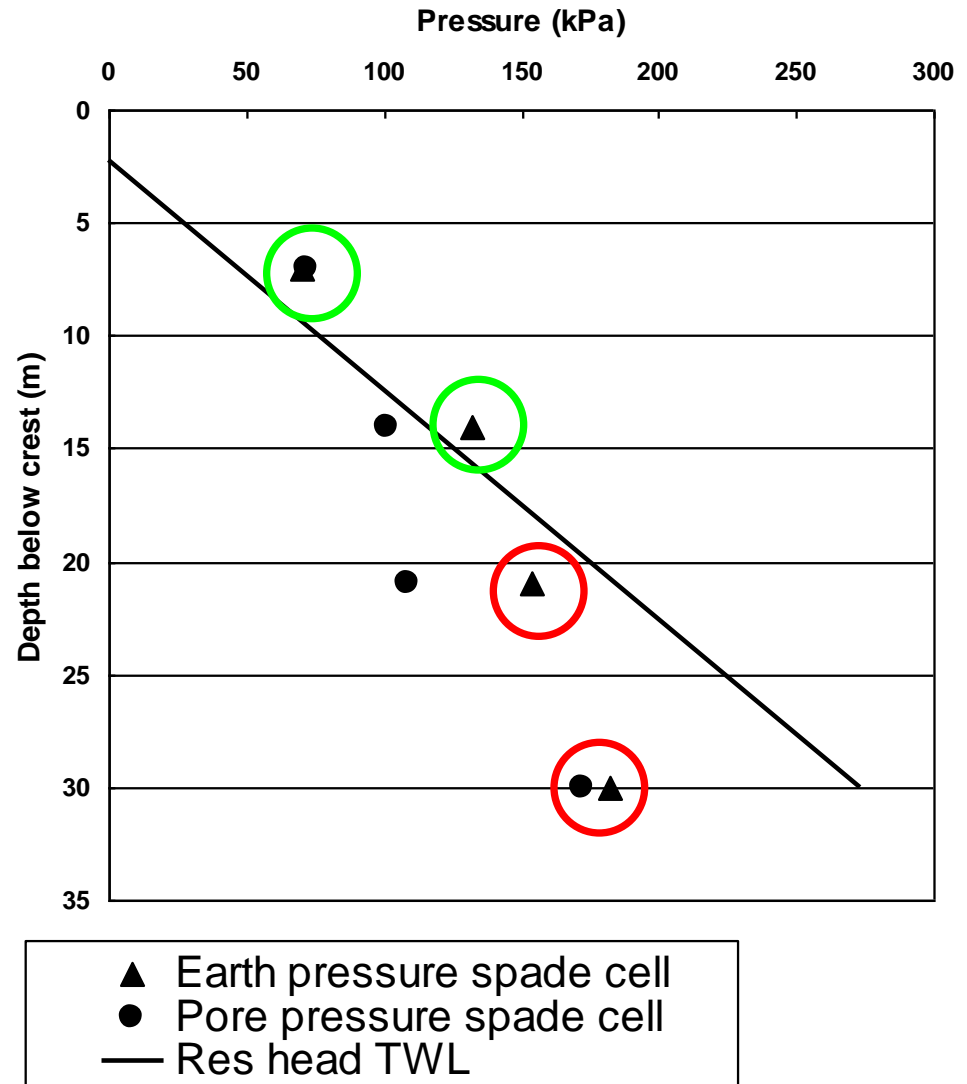
At 30m and 21m the measured earth pressure was significantly less than the pressure due to reservoir head. At 30m, the difference was 9m head (90kPa).

At 7m and 14m, the measured earth pressure was larger than the reservoir head.

- The results therefore indicated vulnerability to hydraulic fracture at depths of 21m and 30m, but not at 7m.
- Were the results due to instrument malfunction?
- Can we believe what we measure?
- What other methods were available to verify these findings? – critical pressure tests

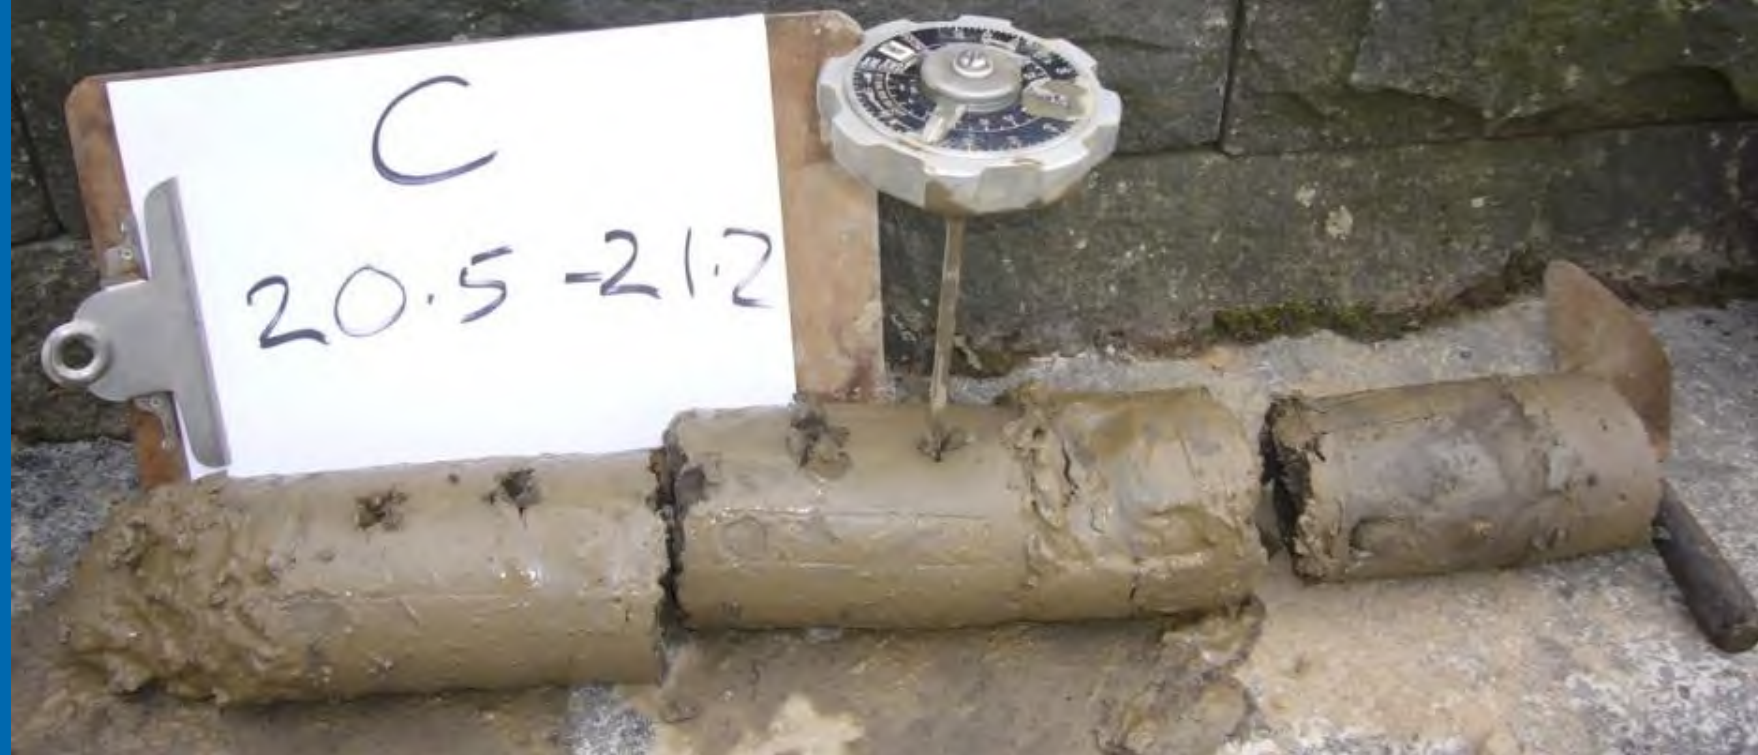
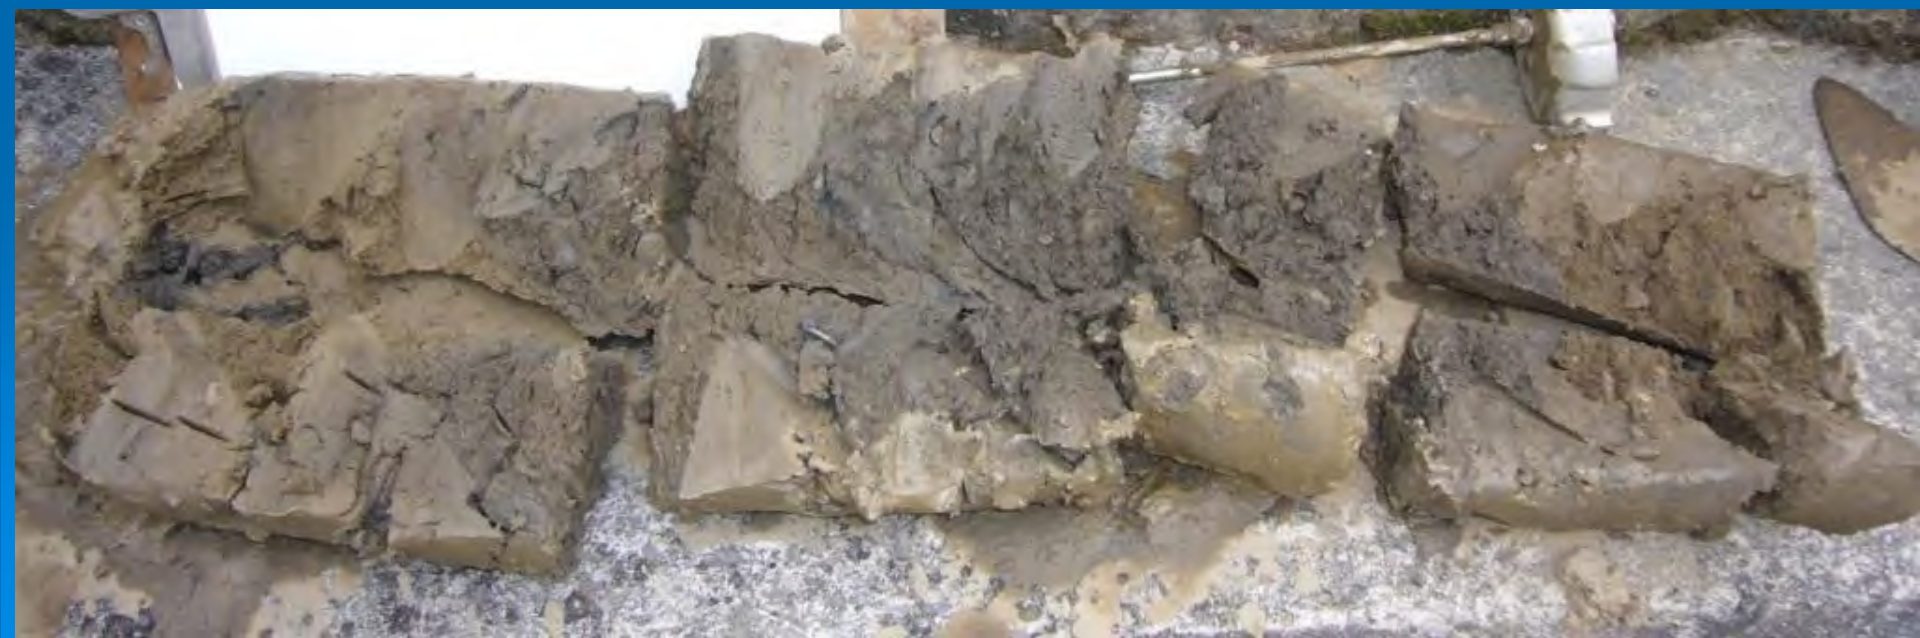
# Clay core – observations during drilling

- Very soft to soft well graded, silty sandy, slightly gravelly CLAY of low to intermediate plasticity
- Hand vane gave shear; between 15 and 40 kPa
- Core recovery very variable. Depth 4m to 14m: 0.35 to 0.4m. Below 21m, the plastic inner sampler tube became stuck due to sand or silt.
- Permeability tests indicated low values, no evidence of hydraulic fracture indicated by loss of water.
