Condition assessment of Government-owned dams in Finland

SYNOPSIS. Some 480 dams in Finland are covered by dam safety legislation and of these, some 50 dams are government-owned. In spite of shortcomings and a few incidents there has been no complete dam failure in Finland affecting water storage dams that have a significant damage potential in case of failure. To unify the safety level of government-owned dams and to prioritise future maintenance work, the environment administration has decided to carry out condition assessments of dams that have a significant damage potential in case of failure.

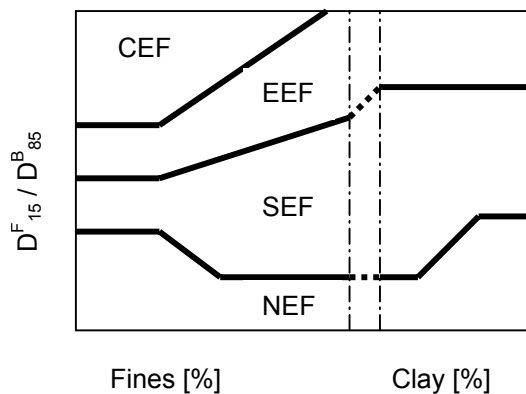
Figure 4: Principle of applied filter criteria chart. NEF = no erosion filter, SEF = some erosion filter, EEF = excessive erosion filter and CEF = continuous erosion filter. All percentages and grain sizes are calculated from corrected grain size distribution curves. D^F_{15} and D^B_{85} represent filter and base material grain size diameters, through which 15 and 85 % respectively, of the material will pass.

- application of the Fuller curve to determine the grain size distribution curve of the active portion of soil
- modification of the Foster and Fell filter criteria for practical activity; the principle is presented in Fig. 4

- utilisation of the principle of fuzzy logic; the principle is presented in Fig. 5; in fact Fig. 4 includes the concept of fuzzy logic as well.
