Improving Dam Safety: Auxiliary Spillway Design

SYNOPSIS. This paper describes aspects of the design and construction of a new auxiliary spillway, incorporating a labyrinth weir and collapsible safety screens, for an existing cyclopean masonry dam. The works were required to comply with current dam safety legislation. The role of Designer was undertaken by Atkins Limited on behalf of South West Water Ltd (SWW). At the time of writing the works were substantively complete.

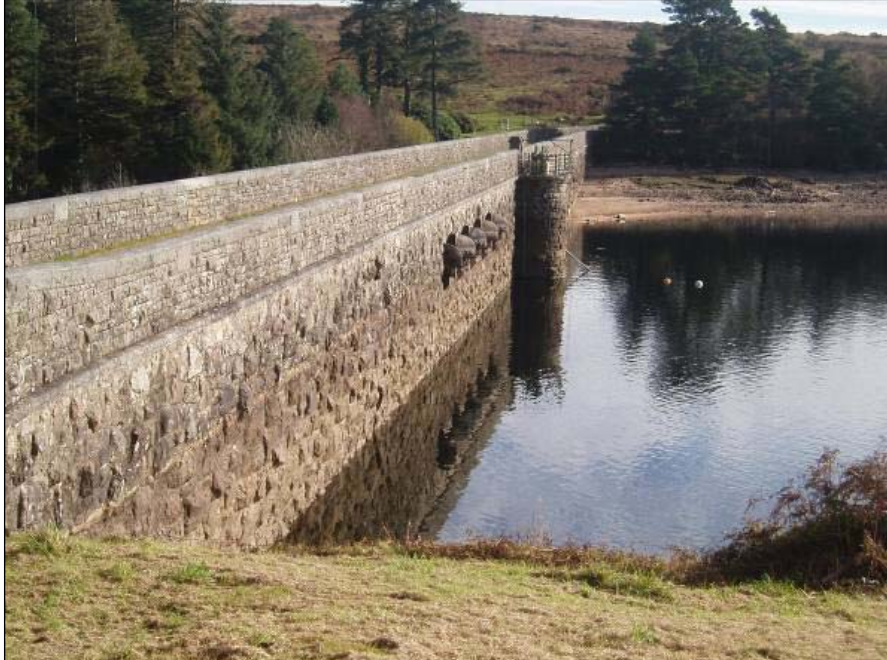
Figure 2. View looking West to East on upstream face of Venford Dam

‘plum’ core. Four spillway openings allow flood water to safely pass the dam when reservoir TWL is exceeded. Figures 2 & 3 show the upstream and downstream faces of the dam.

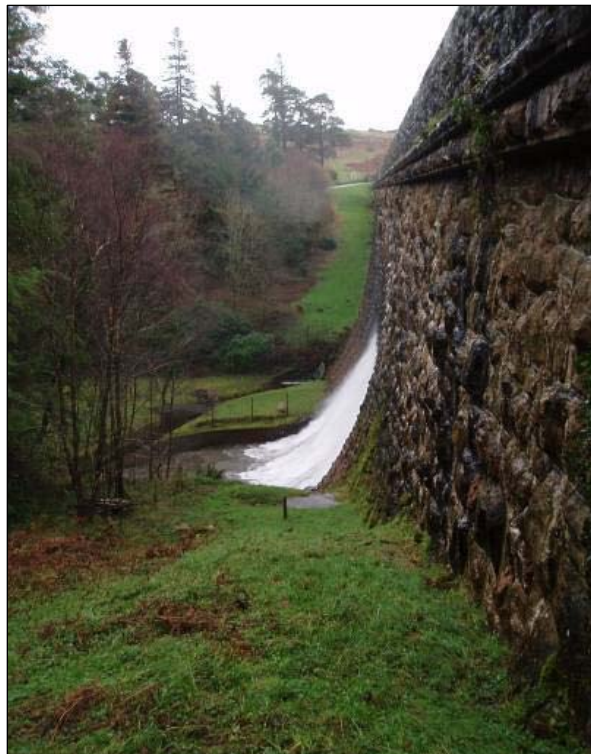
Figure 3. View Looking West to East on downstream face of Venford Dam

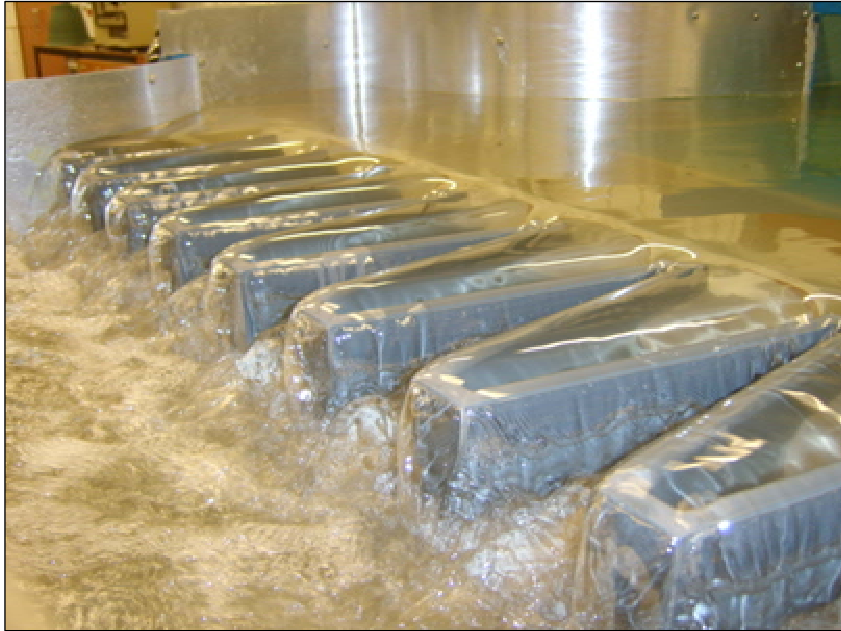
Figure 4. Physical Model of Labyrinth Weir in Operation

The auxiliary spillway capacity was assessed to be 38m³/s using theoretical hydrological flood routing analysis and hydraulic calculation. The findings of the theoretical analyses were further verified through scaled physical modelling undertaken at Exeter University, see Figure 4.

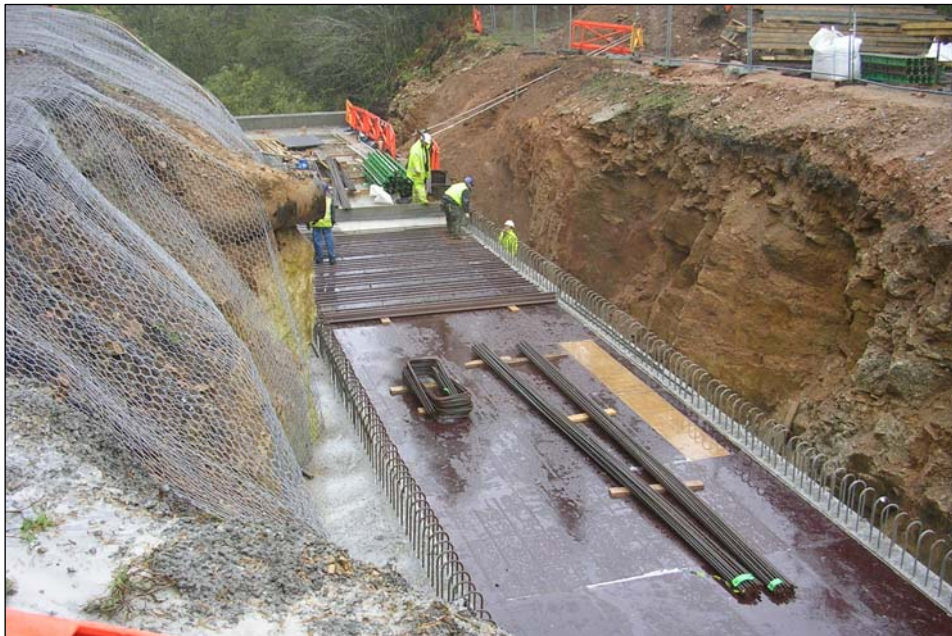
Figure 6. Construction of Buried Culvert in Progress. View looking downstream toward quarry

Open channel options were ruled out on a number of grounds including health and safety, available space and cost. Uncertainty, in the short and long term, of the stability of the excavated unweathered rock faces was a notable deciding factor. The potential safety hazard to operational and inspecting personnel in maintaining an unlined open channel up to 8m deep, together with its proximity to an area of high public amenity, was considered unacceptable. As such a lined buried culvert option was selected in the final design (Figure 6).

The choice of a single box culvert was driven by hydraulic performance, access for maintenance and inspection activities and cost considerations.

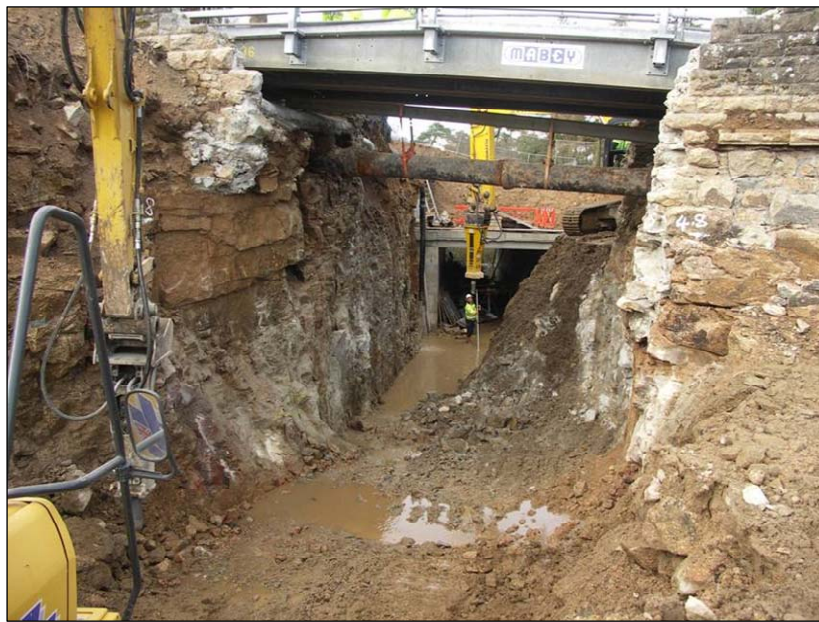
Figure 7. View Looking Downstream through Dam Cut with Temporary Bridge in Position

Further consultations with Dartmoor National Park Authority (DNPA), and a revision to the construction programme by SWW led to a cut and fill option being selected in the final design. A six week road closure period was agreed between SWW and DNPA to allow the works to be completed. As the works were programmed to be undertaken outside the peak tourist seasons the impact on the local economy was minimised. A temporary road bridge was also used to allow limited access for local residents and construction traffic. Figure 7 shows the cut through the dam during construction.

The stone parapet walls of the dam were dismantled and each block numbered for reinstatement. Unweathered rock head was encountered close to road base level and a stitch drilling technique was used to minimise the extent of excavation through the dam. The Contractor was required, by the QCE, to provide appropriate temporary works to maintain the standard of protection provided by the dam to PMF level. This was achieved by earth filled one tonne bags wrapped in plastic sheeting.

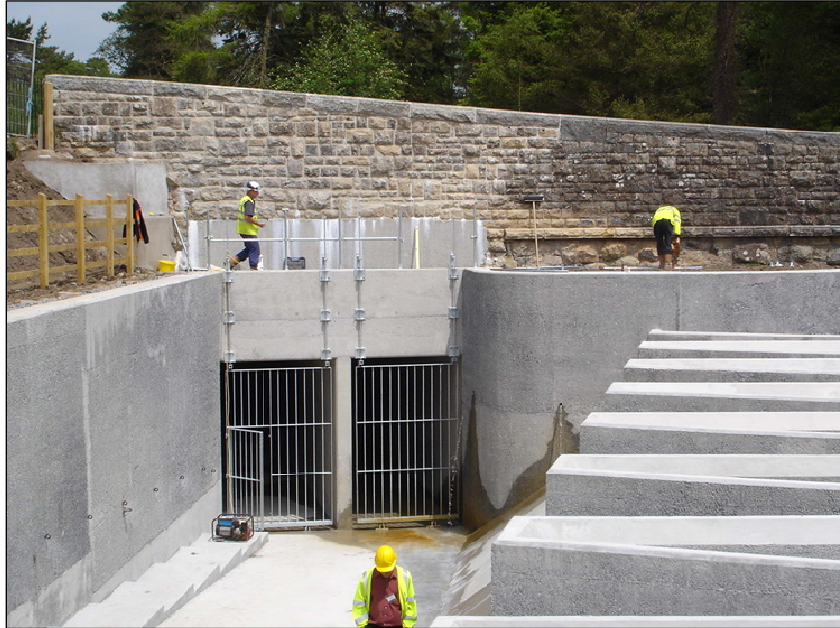
Figure 8. Showing Reinstated Parapet Wall and Near Complete Entrance Works to Buried Culvert

Due to the relatively small scale of the works, and width constraints on the approach road to the dam, it was decided to construct the buried culvert (spillway channel) in situ. As the sides of the excavation were close to vertical it was possible to use the exposed unweathered rock faces as a back shutter, negating the requirement for extensive backfilling. The culvert through the dam was then backfilled with foam concrete to sub base level before reinstating the roadway and parapet walls, see Figure 8 below.

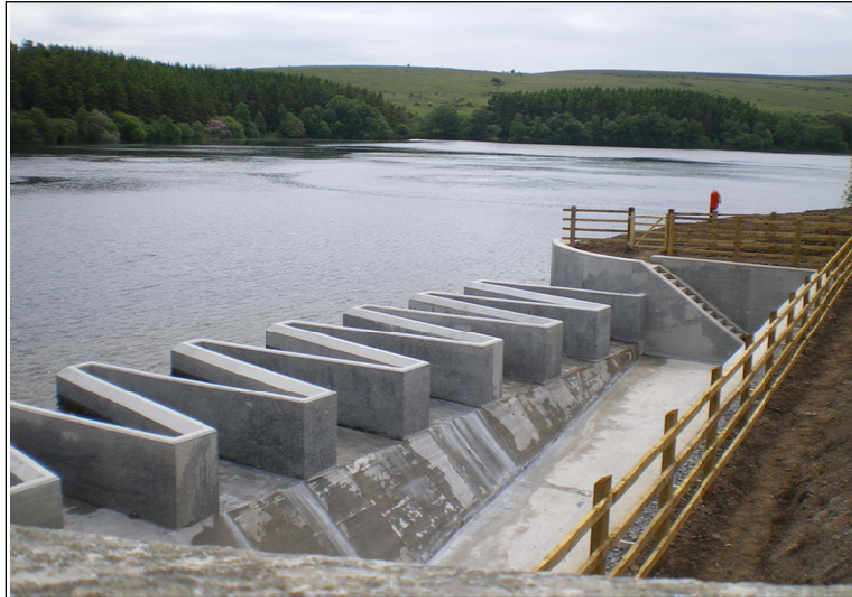
Figure 10. View of Completed Labyrinth Weir and Receiving Channel Viewed from the Dam

overlying weathered rock band. This, combined with the highly fractured nature of the unweathered rock in the receiving channel area, and the highly turbulent flow conditions expected during operation, meant that the only viable solution was to design a reinforced concrete lined receiving channel. Leaving the channel unlined would also have compromised safe access for future inspection and maintenance activities. Figures 10 and 11 show the completed labyrinth weir and receiving channel

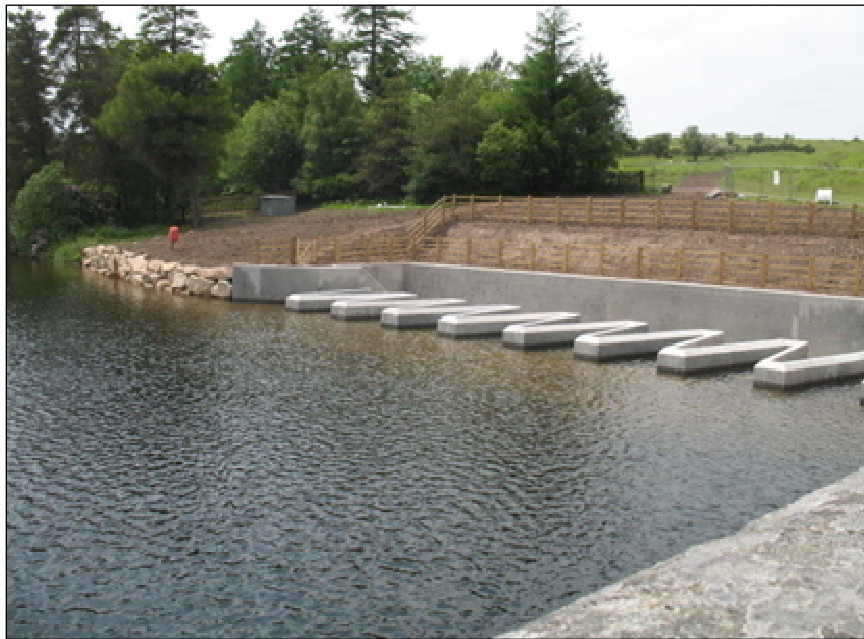
Figure 11. View of Completed Labyrinth Weir and Receiving Channel with Reservoir Level at TWL, viewed from the Dam

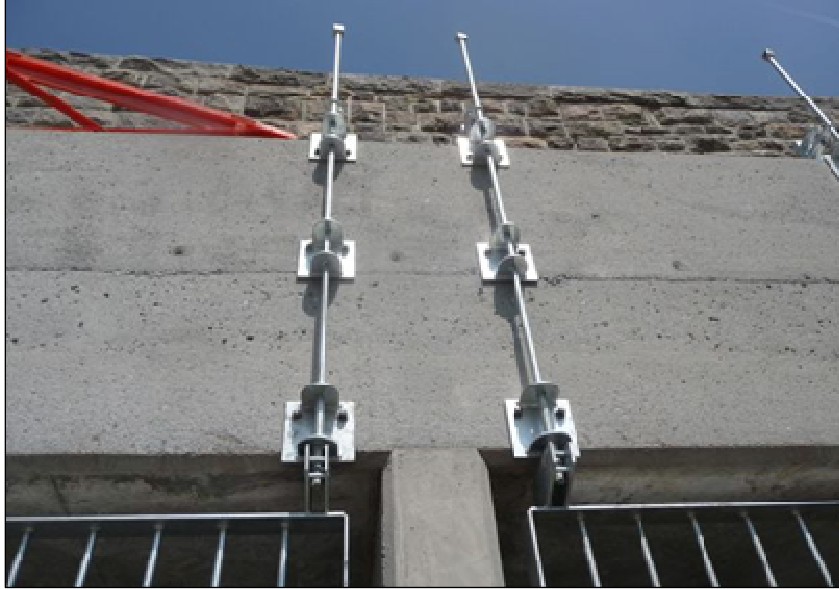
Figure 12. Entrance Safety Screen – Shear Mechanism Under Construction

Shear pins were built into the top fixings. When the design collapse loading is exceeded on the face of the screen (due to debris build-up) the shear pins are designed to shear, and the screen will collapse downstream into the mouth of the culvert. The bottom fixings are permanently hinged to prevent the screen being dragged into the culvert (potentially causing a blockage inside the culvert or hanging up on the exit screen). Figure 8 shows the general arrangement of the entrance screens. At the request of the Panel Engineer, provision has also been made to manually collapse the screen. A simple latching mechanism, accessed from above the culvert entrance facilitates this requirement, see Figure 12.

The mechanism has been designed to provide a ‘safe’ mode which takes the shear pin out of the collapse mechanism. It is intended that this mode may be adopted during maintenance activities on the screen or during inspections as an added safety measure. Provision has also been made to test the

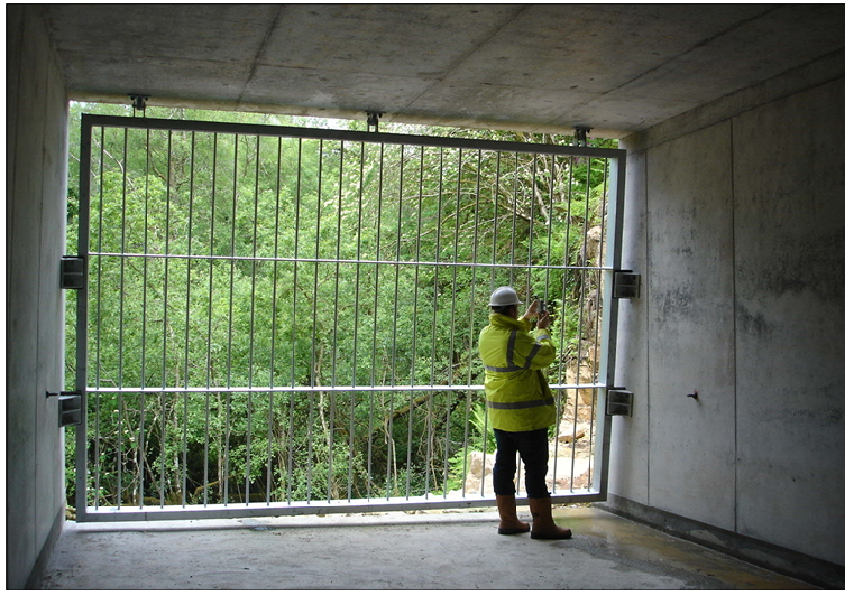
Figure 13. Exit Screen Viewed from Inside the Buried Culvert

A captive shear pin is positioned within the top hinge fixings. When the derived collapse load, applied on the upstream face of the screen, is reached the shear pins are designed to shear. The entire screen is then designed to be released and forcibly ejected by flowing water into the disused quarry downstream. A third (central) top fixing is also provided. During operation this would not have any captive shear pin. However, it allows for insertion of a (non-shear) captive pin to isolate either of the outer shear pins for maintenance, inspection and/or screen replacement activities (Figure 13).

The top fixings are deliberately positioned on the culvert soffit to enable ease of inspection from inside the culvert. Hence, there is no requirement to approach the screen from its downstream side. The screen is also positioned close to the culvert exit to minimise manual handling, allowing the screen to be safely installed/replaced by crane from above. The screen is installed on a slight angle, again to allow ease of installation
