Some Aspects of Embankment Dams Constructed on the Mercia Mudstone

T. BLOWER, Mott MacDonald, Cambridge, UK
L. F. JARVIS, Mott MacDonald, Cambridge, UK

This paper deals with the geotechnical challenges posed by dam construction on the Mercia Mudstone. It highlights some of the essential features of this formation using examples from the site of a proposed new reservoir in Lincolnshire, but also from some historical dams.

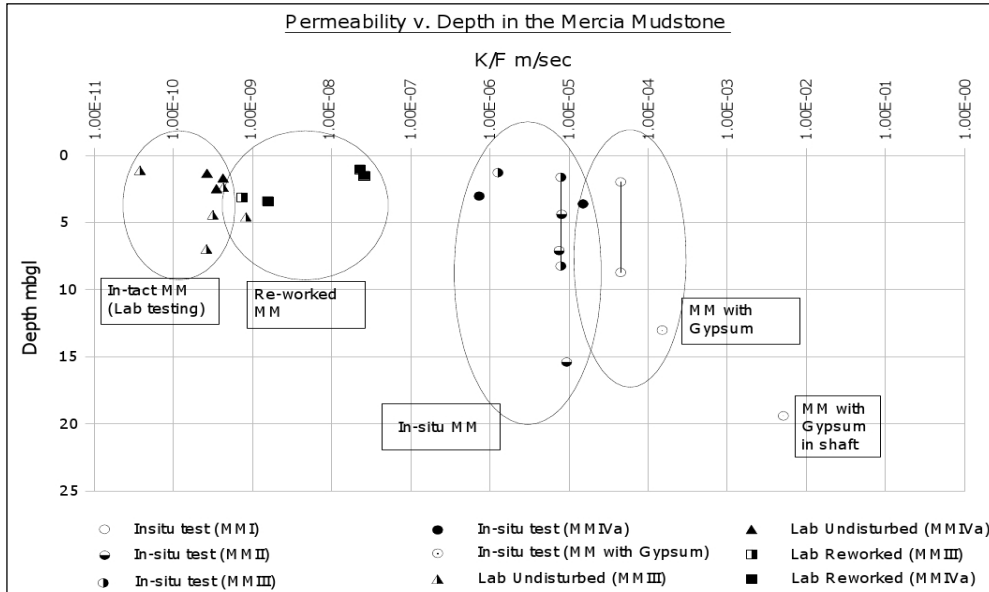
Permeability testing conducted on the MM comprised in-situ falling head tests and laboratory tests on intact and reworked samples. The in-situ tests were interpreted firstly using the method set out in BS5930¹⁵ for saturated soils. However, due to the low water table, this was not applicable in many cases so an alternative 'soakaway' methodology was used. The latter method calculates a 'soil infiltration rate', 'f', which can be compared to permeability 'k' values. The k and f values obtained are shown in Figure 2.

Figure 2. Permeability of the MM at the proposed Lincoln RWR site

The permeability of intact samples taken from the more weathered MM was very low, and that of samples of re-worked MM similarly so, although in two cases it was somewhat higher. However, the values recorded for the MM ‘en masse’ are three to four orders of magnitude higher. This is considered to be due to the effects of bedding, fissuring, lithological variations and so on, that do not affect small laboratory samples. The highest values of all were recorded over borehole test sections containing gypsum, the high values being attributed to bedding effects and possibly the dissolution of gypsum. These values are fully six orders of magnitude higher than that of the in-tact material. Even more startling results were obtained in permeability tests on the MM at the river intake site. In one test water could not be pumped into the borehole fast enough to raise the water level and in another the water level fell from 0.5m depth to 12m, only to rise again of its own accord to 8m. Such variable and strange test results were of considerable concern to the reservoir design team.
