## **Pebley Reservoir (Derbyshire) Emergency Drawdown Exercise**

D. M. WINDSOR, Canal and River Trust, UK

**SYNOPSIS.** This paper details the exercising of an on-site emergency drawdown plan carried out at Pebley Reservoir. It highlights the lessons learnt, compares the use of submersible and suction pumps and recommends a frequency for future exercises.

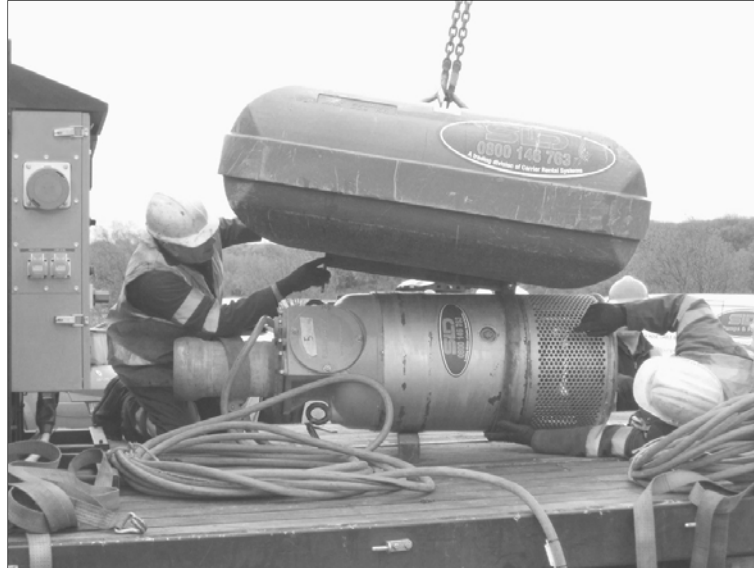
Figure 2. 8” Submersible Pump and Floatation Unit

By 0910 the first submersible pump and three wagons of hoses were on site and floats were being connected to the pumps as shown in Figure 2.

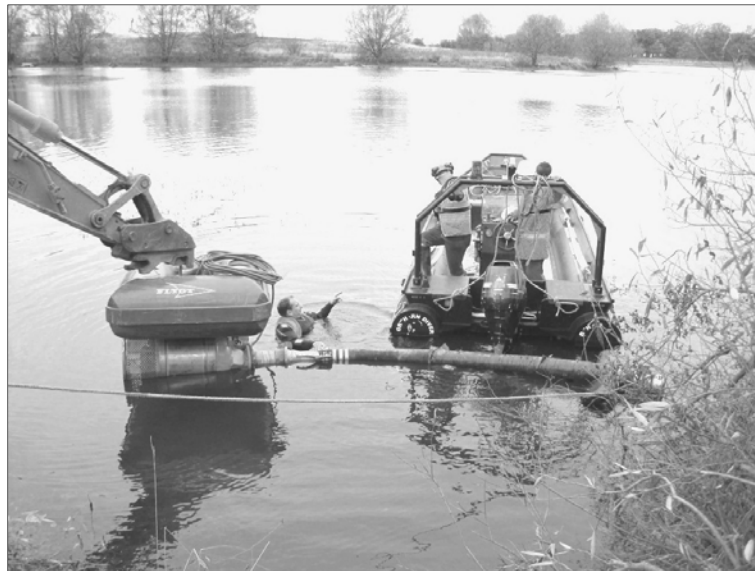
The exercise was then amended to install just one 8” submersible pump for two days and to investigate the deployment and performance of suction pumps commencing on day 2 of the exercise. The launching of the submersible pump is shown in Figure 3.

Figure 3. Launching of Submersible Pump and Flotation Unit

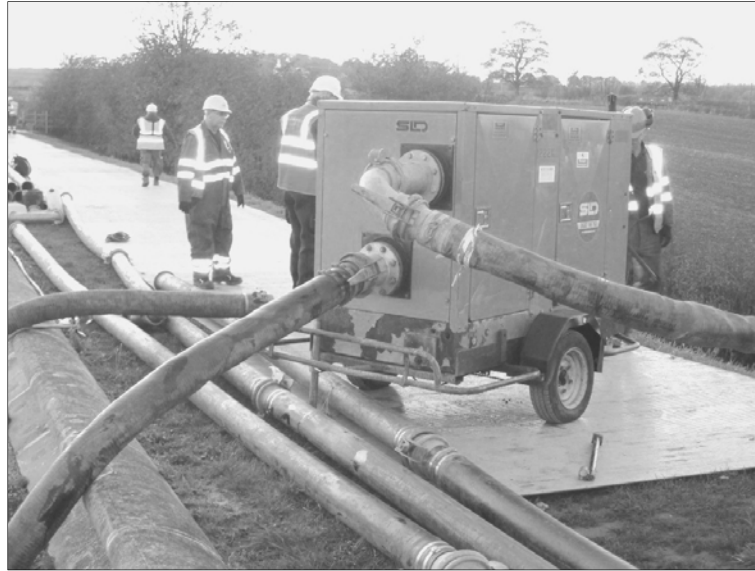
Trakway matting was laid, welfare cabins arrived (the previous day's welfare having been provided by welfare vehicles) and hoses were being connected by a reduced labour force. Pumps were arriving from 1520 onwards, having travelled from depots as far flung as Peterborough, London and Glasgow, most on very large vehicles which caused logistical problems. The first suction pump to be set up is shown in Figure 4 below.

The pumps heads were placed using the dive boat (still on hire from the previous day), though could have been done from the crest of the dam. The locations for the heads was chosen to make them easy to recover but also to provide the level of drawdown required for the subsequent CCTV works. In a real situation they would have been located in deeper water to ensure they could continue to operate as water levels were reduced.

Figure 4. Suction Pump Set Up

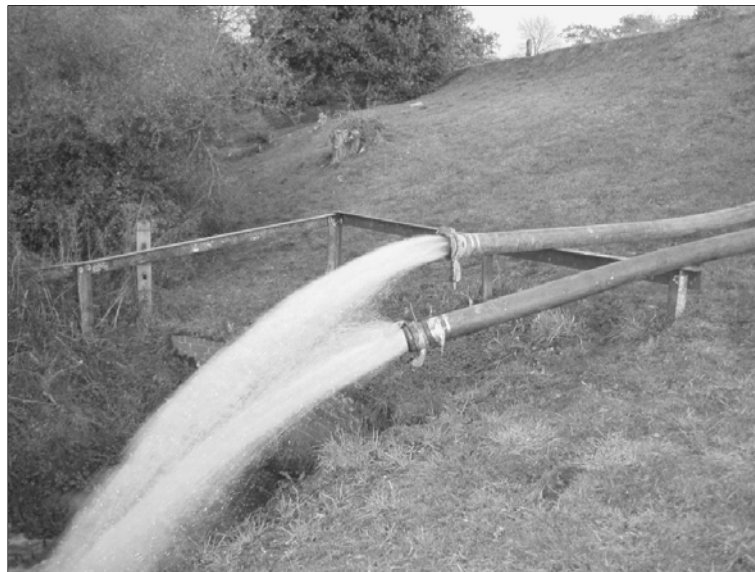
The first two pumps were running at 1640 and discharging to the drawdown outlet feeder channel, as shown in Figure 5 below. By 1710 a third pump was discharging to the spillway channel.

Figure 5. Discharge Hoses

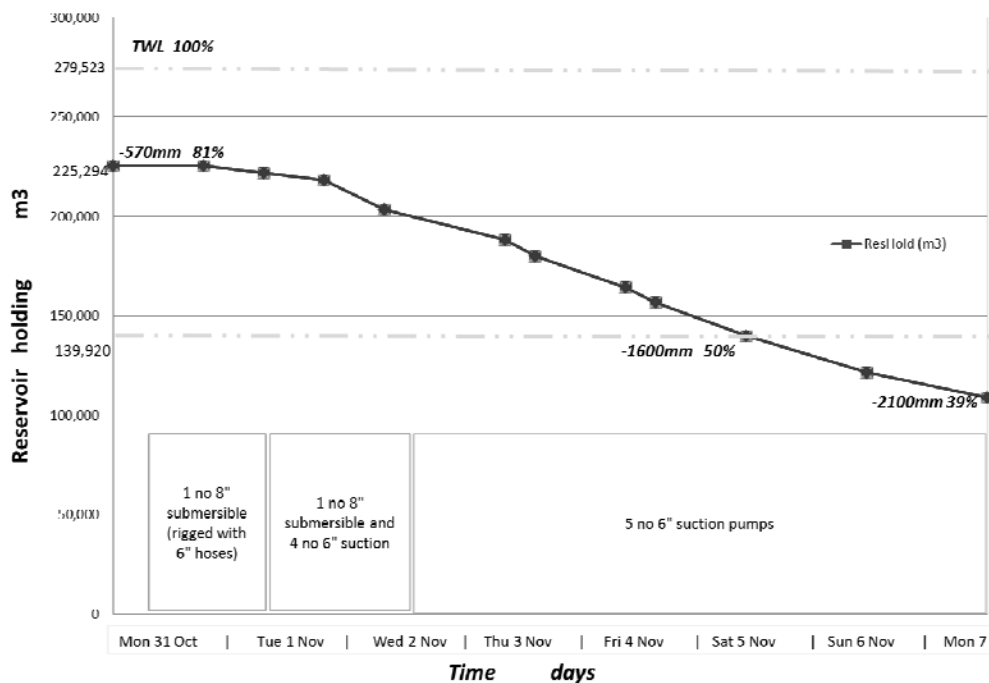
The EDP requires that the volume of impounded water is reduced to 50% of the maximum capacity within five days. The plan detailed five 6" pumps, with an additional two 6" pumps if the drawoff culvert could not be used. Since the starting volume was at 81% of the total capacity it was calculated that five 6" pumps would be sufficient to meet that target, and deploying more than five for the purpose of the exercise would incur additional cost for negligible learning benefit. Figure 6 below shows the progress of the drawdown, with the 50% level being reached on day 5, in spite of the first and second day being disrupted by the change from submersible to suction pumps.

Figure 6. Drawdown record
