Internal Erosion News: Informal Report on ICOLD Prague, July 2017

1. ICOLD Embankment Dams Committee Meetings, Prague, Monday 3 July and Tuesday 4 July 2017

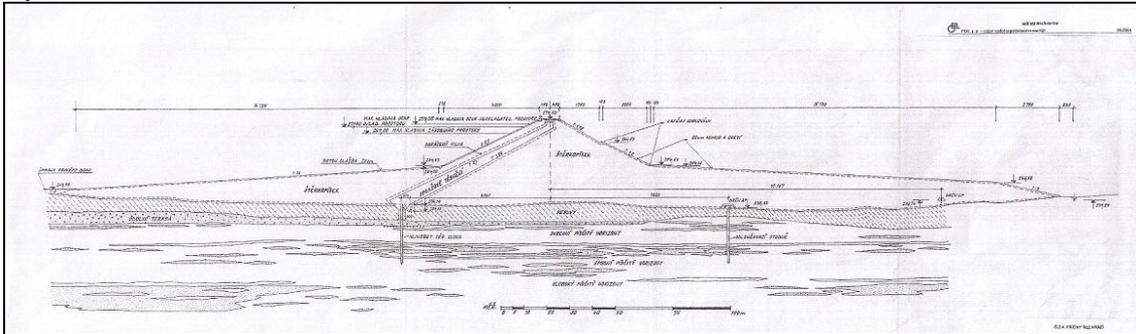
Figure 1 Nechrance Dam Section showing great width of dam, long berms and sloping core, and overburden in upper foundation with foundation strata below (from print provided by Povodi Ohre site staff)

As shown on the cross-sections, Figures 1 and 2, the dam fill is sands and gravels excavated from the reservoir basin, with an upstream sloping core of loess loams. The dam is up to 800 m wide at its highest part. The great width is a consequence of the weak foundation, a long length of foundation soil is required to provide sufficient resistance to the thrust from the core. The designers' solutions to the issues posed by the properties of the foundation soils are similar to those at Empingham Dam (Bridle et al, 1985), where the core also slopes upstream to reduce thrust from the central part of the dam, and keep the dam width as low as possible. There appear to be filters upstream and downstream of the core, and a partial cut-off into a less permeable layer below the core-foundation contact zone, with relief wells downstream.

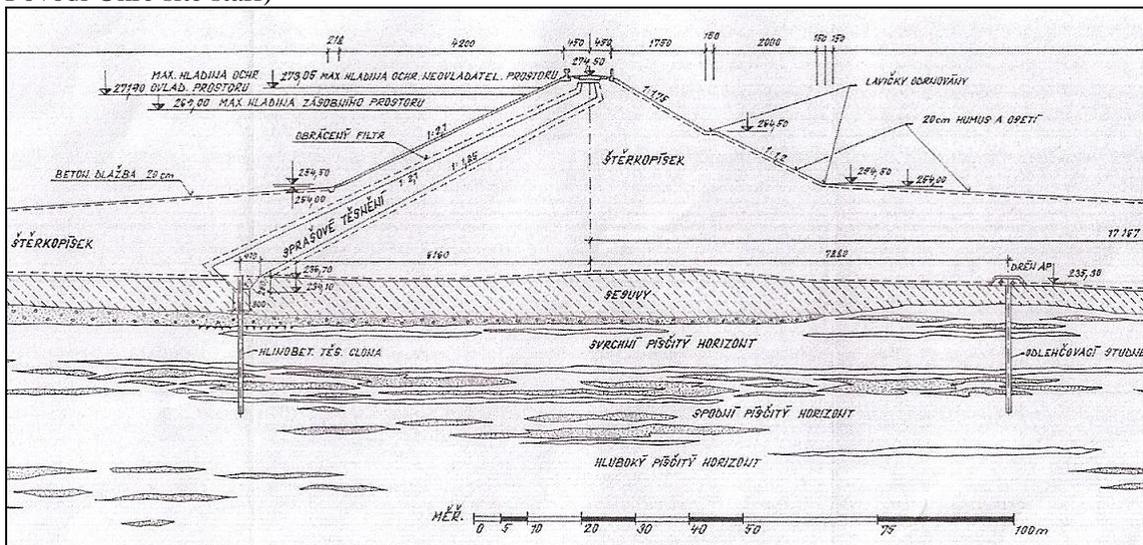
Figure 2 Nechrance Dam Central Section showing sloping core, filters, partial cut-off and relief well (from print provided by Povodi Ohre site staff)

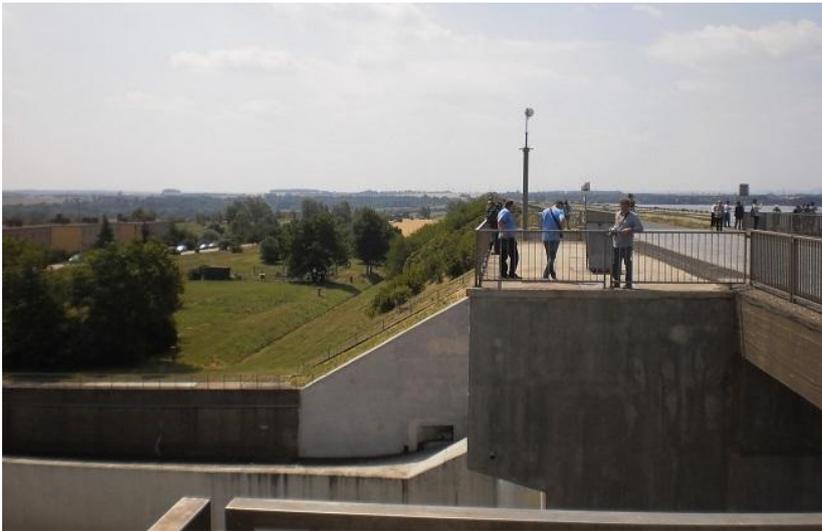
Figure 3 Nechranice Dam: upper slope and downstream berm viewed across overflow

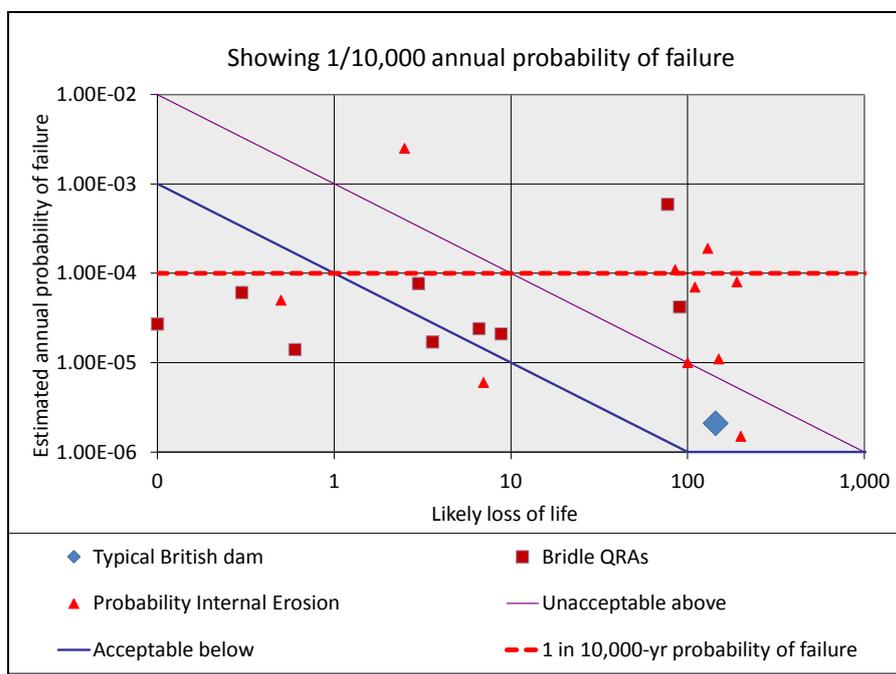
Figure 7 Probability of failure of a sample of British dams, estimated using Brown and Gosden (2004)

The results were not derived from application of the Bulletin, but from Brown and Gosden (2004) which projects results from records of many internal erosion incidents through to failure. As, unbeknown to the authors at that time, it was the hydraulic forces that would have caused failure, the probabilities from their method are also the probabilities of occurrence of particular water levels occurring during floods. The embankment dams on the plot include dams with puddle clay cores, and several are very old and without cores (i.e. unzoned). Only four of the 20

dams assessed show an annual probability of failure higher than 1 in 10,000-years, and a total of eight are in the 'unacceptable' zone. This sample of results suggests that, depending on what level of risk is acceptable to society, and bearing in mind the uncertainties in the estimates, between 20% and 40% of embankment dams might need remediation in order to improve their resistance to internal erosion.
