# Maintaining the safety of **our reservoirs**

Raw water reservoir surveillance training manual

SEVERN  
TRENT

Third Edition November 2018

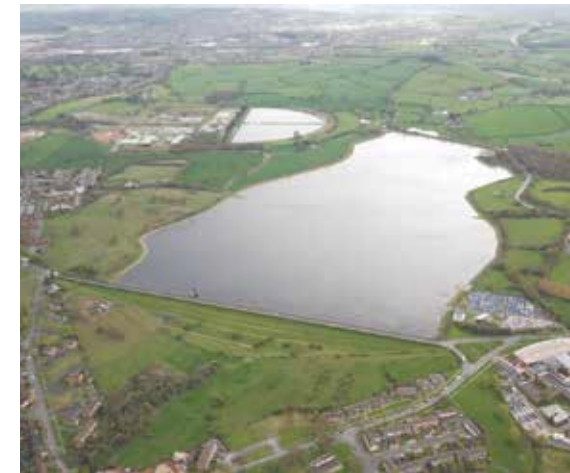
## Bartley

**Type of reservoir:** Non-impounding raw water  
**Type of dam:** Earth embankment - Concrete core  
**Height:** 19.2m  
**Date of construction:** 1930  
**Total capacity:** 2,400,000 m<sup>3</sup>

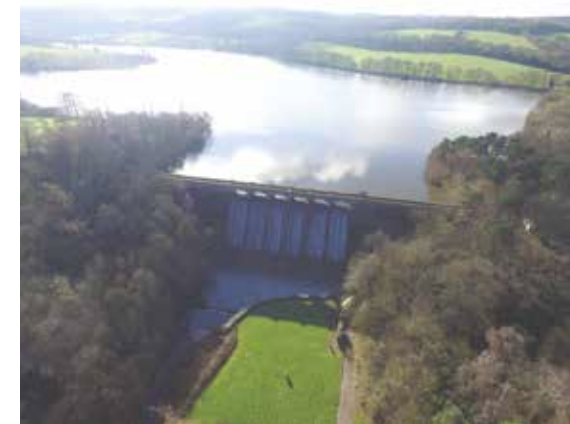
## Blackbrook

**Type of reservoir:** Impounding raw water  
**Type of dam:** Concrete and masonry gravity dam  
**Height:** 23.0m  
**Date of construction:** 1906  
**Total capacity:** 2,300,000 m<sup>3</sup>

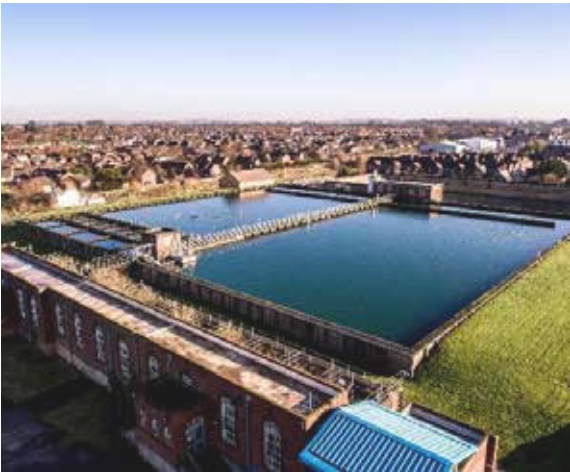
### Boughton North & Mid

**Type of reservoir:** Non-impounding raw water  
**Type of dam:** Reinforced concrete buttress  
**Height:** 4.27m  
**Date of construction:** 1933  
**Total capacity:** 44,082 m³

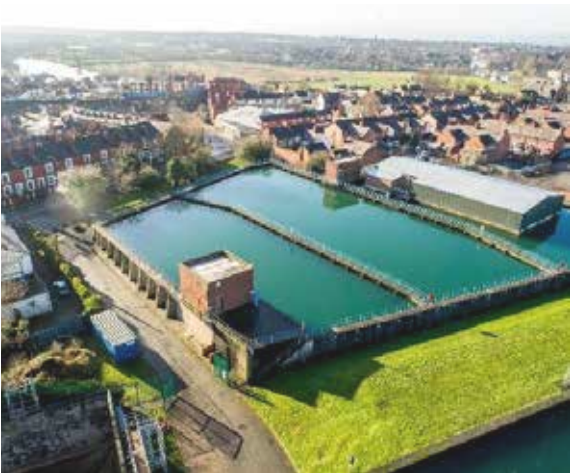
### Boughton South

**Type of reservoir:** Non-impounding raw water  
**Type of dam:** Reinforced concrete buttress  
**Height:** 6.4m  
**Date of construction:** 1968  
**Total capacity:** 32,000 m³

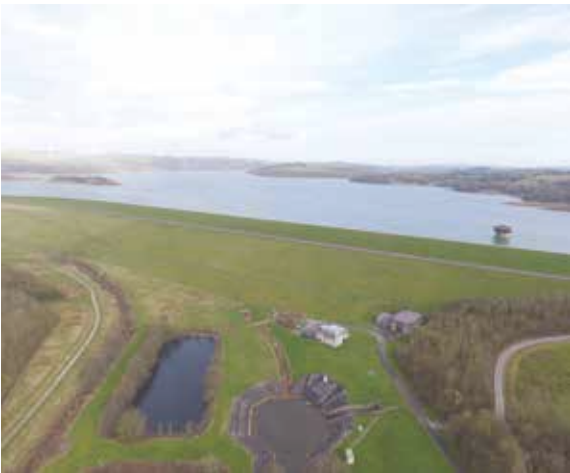
### Carsington

**Type of reservoir:** Pumped storage/Impounding  
**Type of dam:** Earth embankment - Rolled clay core  
**Height:** 34.3m  
**Date of construction:** 1992  
**Total capacity:** 36,000,000 m³

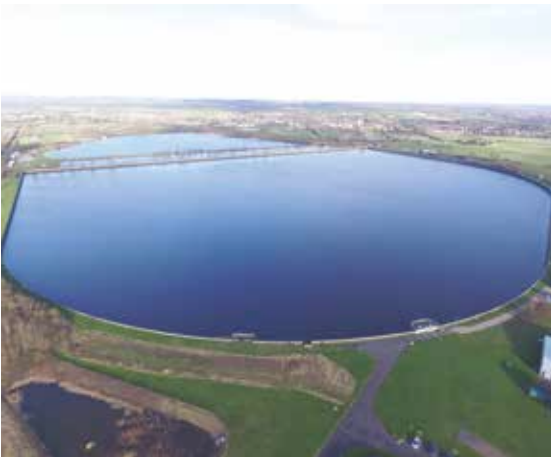
### Church Wilne

**Type of reservoir:** Non-impounding raw water  
**Type of dam:** Earth embankment - Concrete walls  
**Height:** 10.0m  
**Date of construction:** 1971  
**Total capacity:** 2,790,000 m³

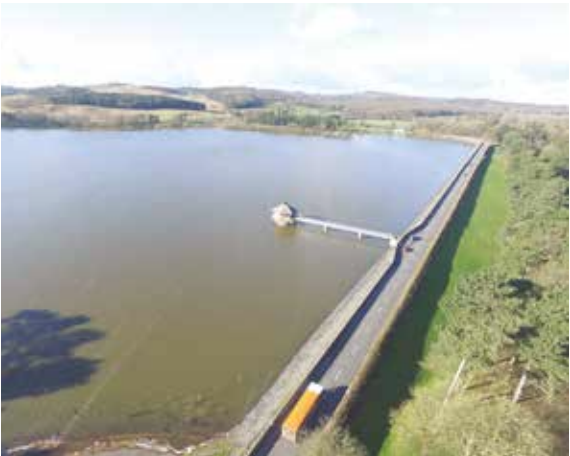
### Cropston

**Type of reservoir:** Impounding raw water  
**Type of dam:** Earth embankment - Puddle clay core  
**Height:** 13.5m  
**Date of construction:** 1870  
**Total capacity:** 2,528,000 m³

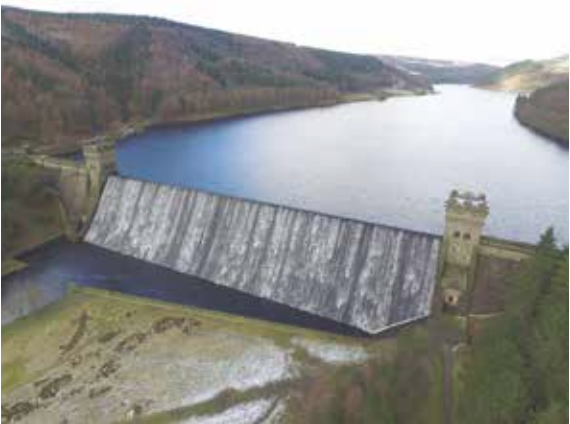
### Derwent

**Type of reservoir:** Impounding raw water  
**Type of dam:** Concrete and masonry gravity dam  
**Height:** 36.4m  
**Date of construction:** 1916  
**Total capacity:** 9,470,000 m³

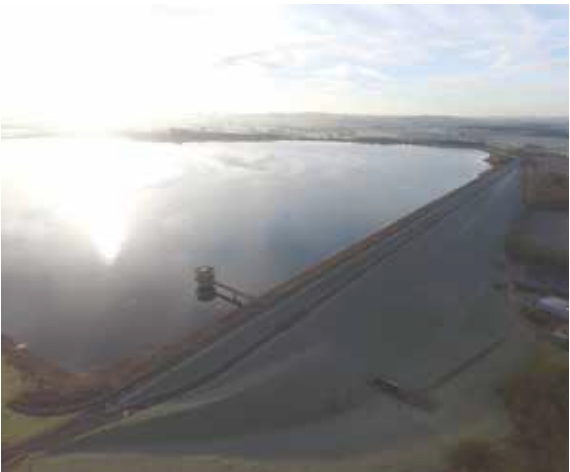
### Draycote

**Type of reservoir:** Non-impounding raw water  
**Type of dam:** Six earth embankments - Rolled clay cores  
**Height:** 19.7m  
**Date of construction:** 1969  
**Total capacity:** 22,730,000 m³

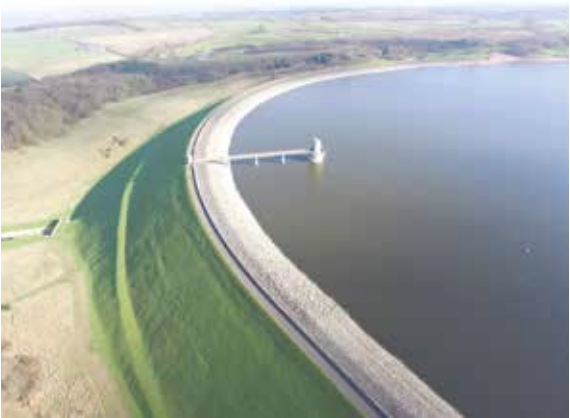
### Foremark

**Type of reservoir:** Pumped storage/Impounding  
**Type of dam:** Earth embankment - Rolled clay core  
**Height:** 35.8m  
**Date of construction:** 1977  
**Total capacity:** 13,200,000 m³

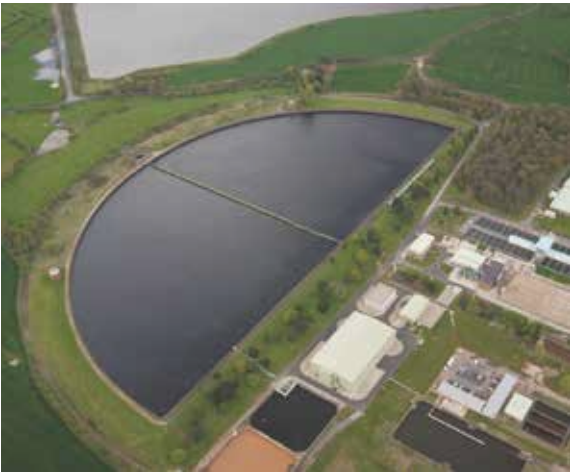
### Frankley Raw Water

**Type of reservoir:** Non-impounding raw water  
**Type of dam:** Earth embankment - Concrete core  
**Height:** 11.9m  
**Date of construction:** 1904  
**Total capacity:** 932,000 m<sup>3</sup>

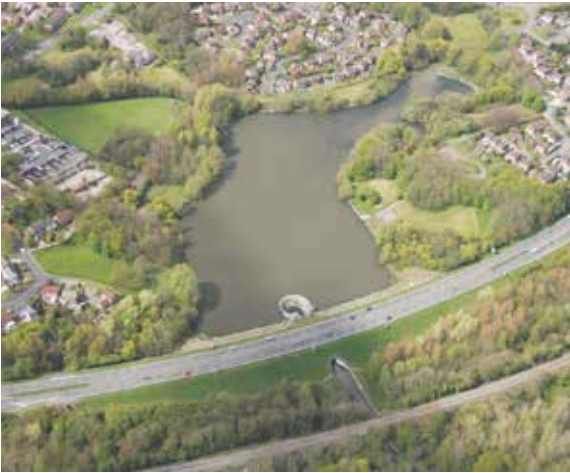
### Holmer Farm

**Type of reservoir:** Flood balancing  
**Type of dam:** Earth embankment - Clay core  
**Height:** 8.2m  
**Date of construction:** 1970  
**Total capacity:** 90,920 m<sup>3</sup>

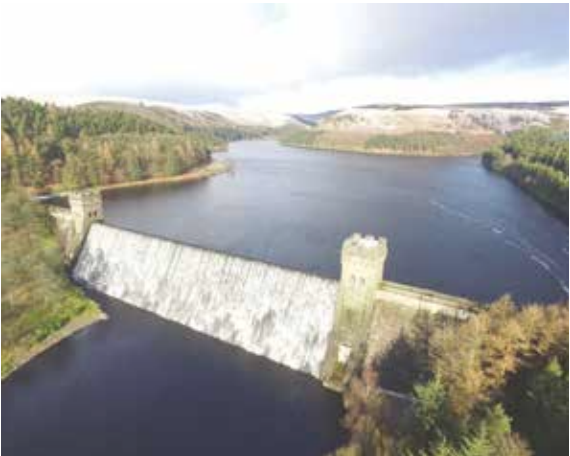
### Howden

**Type of reservoir:** Impounding raw water  
**Type of dam:** Masonry gravity dam  
**Height:** 37.4m  
**Date of construction:** 1912  
**Total capacity:** 8,990,000 m<sup>3</sup>

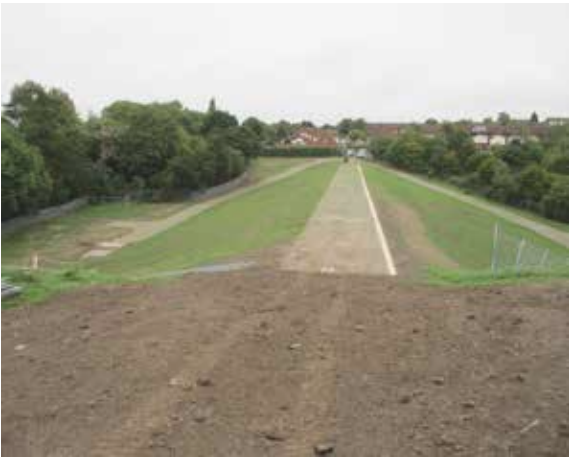
### Ketley Sands

**Type of reservoir:** Flood balancing  
**Type of dam:** Earth embankment - Clay core  
**Height:** 10.5m  
**Date of construction:** 1974  
**Total capacity:** 175,000 m<sup>3</sup>

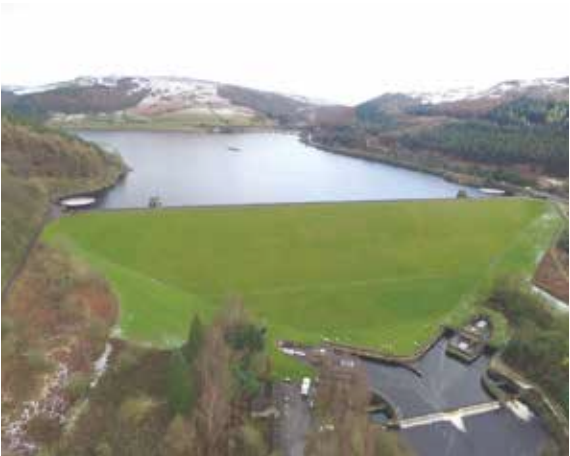
### Ladybower

**Type of reservoir:** Impounding raw water  
**Type of dam:** Earth embankment - Puddle clay core  
**Height:** 46.0m  
**Date of construction:** 1945  
**Total capacity:** 27,800,000 m<sup>3</sup>

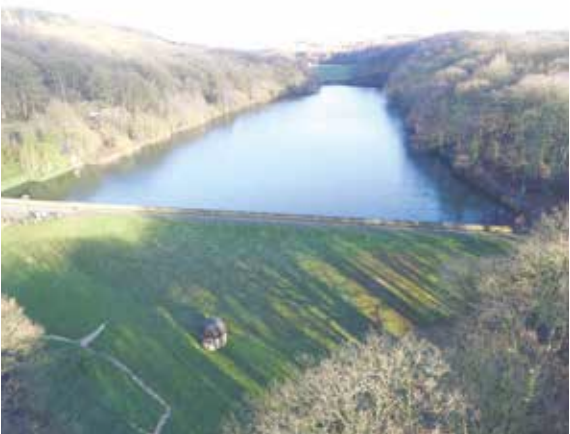
### Linacre Lower

**Type of reservoir:** Impounding raw water  
**Type of dam:** Earth embankment - Clay core  
**Height:** 11.6m  
**Date of construction:** 1854  
**Total capacity:** 140,000 m<sup>3</sup>

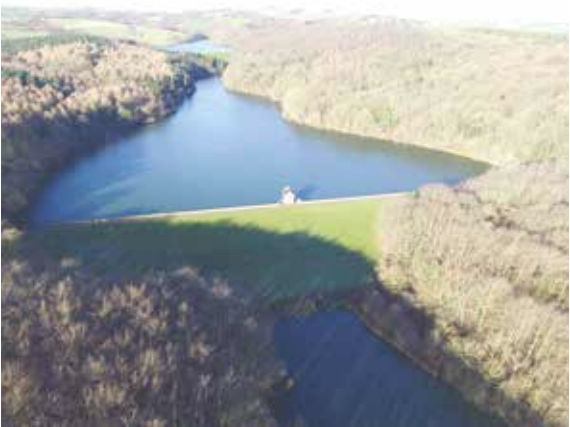
### Linacre Middle

**Type of reservoir:** Impounding raw water  
**Type of dam:** Earth embankment - Clay core  
**Height:** 14.6m  
**Date of construction:** 1911  
**Total capacity:** 409,000 m<sup>3</sup>

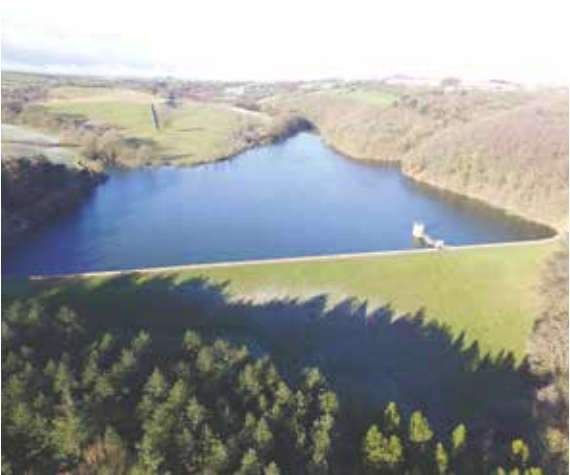
### Linacre Upper

**Type of reservoir:** Impounding raw water  
**Type of dam:** Earth embankment - Clay core  
**Height:** 20.2m  
**Date of construction:** 1864  
**Total capacity:** 572,000 m<sup>3</sup>

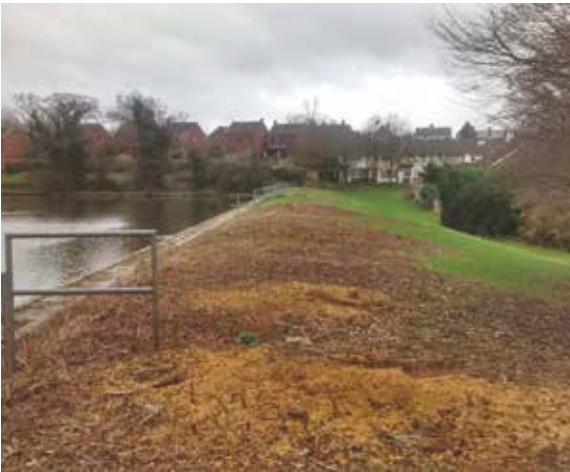
### Lodge Pool

**Type of reservoir:** Flood balancing  
**Type of dam:** Earth embankment  
**Height:** 4.6m  
**Date of construction:** 1969  
**Total capacity:** 23,340 m³

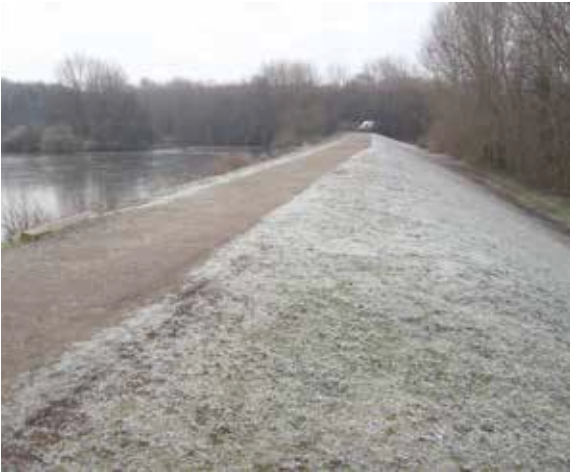
### Middle Pool

**Type of reservoir:** Flood balancing  
**Type of dam:** Rockfill embankment - Clay core  
**Height:** 4.9m  
**Date of construction:** 1976  
**Total capacity:** 54,800 m³

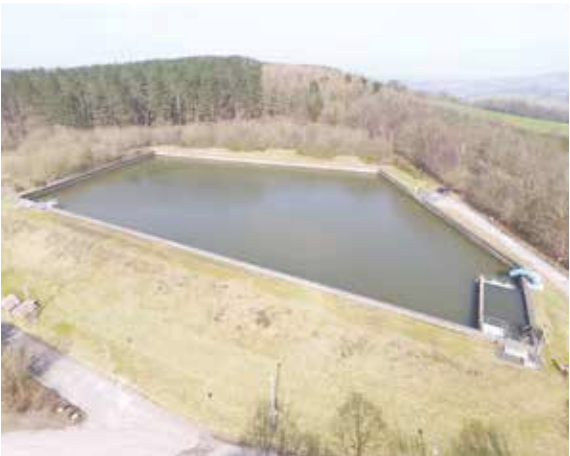
### Mitcheldean

**Type of reservoir:** Non-impounding raw water  
**Type of dam:** Reinforced concrete  
**Height:** 6.3m  
**Date of construction:** 1977  
**Total capacity:** 36,400 m³

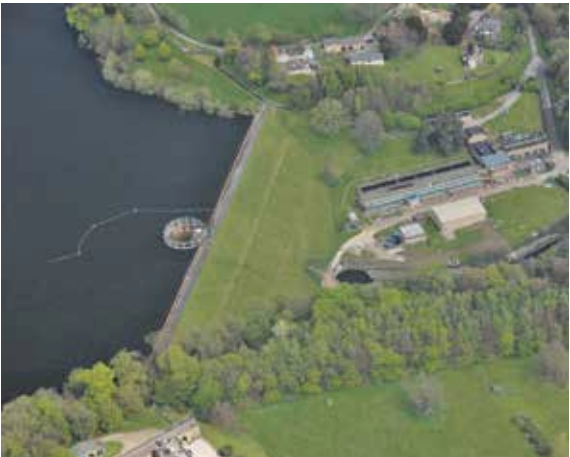
### Ogston

**Type of reservoir:** Impounding raw water  
**Type of dam:** Earth embankment - Puddle clay core  
**Height:** 19.8m  
**Date of construction:** 1960  
**Total capacity:** 6,180,000 m³

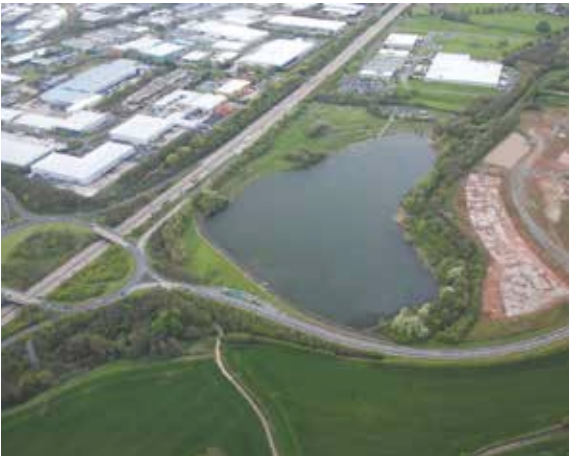
### Priorslee

**Type of reservoir:** Flood balancing reservoir  
**Type of dam:** Earth embankment - Rolled clay core  
**Height:** 10.7m  
**Date of construction:** 1982  
**Total capacity:** 196,000 m³

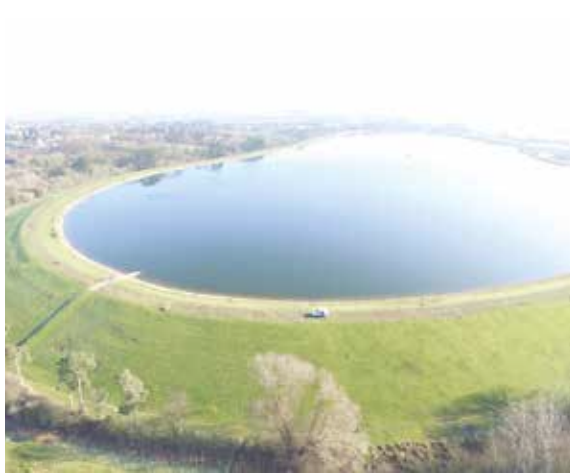
### Shustoke Lower

**Type of reservoir:** Non-impounding raw water  
**Type of dam:** Earth embankment - Puddle clay core  
**Height:** 8.4m  
**Date of construction:** 1885  
**Total capacity:** 1,921,000 m³

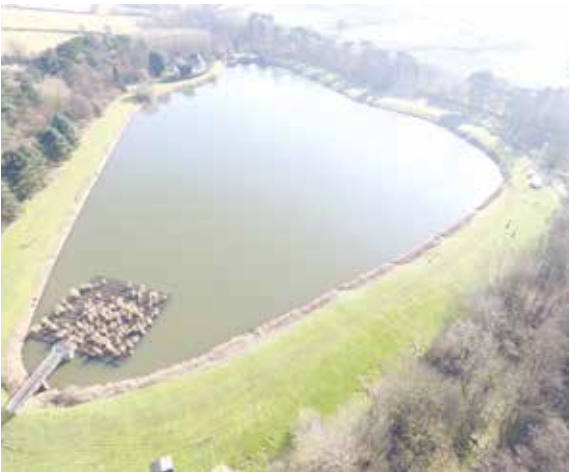
### Shustoke Upper

**Type of reservoir:** Impounding raw water  
**Type of dam:** Earth embankment - Puddle clay core  
**Height:** 6.1m  
**Date of construction:** 1885  
**Total capacity:** 92,000 m³

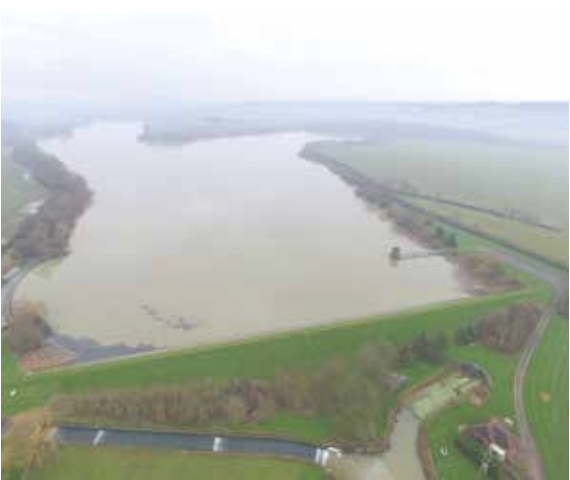
### Stanford

**Type of reservoir:** Impounding raw water  
**Type of dam:** Earth embankment - Puddle clay core  
**Height:** 8.7m  
**Date of construction:** 1928  
**Total capacity:** 1,527,000 m³

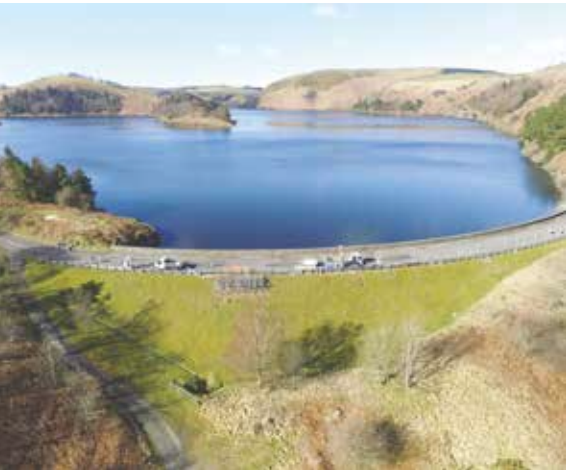
## Bwlch y Gle (Clywedog reservoir saddle dam)

**Type of reservoir:** Impounding raw water  
**Type of dam:** Rock fill embankment - Concrete core  
**Height:** 12.5m  
**Date of construction:** 1967  
**Total capacity:** 50,000,000 m³

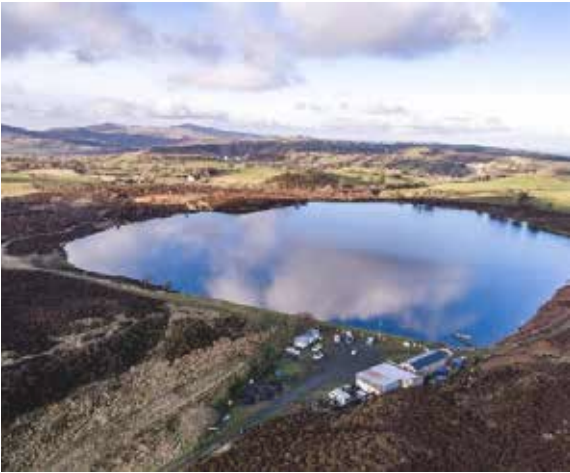
## Esgaireira

**Type of reservoir:** Impounding raw water  
**Type of dam:** Earth embankment - Concrete core  
**Height:** 6m  
**Date of construction:** 1965  
**Total capacity:** c. 20,000

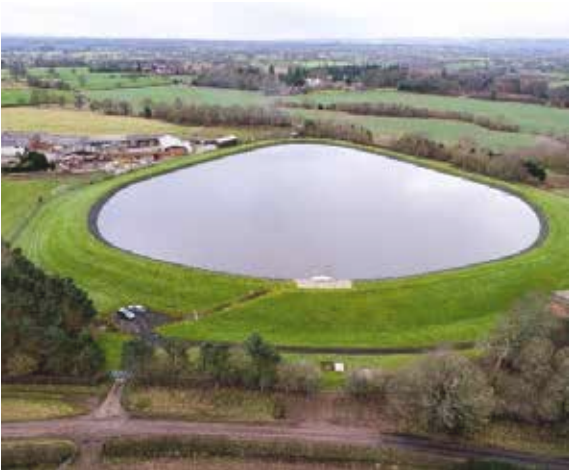
## Llyn Cyfynwy

**Type of reservoir:** Impounding raw water  
**Type of dam:** Earth embankment – puddle clay core  
**Height:** 1 and 2 - 2.6m  
**Date of construction:** 1892  
**Total capacity:** 295,000 m³

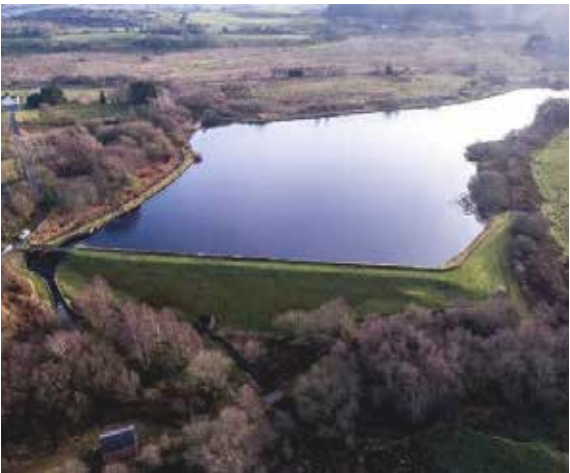
## Marchwiel

**Type of reservoir:** Non-impounding raw water  
**Type of dam:** Earth embankment – 2.5mm HDPE liner  
**Height:** 7.5m  
**Date of construction:** 1981  
**Total capacity:** 139,000 m³

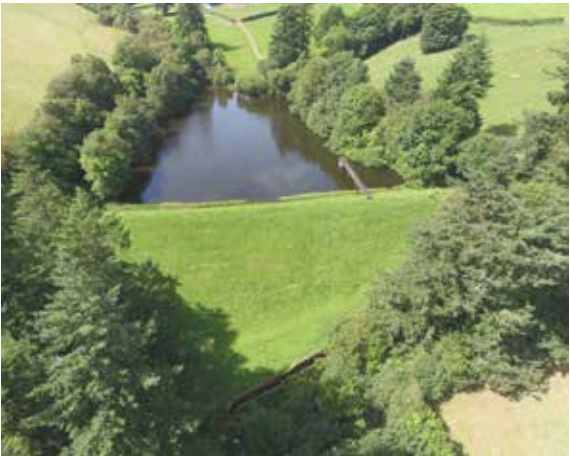
## Nant-y-ffrith

**Type of reservoir:** Impounding raw water  
**Type of dam:** Earth embankment – puddle clay core  
**Height:** 8.5m  
**Date of construction:** 1871  
**Total capacity:** 103,000 m³

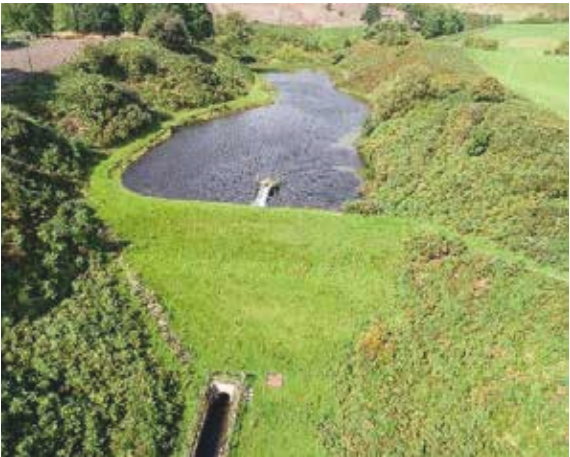
### Nant y Geifr

**Type of reservoir:** Impounding raw water  
**Type of dam:** Earth embankment - Puddle clay core  
**Height:** 7m  
**Date of construction:** 1899  
**Total capacity:** 15,148 m³

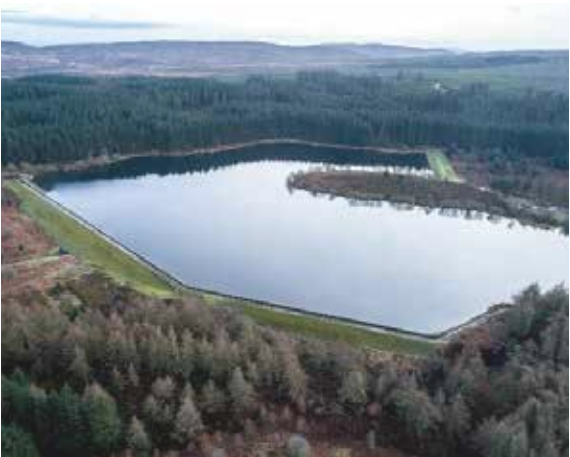
### Pant Glas

**Type of reservoir:** Impounding raw water  
**Type of dam:** Earth embankment – puddle clay core  
**Height:** 11m  
**Date of construction:** 1940  
**Total capacity:** 18,160 m³

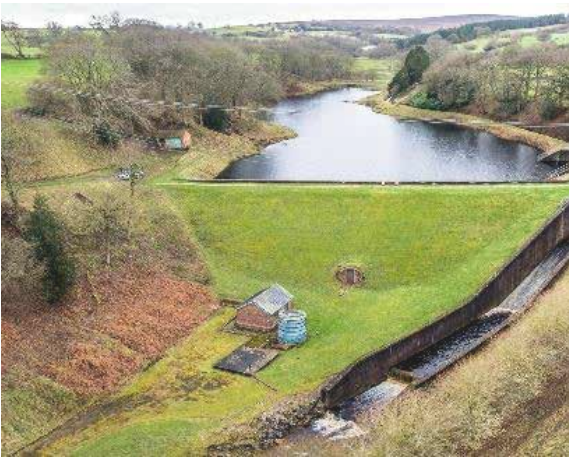
### Pendinas

**Type of reservoir:** Impounding raw water  
**Type of dam:** 4 No. Earth embankments (Dams 1 to 4) - puddle clay core  
**Height:** Dam 1 to 3 – 4m, Dam 4 - 9m  
**Date of construction:** 1897  
**Total capacity:** 282,000 m³

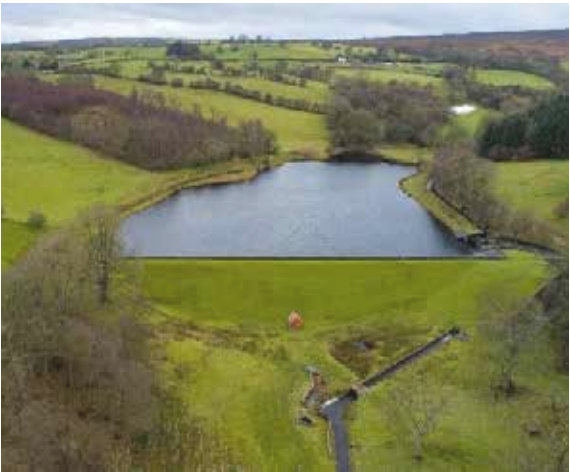
### Penycae Lower

**Type of reservoir:** Impounding raw water  
**Type of dam:** Earth embankment - puddle clay core  
**Height:** 10m  
**Date of construction:** 1872  
**Total capacity:** 39,000 m³

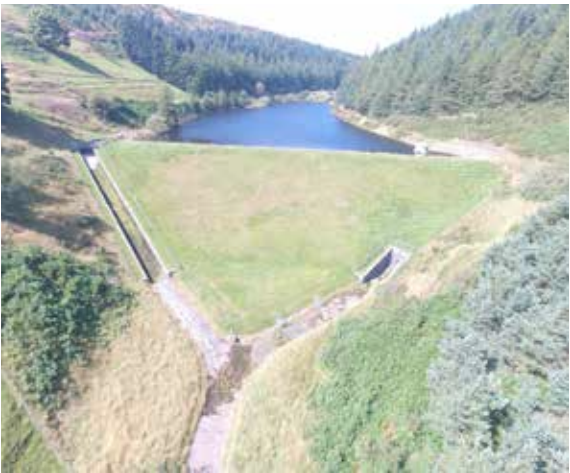
### Penycae Upper

**Type of reservoir:** Impounding raw water  
**Type of dam:** Earth embankment - puddle clay core  
**Height:** 10.5m  
**Date of construction:** 1902  
**Total capacity:** 102,000 m³

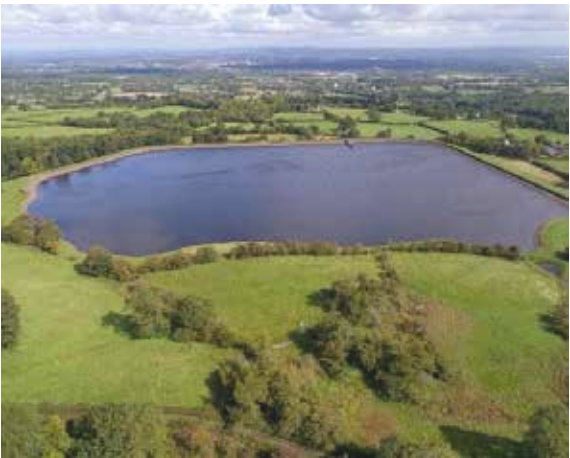
### Pen y Gwely

**Type of reservoir:** Impounding raw water  
**Type of dam:** Earth embankment - Clay core  
**Height:** 16m  
**Date of construction:** 1894  
**Total capacity:** 114,000 m³

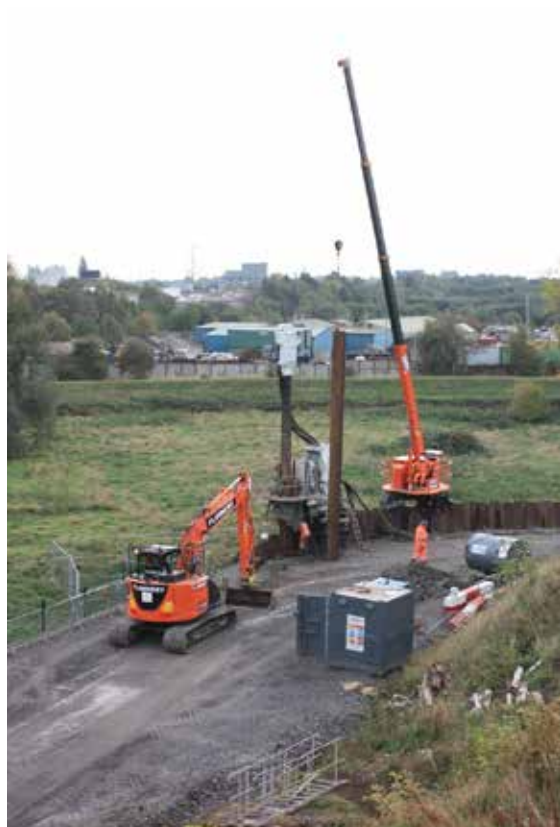
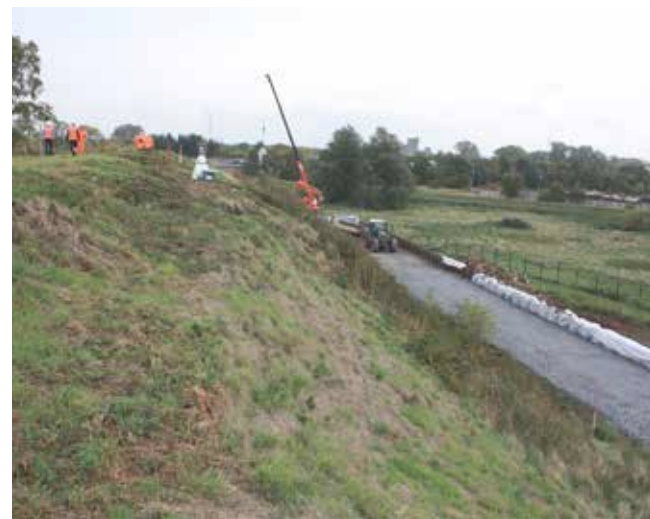
Steel sheet piling installed in 2018 along the toe of Curdworth Lagoon, Minworth as part of the £7m investment to reduce risk and improve resilience of the embankments

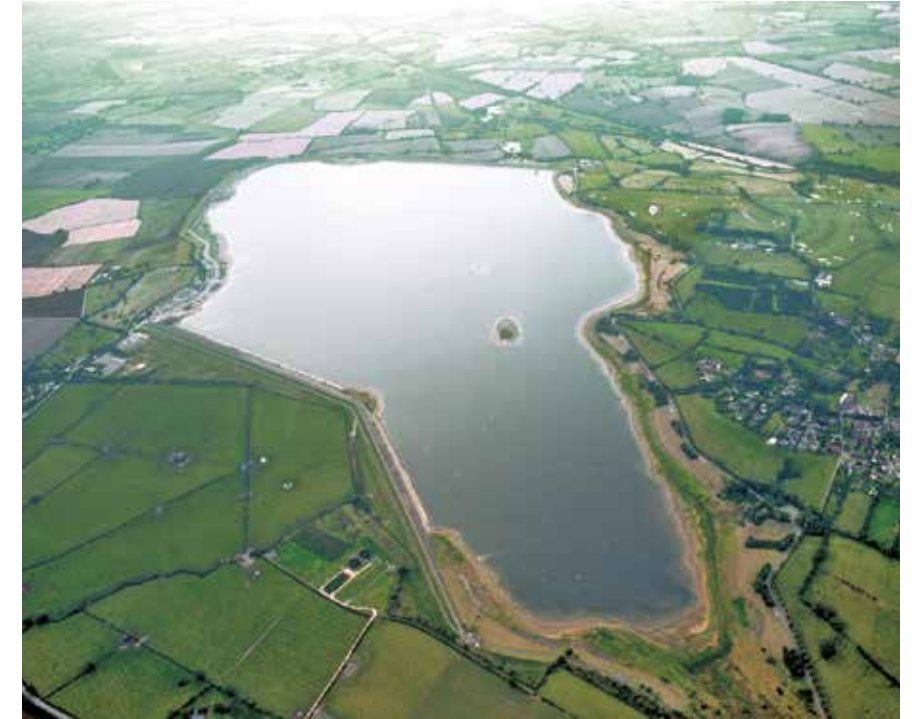
Draycote is a non-impounding reservoir made up from 6 embankment dams.

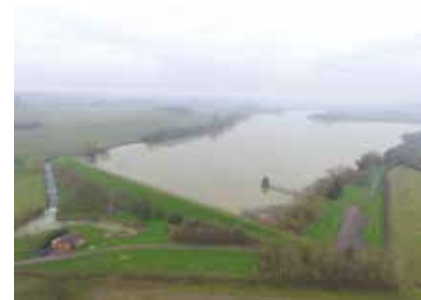
Stanford Reservoir was also built with a bywash channel which feeds into the spillway, allowing flow to be diverted around the reservoir.

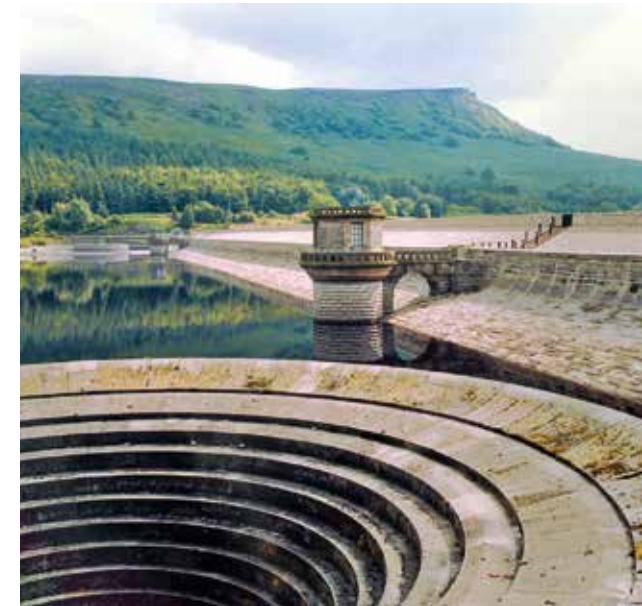
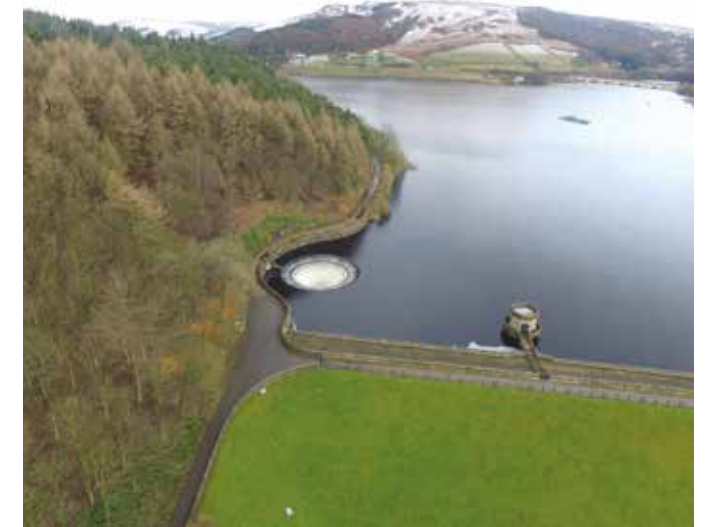
The drop shaft spillway at Ladybower Reservoir is pictured; both dry and spilling

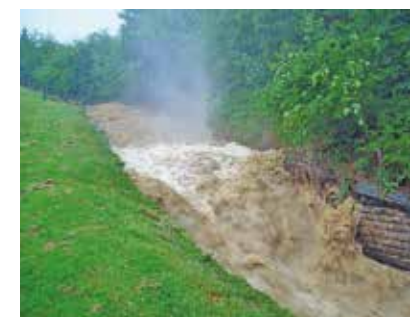
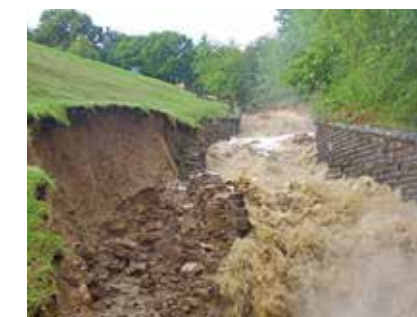
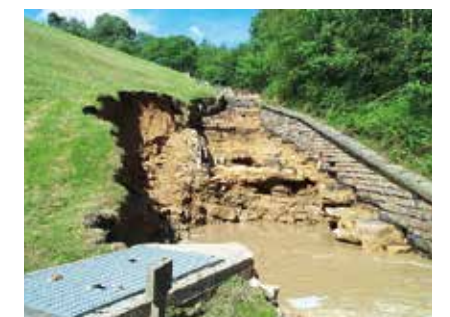
Boltby Reservoir, Yorkshire, in 2005 during and immediately after a major storm event. The masonry spillway protecting the dam failed as illustrated.

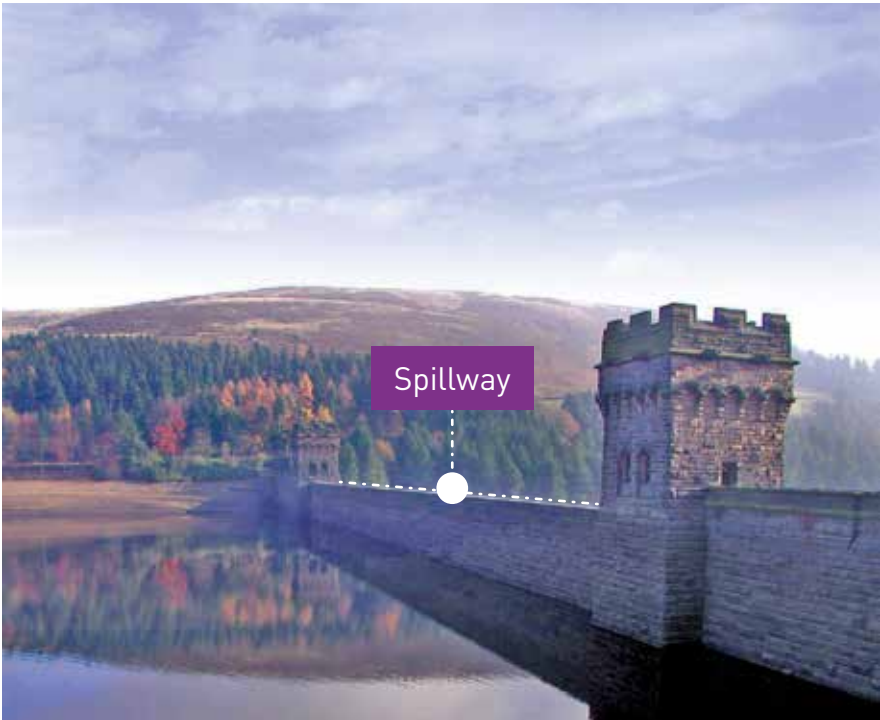
Constructed as part of the dam, the spillway section is lower than the remainder of the crest, allowing water to flow over the top and downstream face. A typical example of this is to be found at Derwent Reservoir.

Derwent Reservoir

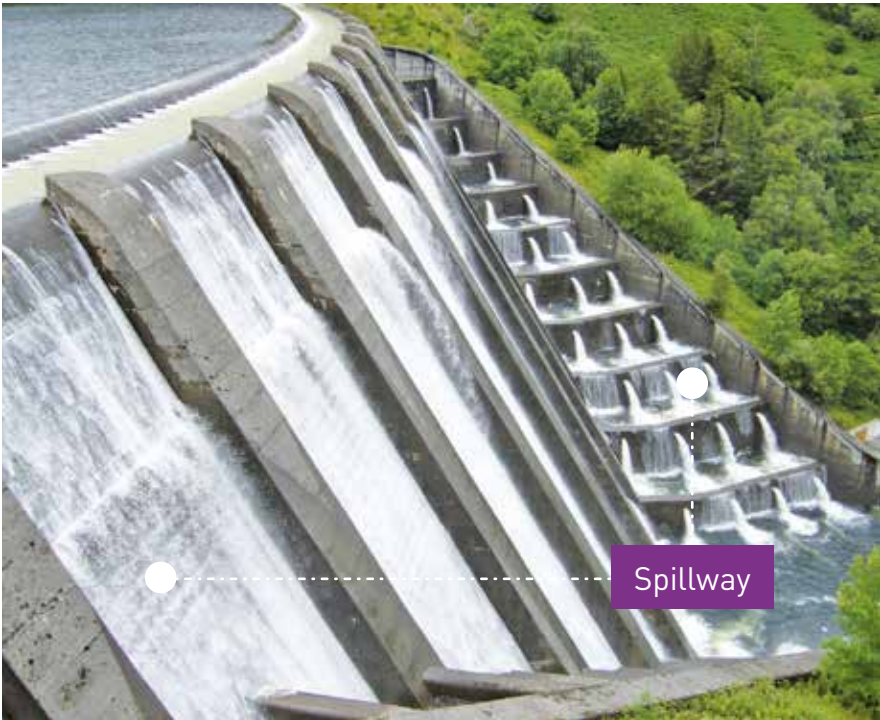
Overtopping of Clywedog Dam showing two types of spillway in use.

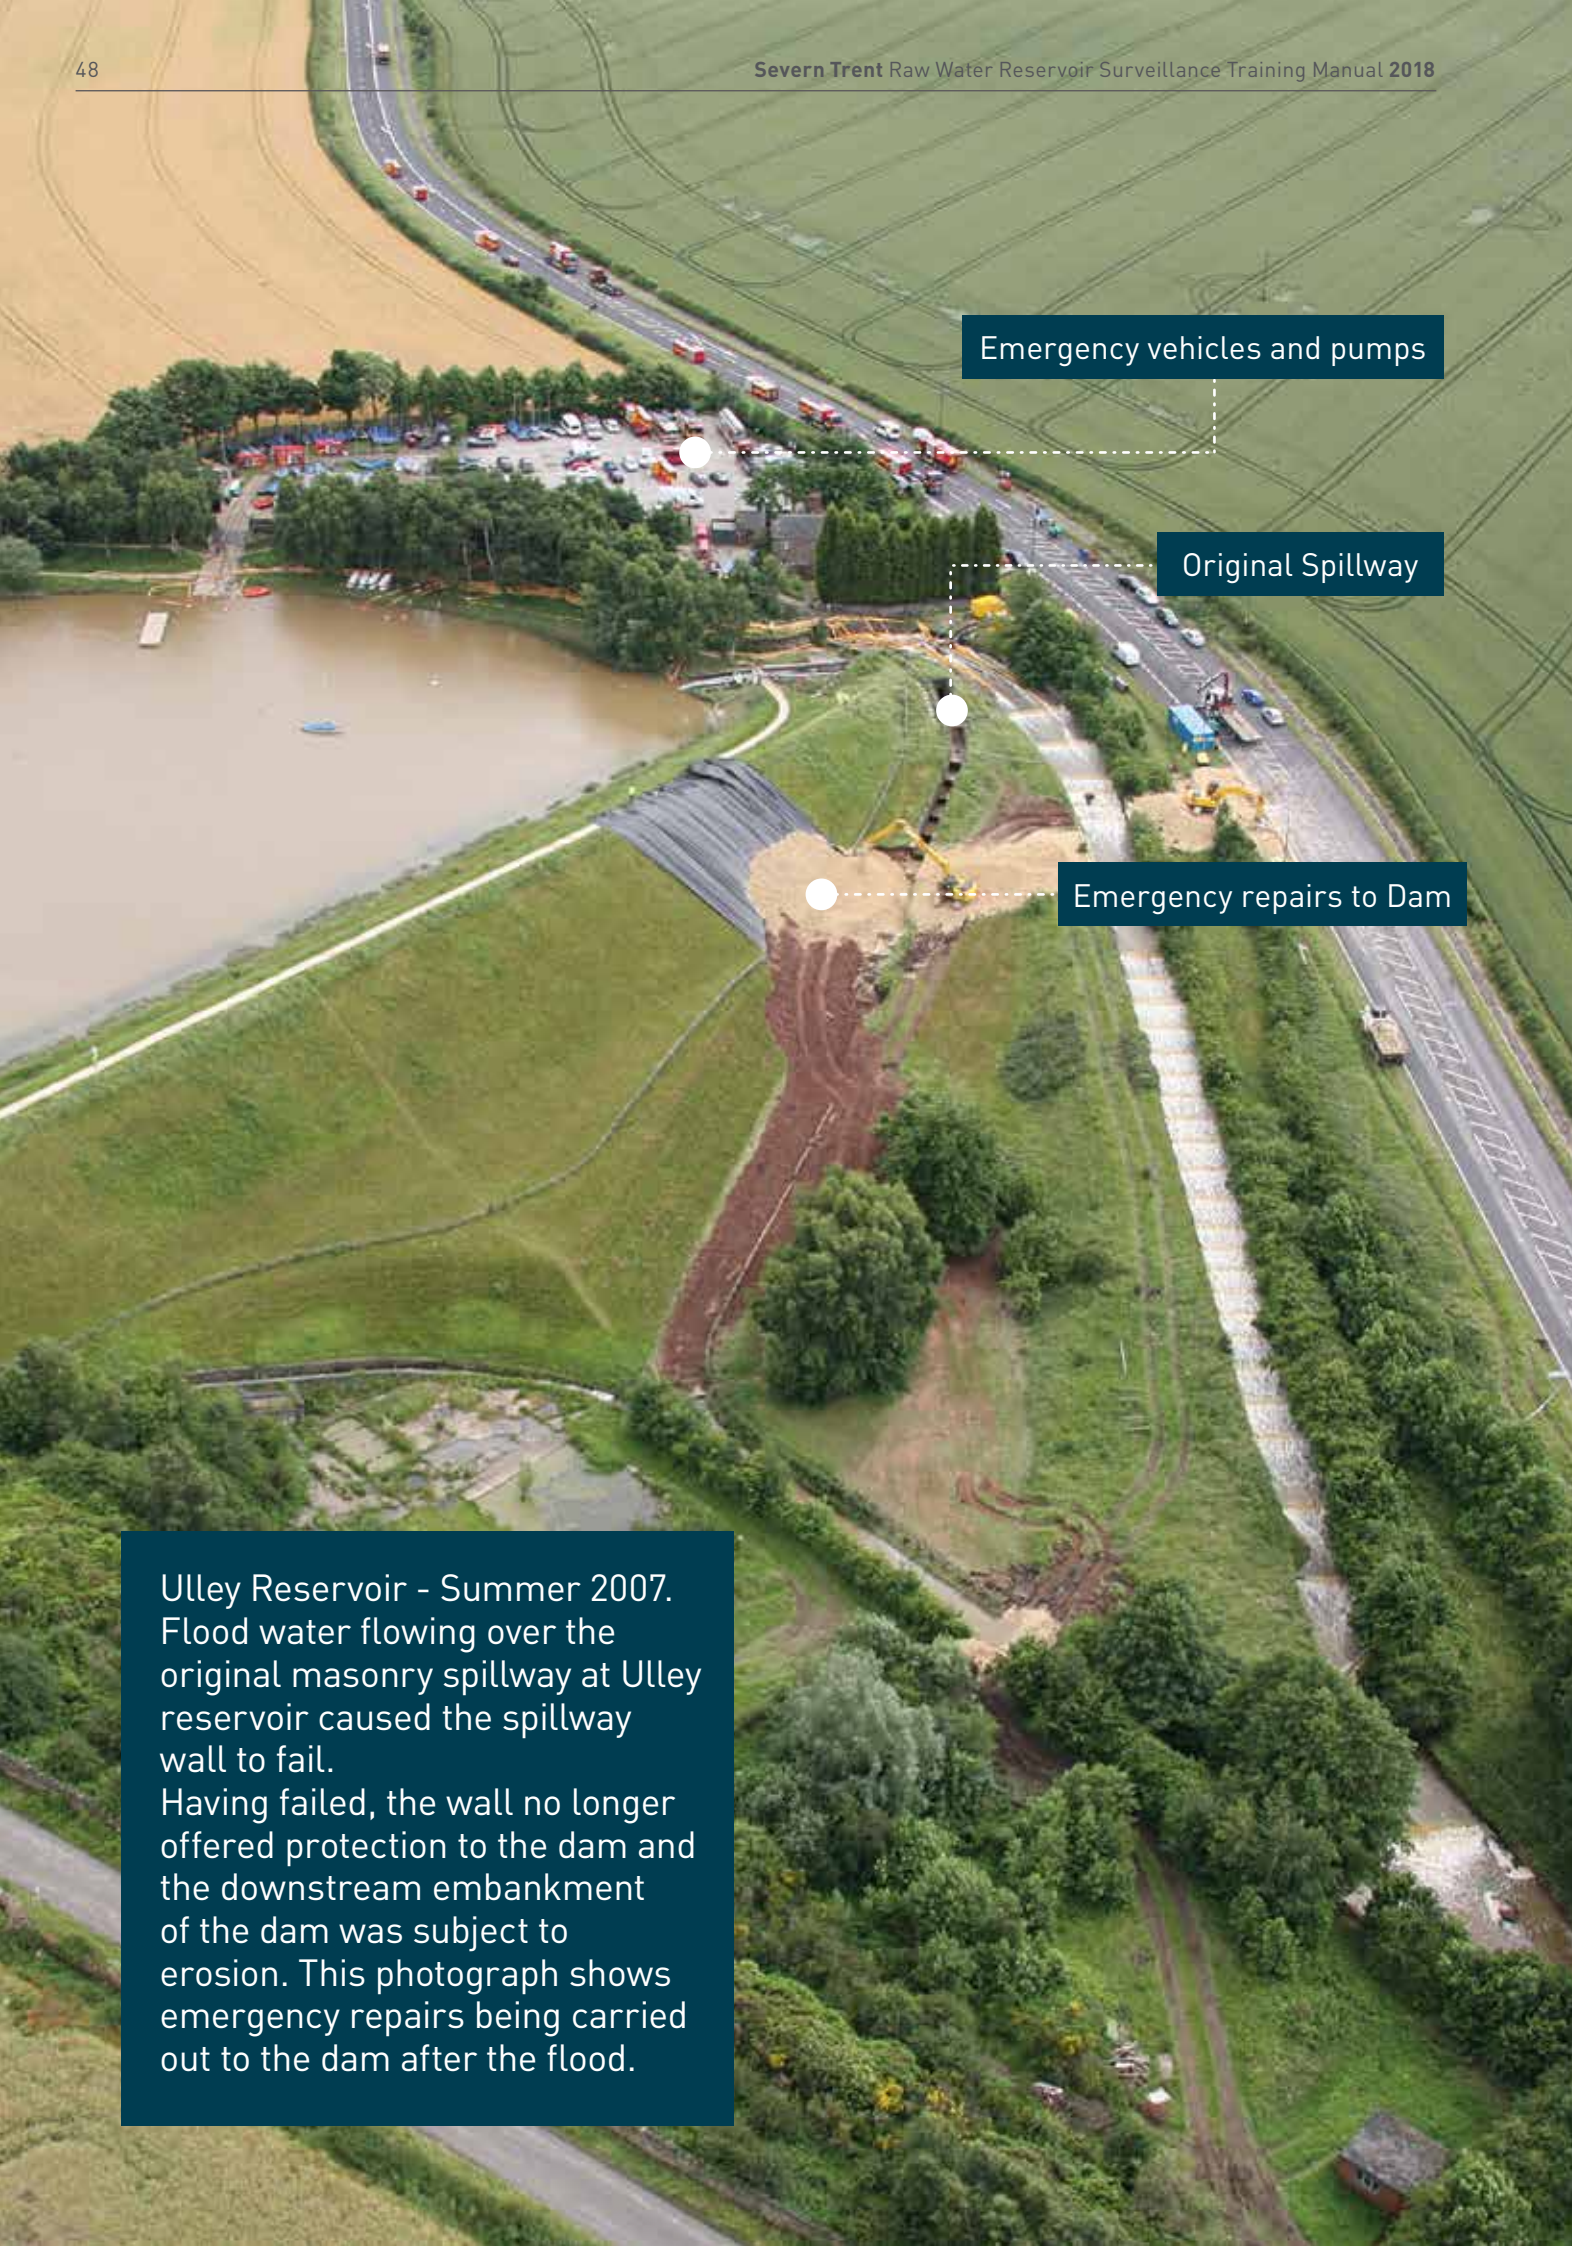
Ulley Reservoir - Summer 2007. Flood water flowing over the original masonry spillway at Ulley reservoir caused the spillway wall to fail. Having failed, the wall no longer offered protection to the dam and the downstream embankment of the dam was subject to erosion. This photograph shows emergency repairs being carried out to the dam after the flood.

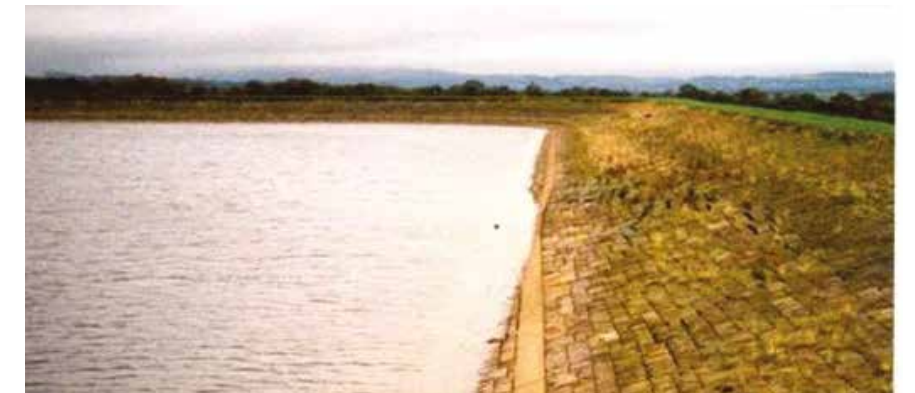
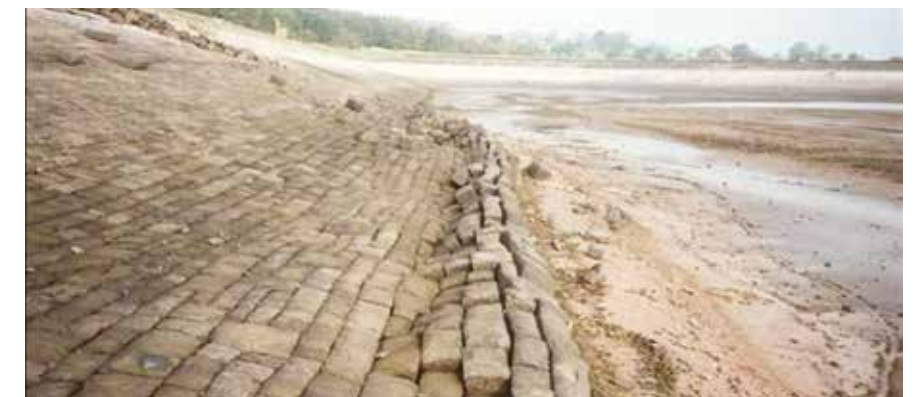
An irregular waterline shows a slip on the upstream face, with a bulge at the toe and distortion of the pitching revealed when the water level is dropped

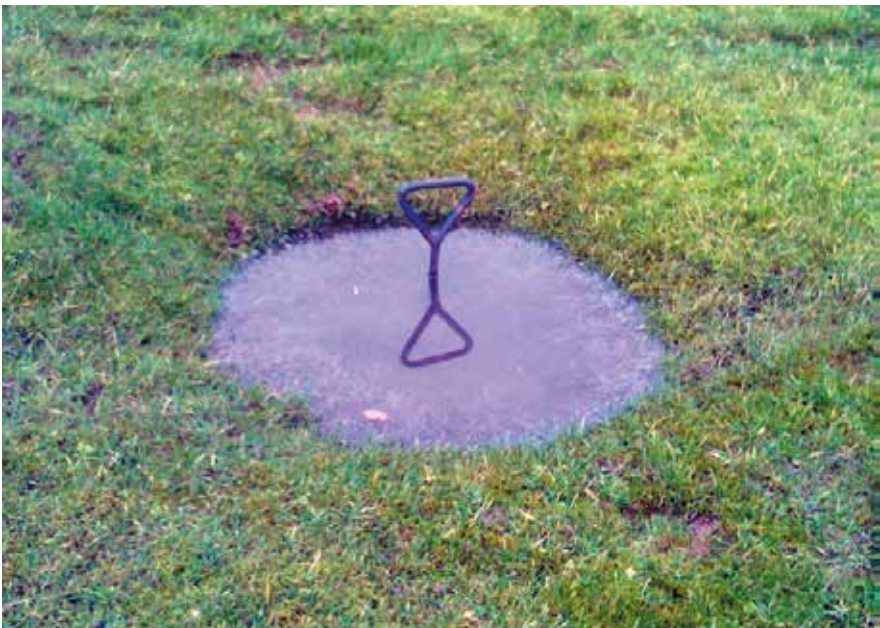
A newly formed depression indicating sub-surface erosion.

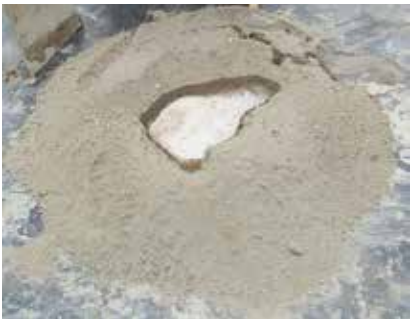
1. Embankment retaining water

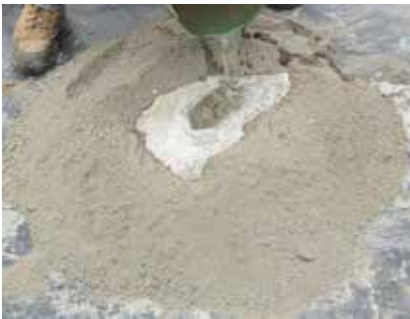
2. Overfilling of reservoir

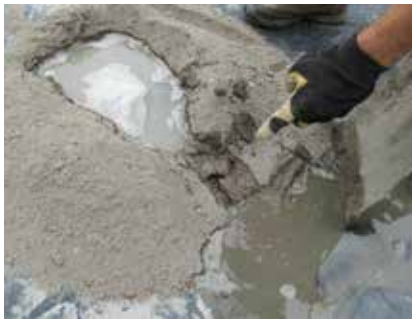
3. As water overflows, the embankment erodes away

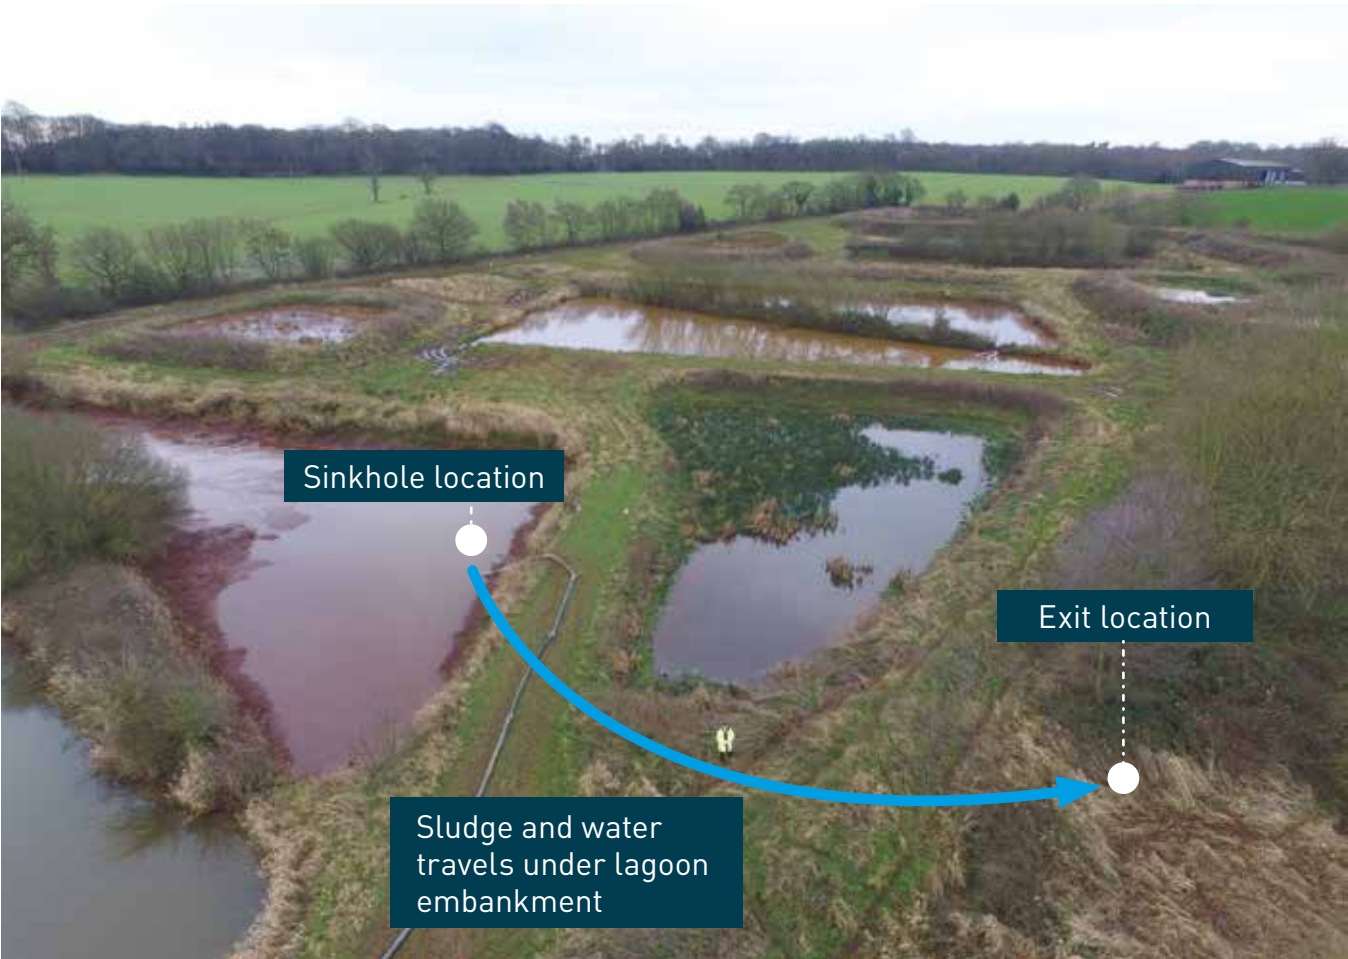
A mixture of sludge and water escaped from a lagoon at Melbourne WTW due to foundation failure of one of the embankments. The likely cause was water penetrating through the foundation of the non-engineered lagoon embankment.
