# Maintaining the safety of **our reservoirs**

Raw water reservoir surveillance training manual

SEVERN  
TRENT

Third Edition November 2018

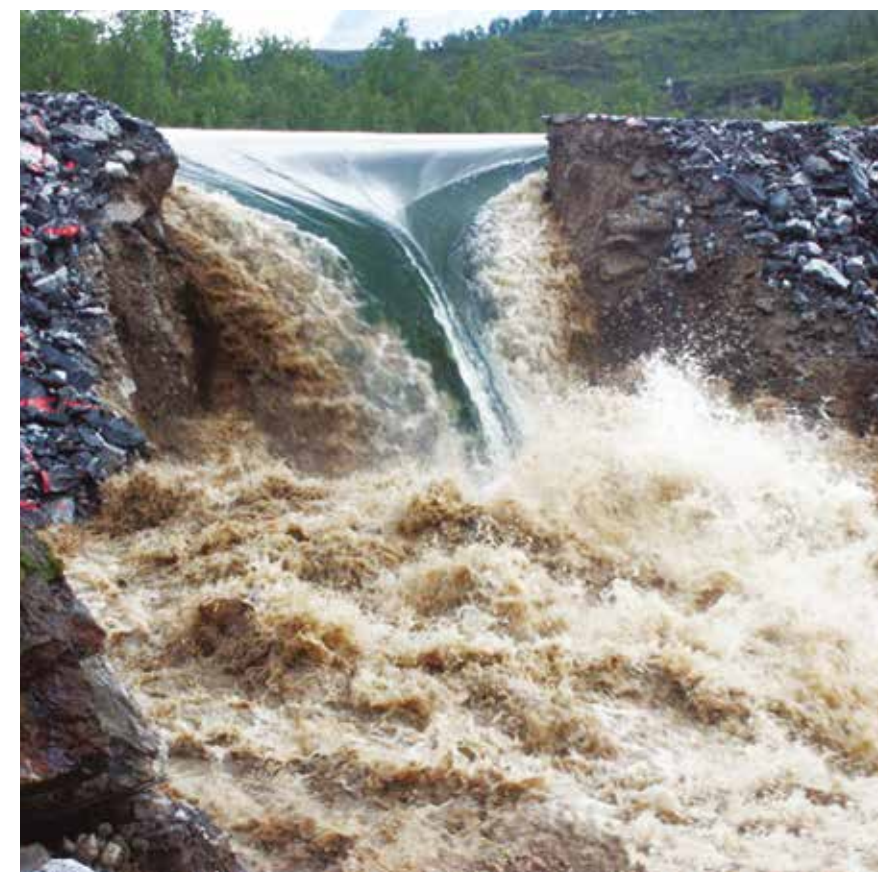
Water released from the reservoir by a breach in the dam causes further erosion.

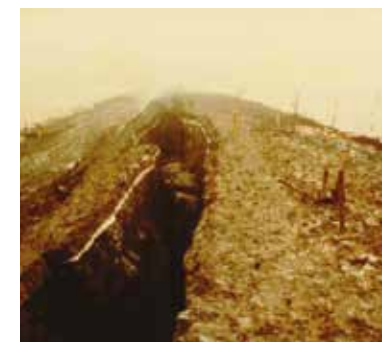
The crack opening at the top of the slip

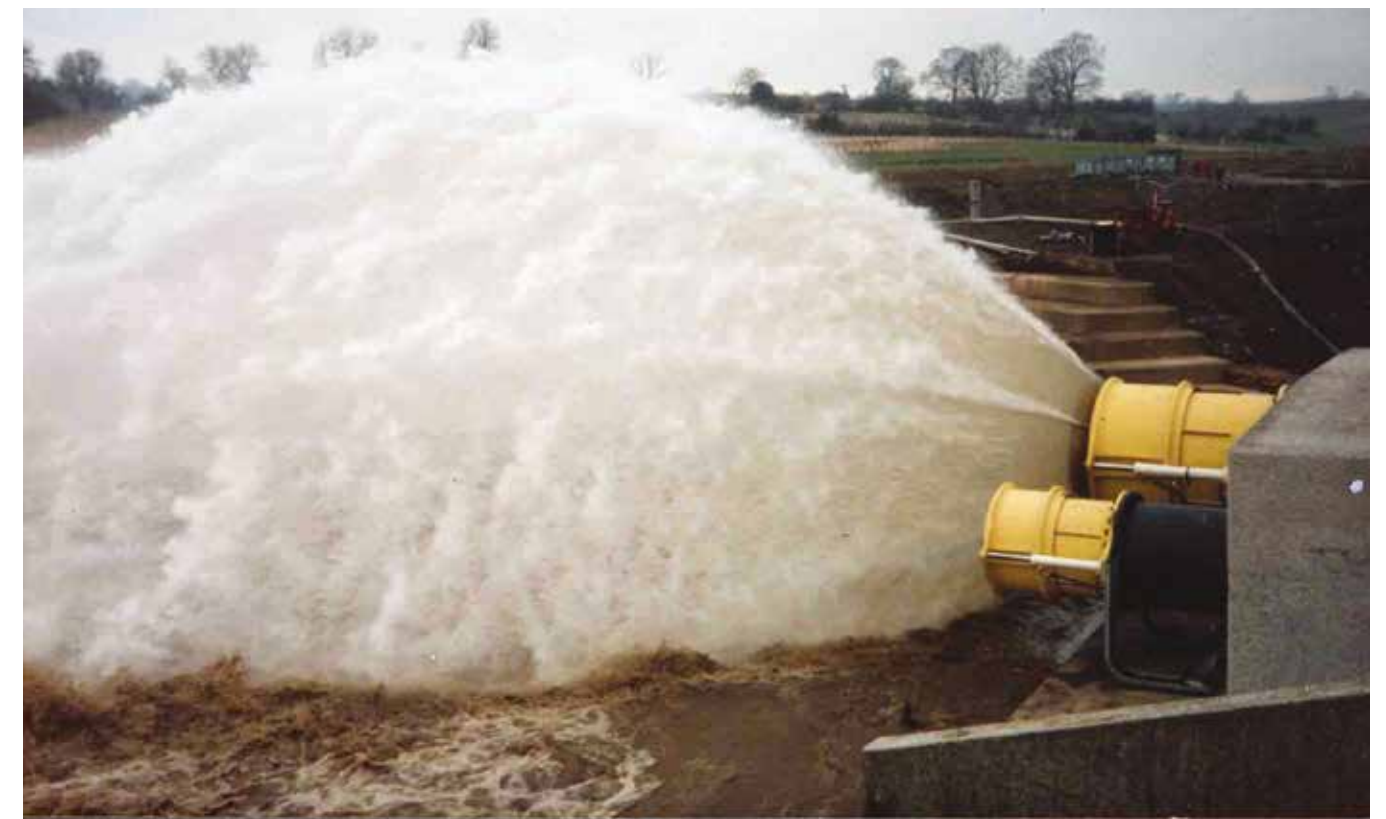
Exercising the scour valve at Carsington Reservoir

We ensure that our valves and pipework are fully operable and valves are regularly tested. In the event of an emergency, the valves may need to be opened to allow the reservoir to be rapidly drawn down.

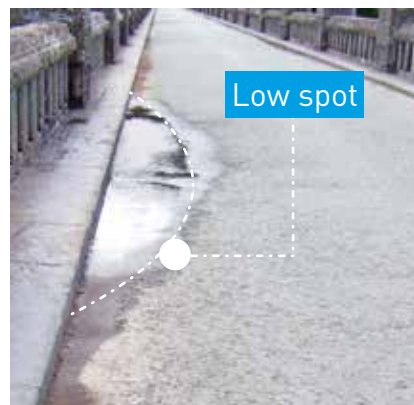
Puddles left after rain fall can indicate new low spots

Low spots or dips may be due to internal erosion or settlement which could indicate that the dam is deteriorating.

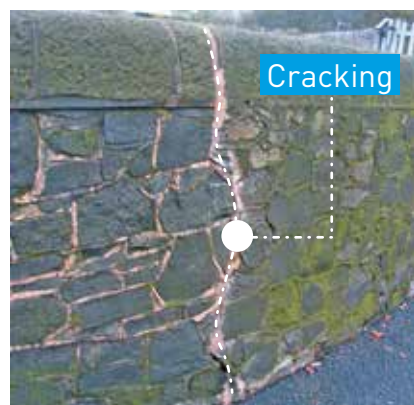
Bartley Reservoir - wave wall

Changes to the alignment or condition of the wave wall can indicate settlement or internal erosion. This will leave the dam vulnerable to failure and possibly overtopping.

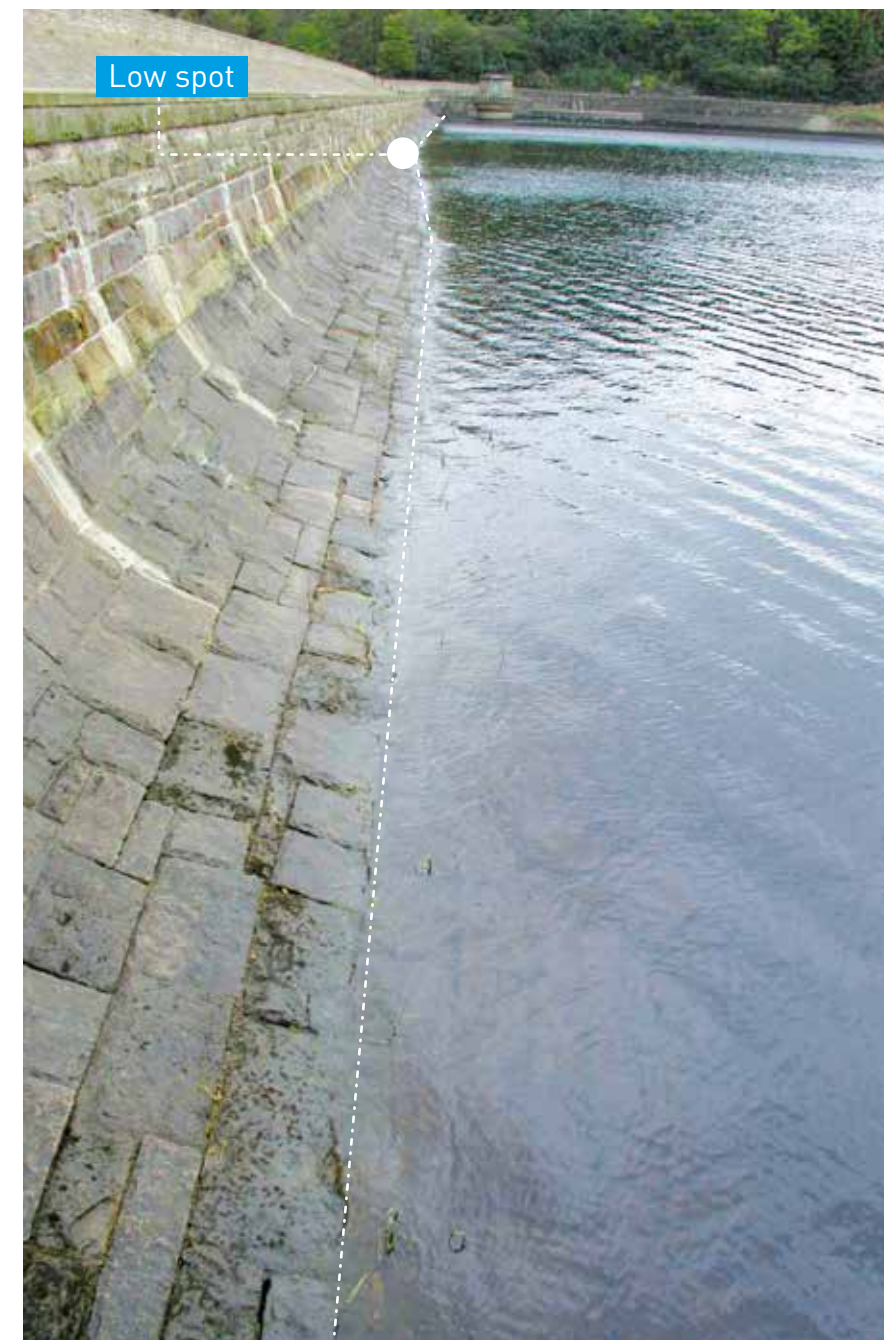
Ladybower Reservoir

The low spot indicates movement in the body of the dam. In the 1990s the embankment was subsequently raised to improve resilience.

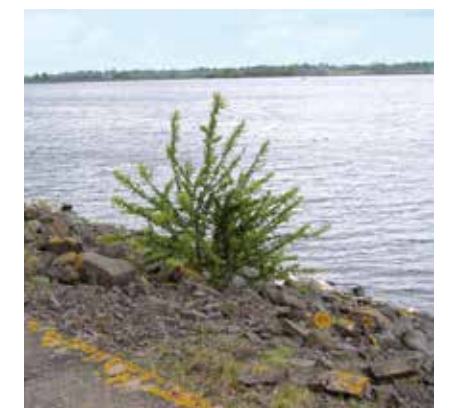
Saplings should be removed before their roots penetrate the body of the dam

concrete slabs, large blocks of masonry or rocks. Any saplings growing should be removed; as they mature they will upset the protective layer and ultimately compromise the protection that it offers.

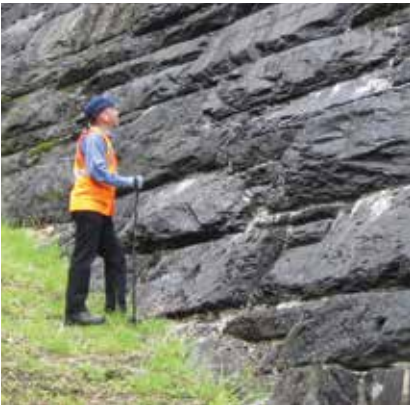
Looking for signs of movement in the stonework at Lake Vyrnwy.

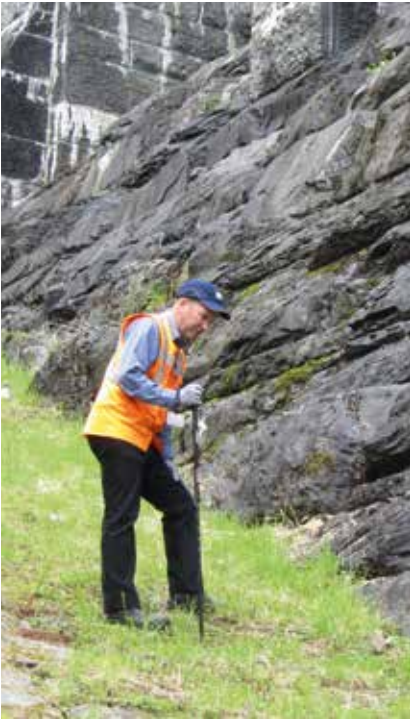
Probing for wet spots in the mitre at Lake Vyrnwy

If safe to do so, you should walk the full length and height of the mitre, searching for signs of seepage or change.

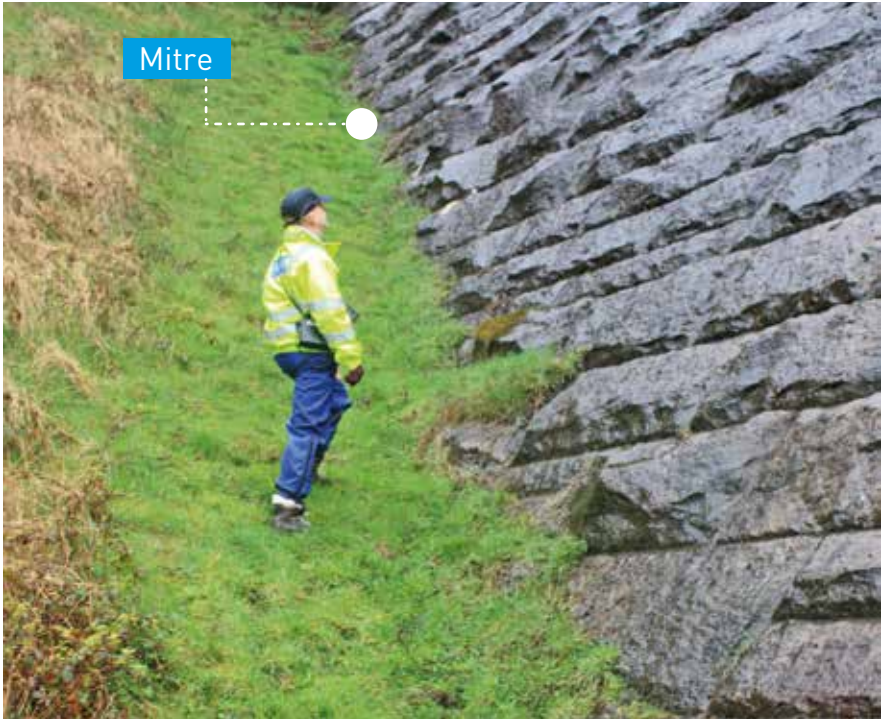
Looking for signs of change at the right hand mitre of Derwent Reservoir

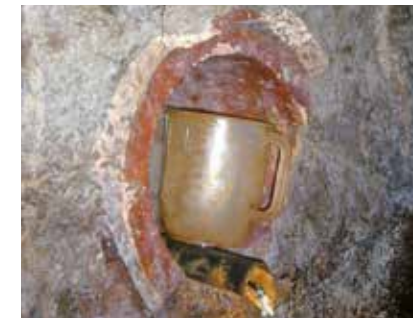
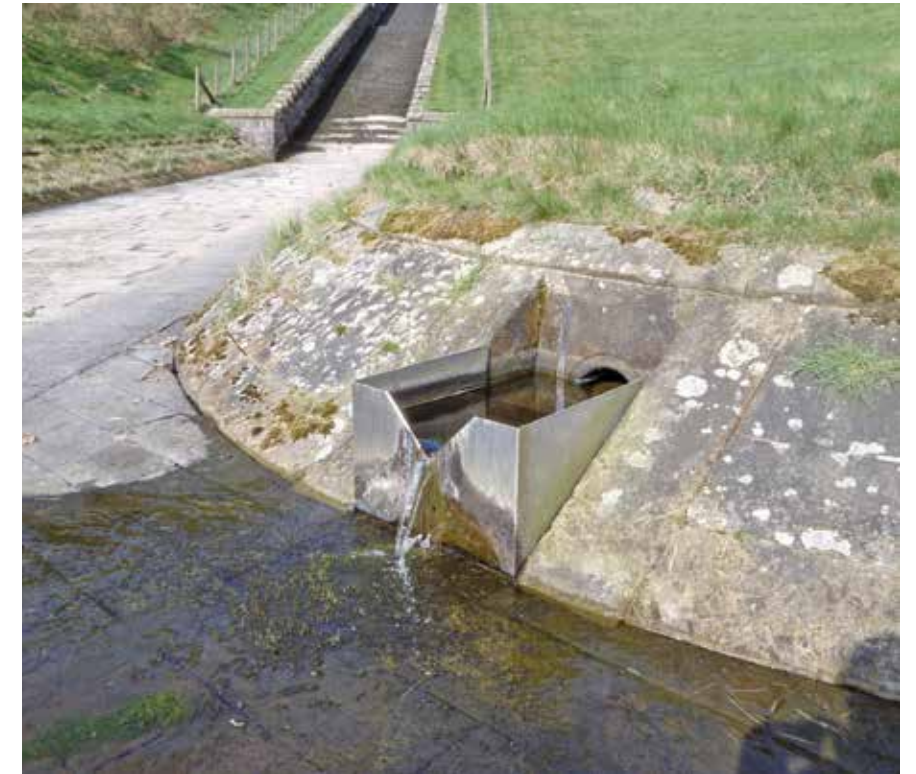
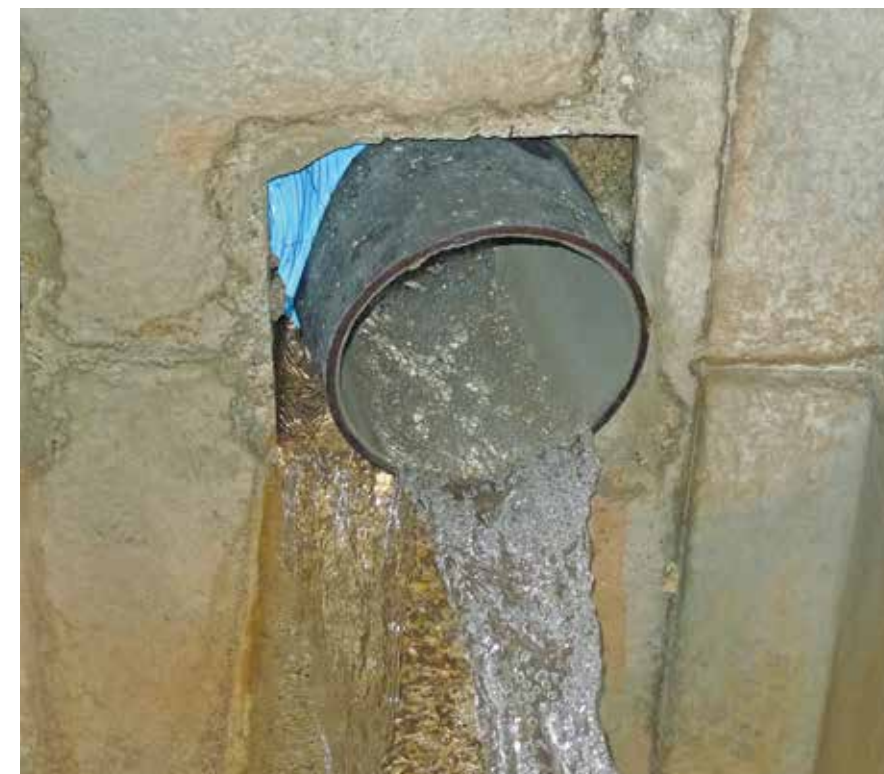
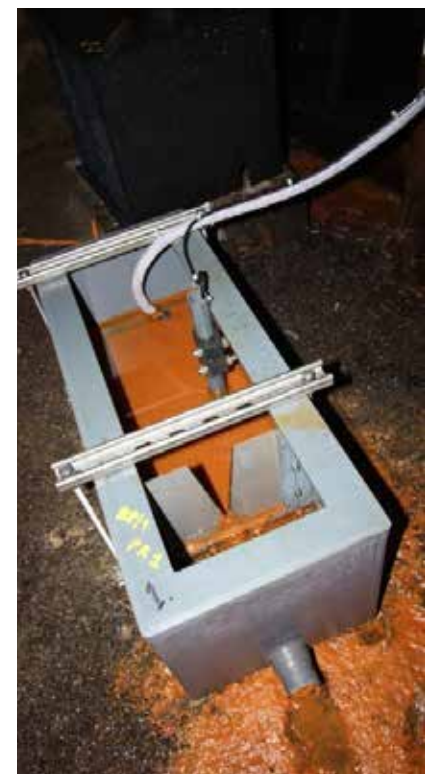
Flows can be captured and measured by a variety of means. For example the rate of flow can be determined by timing how long it takes to fill a known volume (for example, a beaker) or measuring the depth of water upstream of a v-notch weir.

It is particularly important to note any significant changes in flow rate or discolouration of the flow since your previous visit. Discoloured water could indicate that soil is being passed through the dam, creating a void.

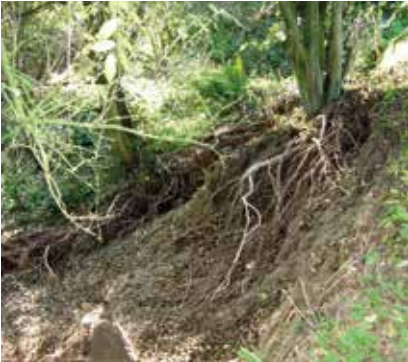
Localised erosion around tree trunk following overtopping event.

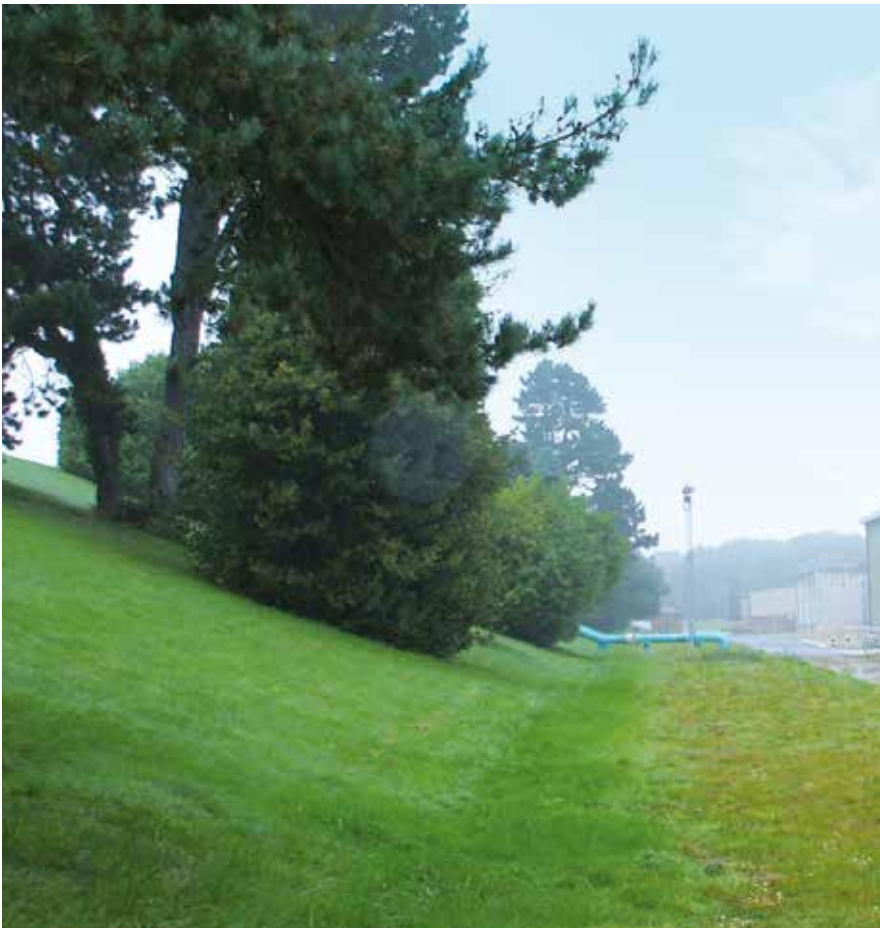
Trees growing on an embankment dam, which is far from ideal.

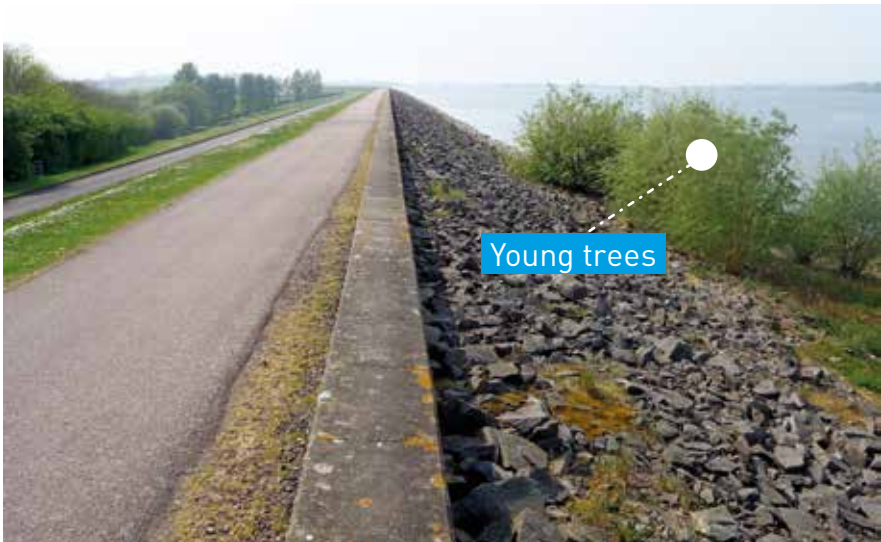
Young trees growing on wave protection requiring removal

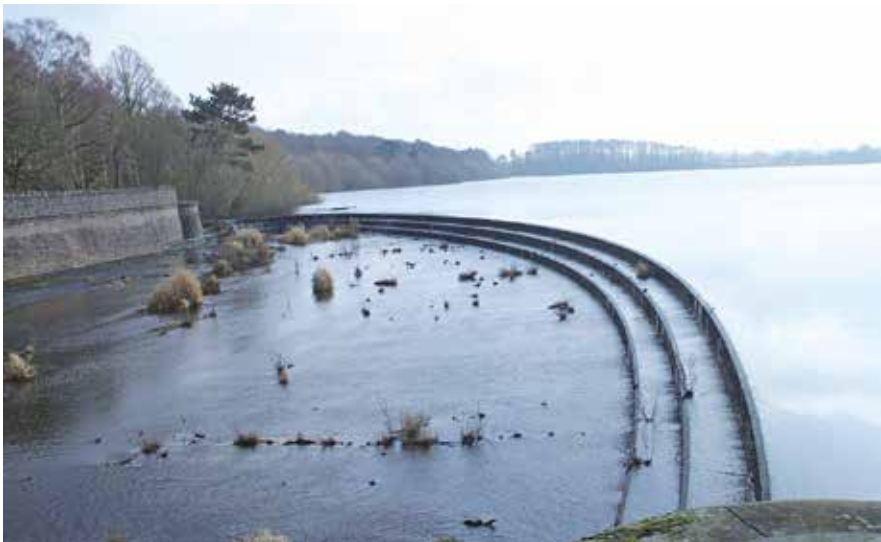
Young trees on a spillway requiring removal

Trees near spillways can cause damage, either as the roots grow up through the concrete or by being blown over and blocking the spillway.

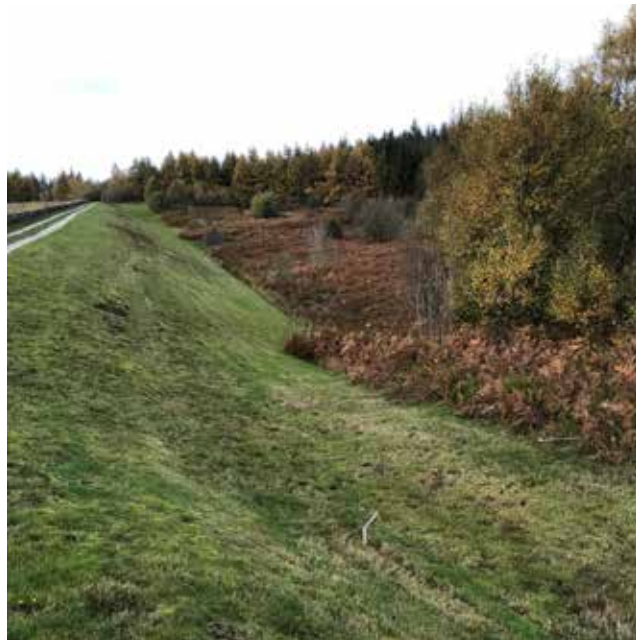
Progressive overgrowth along the toe of Pendinas Reservoir

During your daily inspection, make sure Grounds Maintenance are maintaining the appropriate width of cut to prevent over-growth of hedgerows. This ensures that the toe remains visible at all times.

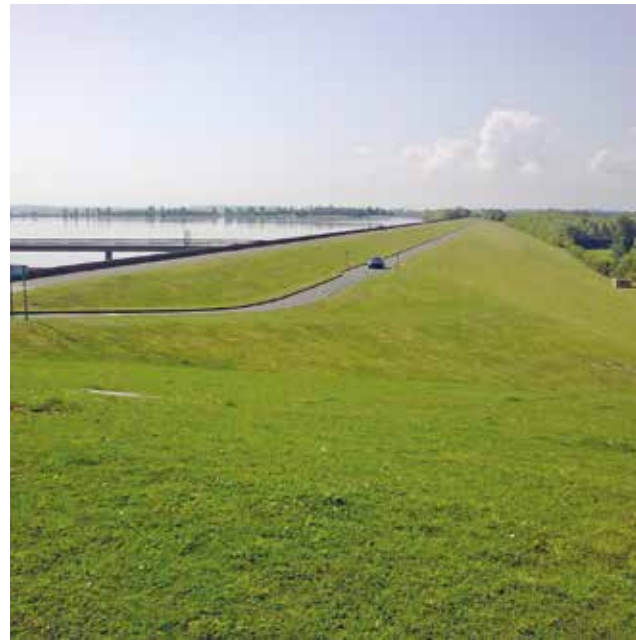
An example of a well maintained embankment at Draycote Reservoir

Ideally, an embankment dam has a covering of short, healthy grass on the downstream face, with no trees or other vegetation. This allows problems to be spotted and corrected early before they become dangerous and expensive to fix. If the grass is well maintained, it provides protection against erosion, and the exposed face of the dam will discourage some animals from burrowing into it.

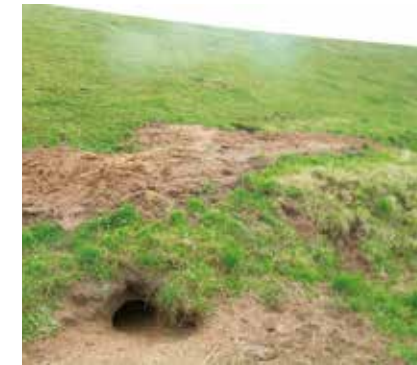
Entrance to badger sett on earth embankment dam

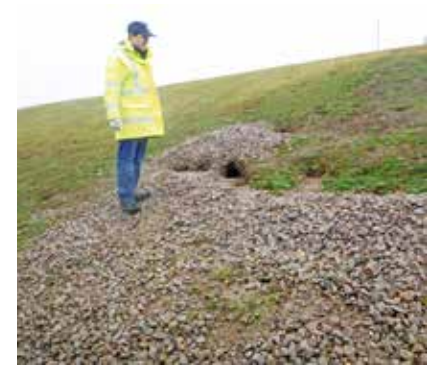
Example of rabbit activity on the downstream face of Draycote Reservoir

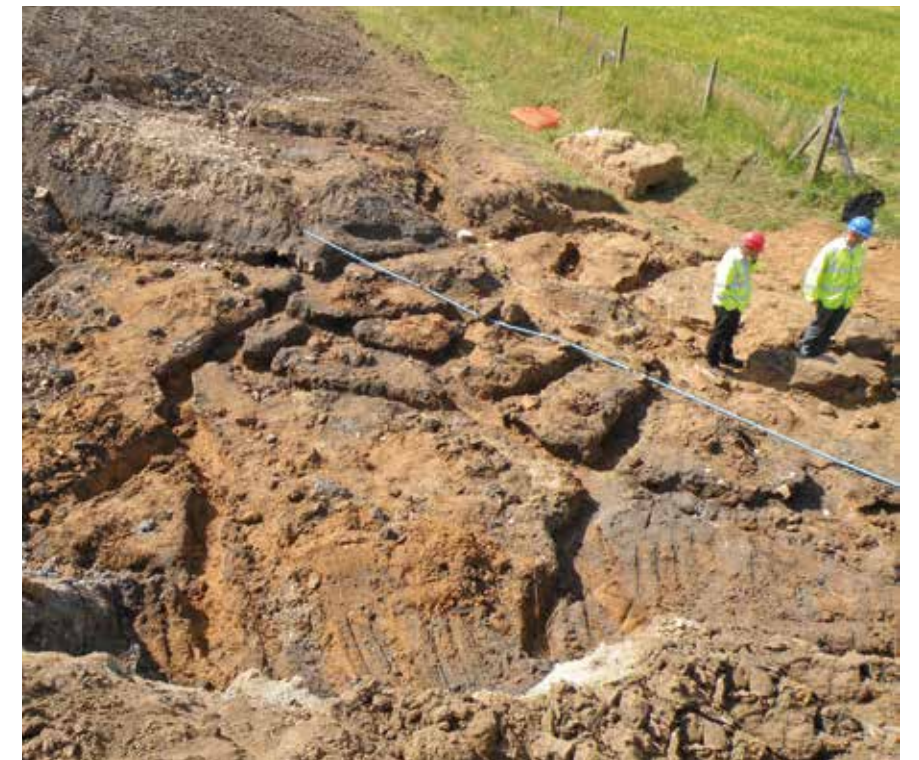
Examples of the extensive impact of burrowing badgers

Whilst the entrance to a badger sett may look comparatively innocent, burrowing in the embankment can be extensive. In the example opposite, over 230 metres of burrow was excavated in the embankment of a flood storage reservoir.

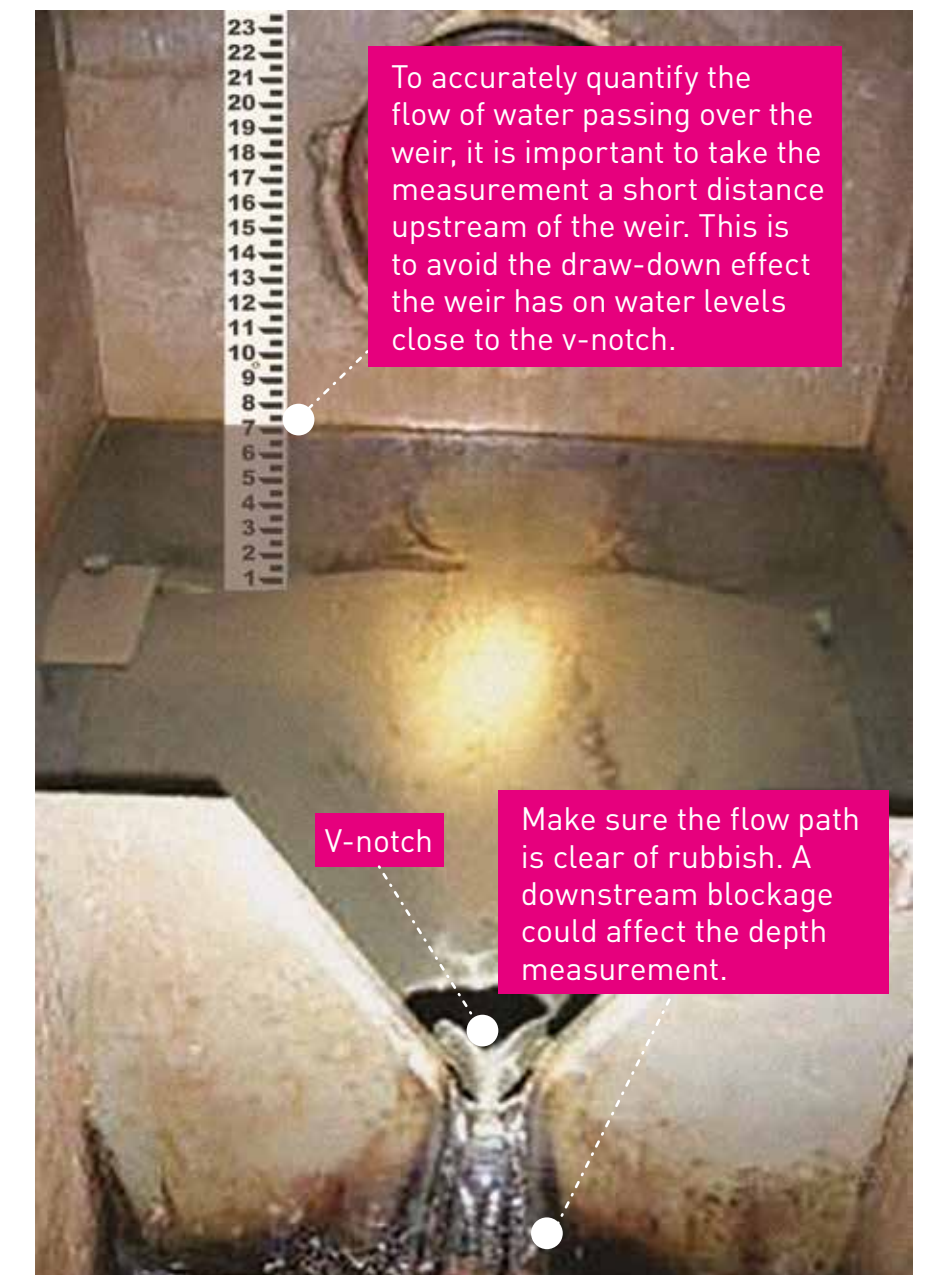
V-notch weirs are found at the end of toe drains.

V-notch weirs on our dams are found at the end of toe drains and in a variety of places.

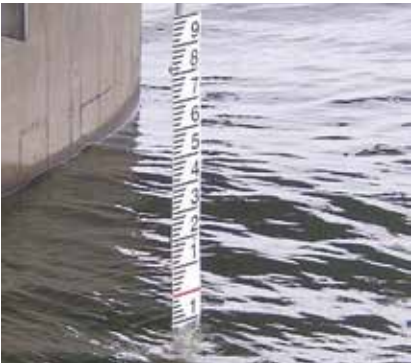
The water level gauge board shows the level of water within the reservoir at that time. Although this is often done automatically, errors can occur, so it is important to manually check the water levels in the reservoir.

Gauge board at Draycote Reservoir

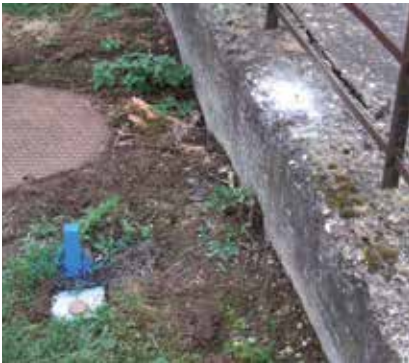
Deformation monitoring points can be placed either on (or near) the crest or on the downstream face. They monitor the vertical movement of the dam.

Examples of monitoring pins

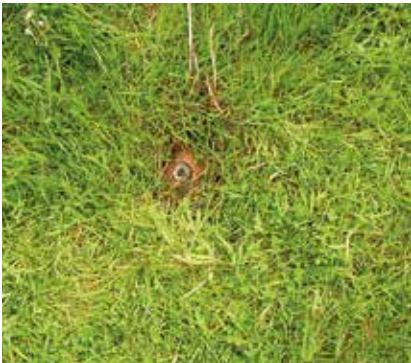
Example of monitoring pins on Earth embankments

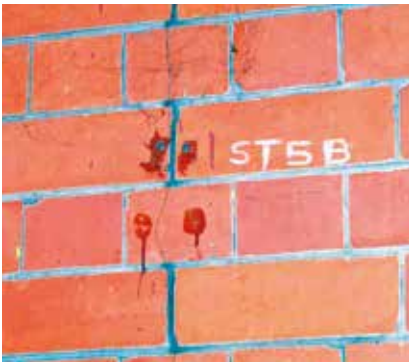
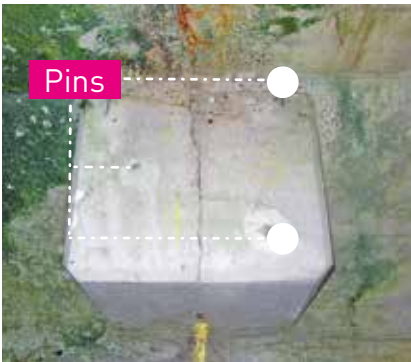
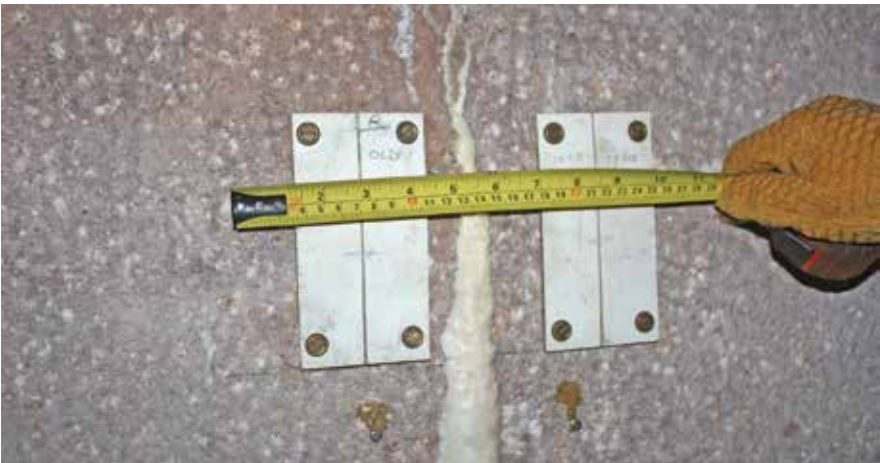
Crack measurement

Generally two pins are placed on either side of a crack and measured regularly to check if the crack is widening.

Movements can be monitored by tape or digital calipers.

Alternatively, a crack width measuring gauge can be permanently installed to monitor the width of a crack.

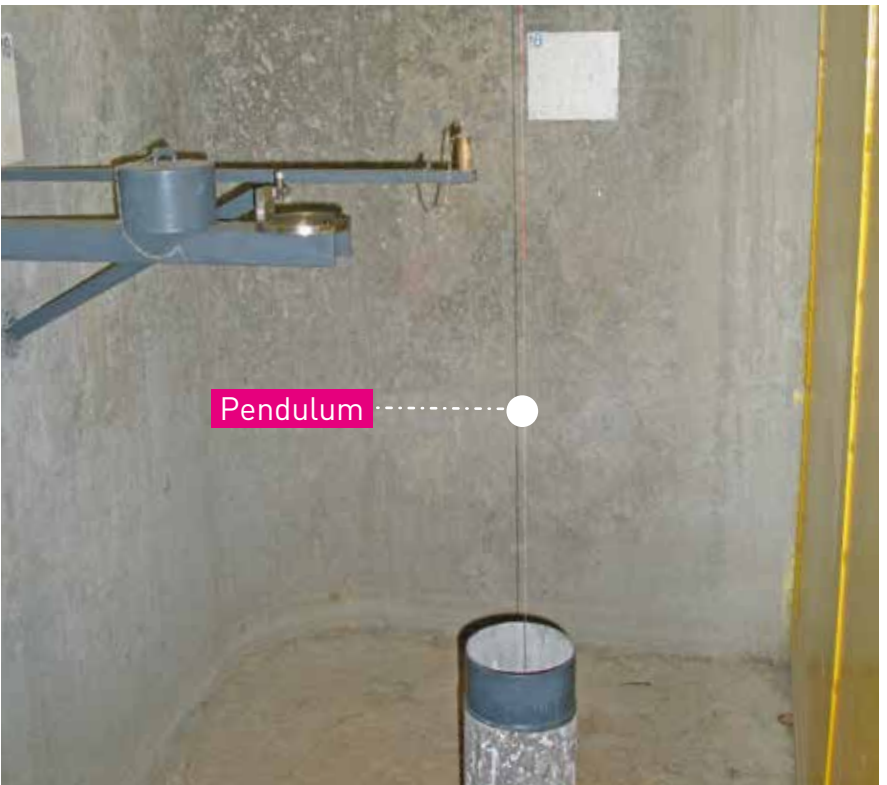
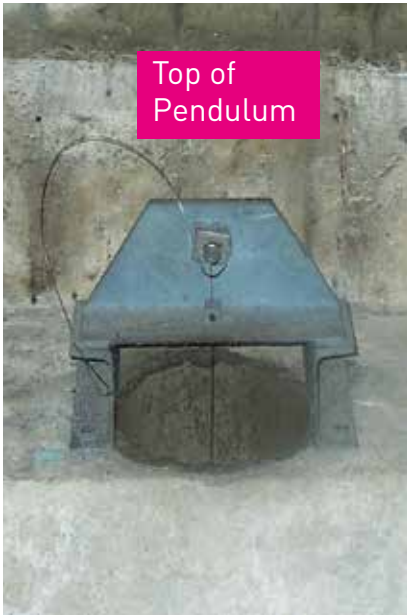
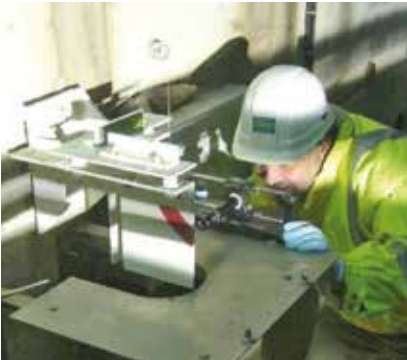
Regular monitoring of the vertical movement of the dam

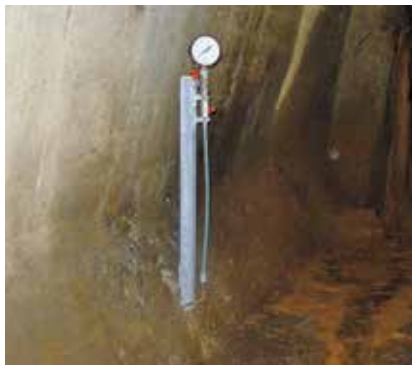
A typical piezometer

Piezometric pressure monitoring

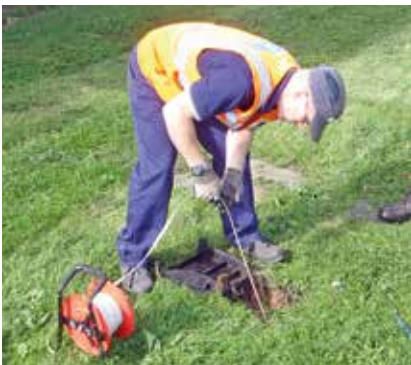
Dipping a piezometer at Trimpey Reservoir

Piezometers are used to measure the pressure of water present within the body or foundation of the dam. Regular monitoring can detect early signs of instability.

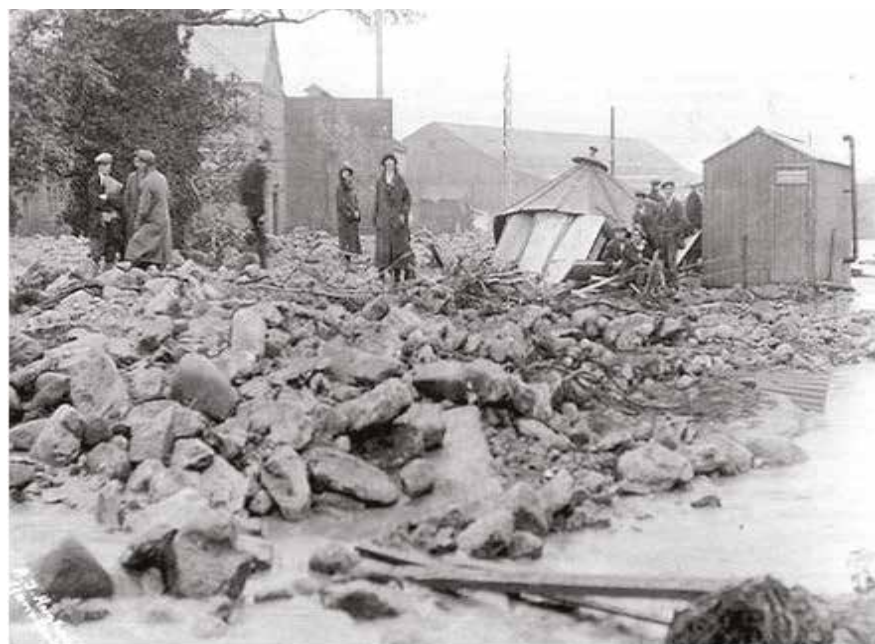
The flood released by the collapsed Eigiau and Coedty dams caused devastating damage downstream

After two reservoir failures in 1925 (See Coedty and Eigau Case Study), legislation was eventually introduced in 1930, ensuring that all large raised reservoirs would be inspected at least every 10 years by a suitably qualified engineer (inspecting engineer).
