1982 CONFERENCE

University of Keele
September 1982

Technical Papers

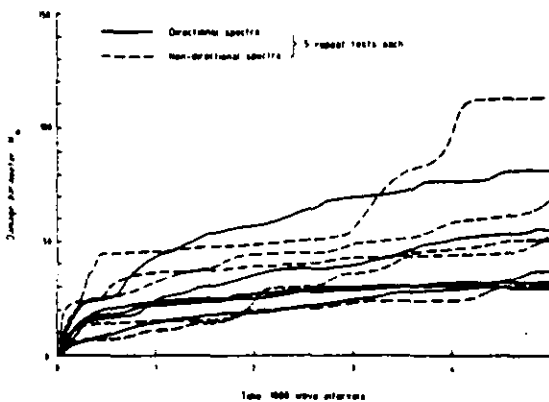
Repeat directionality tests on dolosse armour

Fig 8 Repeat Directionality Tests on Dolosse Armour

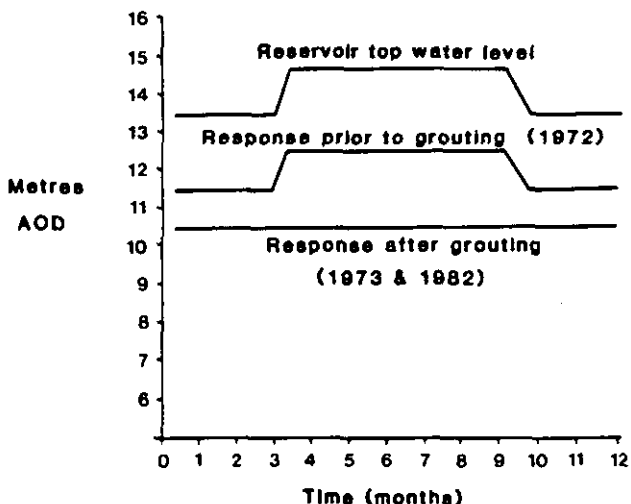
Fig. 4 DIAGRAM SHOWING EFFECT ON WATER LEVELS IN EMBANKMENT BEFORE AND AFTER REMEDIAL WORKS
