1984 CONFERENCE

**University of Cardiff
September 1984**

Technical Papers

Insidious Threats to Dams and Reservoirs

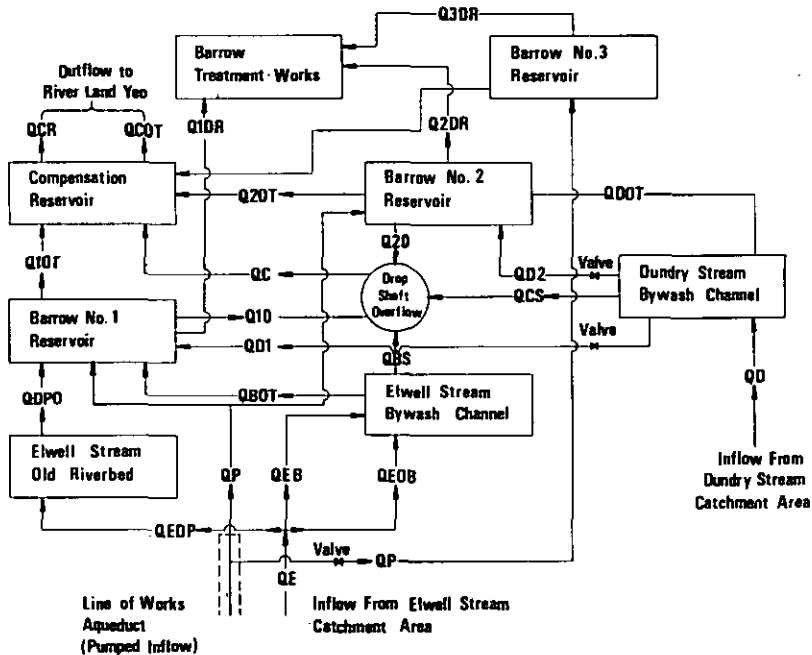
Fig. 4 DIAGRAMMATIC REPRESENTATION OF BARROW RESERVOIRS NETWORK

The complex arrangement of weirs, channels, pipes, valves and flood storage basins, shown diagrammatically in Fig. 4, resulted in the development of an equally complex mathematical model in order to evaluate inflows and outflows. This revealed that the 30 inch diameter overflow pipe under No. 2 Reservoir would not be able to discharge a 0.5 PMF and that the embankment would be overtopped.

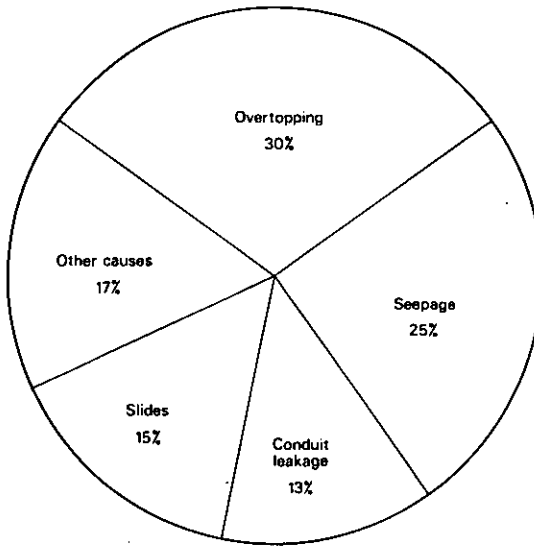
Fig 2 Causes of unsatisfactory performance of earth dams in United States of America as analysed by Middlebrooks⁽⁷⁾

In reviewing dam practice in the United States of America, Middlebrooks⁽⁷⁾ listed unsatisfactory performance of about 200 earth dams. He classified the four main inadequacies which led to partial or complete failure as overtopping, seepage, slides and conduit leakage respectively. His analysis of the data is shown in Figure 2. 83% of the failures could be

classified under one of these four headings. Overtopping accounted for 30% of the failures. Many of the failures classified by Middlebrooks as seepage or conduit leakage were associated with internal erosion and together these accounted for 38% of the cases. Slides accounted for only 15% of the incidents.
