British National Committee
on Large Dams (BNCOLD)

Reservoirs 1986

Discussion Proceedings

8. The Significance of Problems and Remedial Works
at British Earth Dams, by J.A. CHARLES

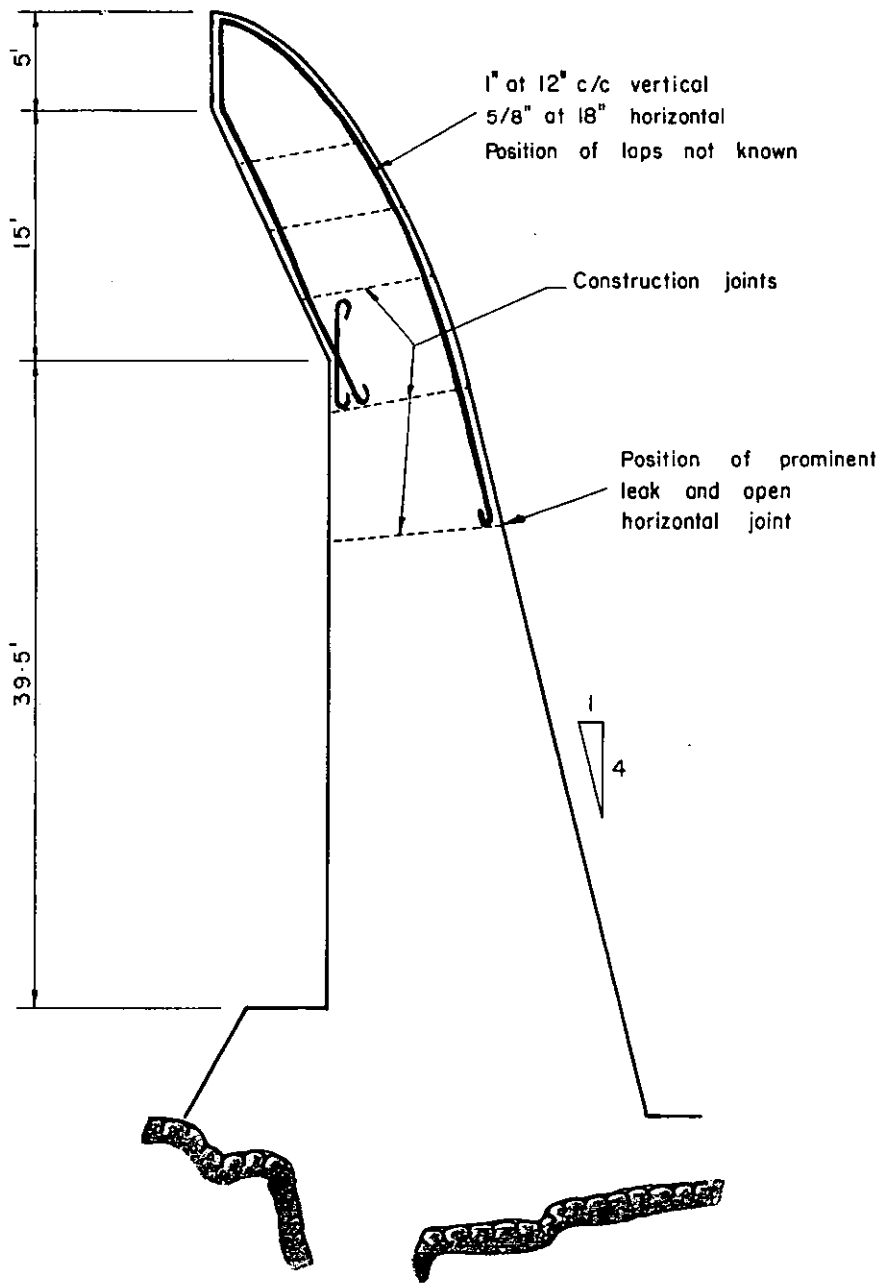
Fig. B.1. Section through an arch dam

The downstream face was reinforced above a certain level and this in itself would lead to very difficult concreting conditions. The individual cantilevers had a calculable tensile stress in the downstream face. The rate at which they were raised would need to provide time for the concrete strength to develop, stage by stage, so that it bonded adequately with the reinforcement. Inadequate concrete strength at any stage of the construction would increase the tensile stresses still further, inevitably leading to local bond failure and micro cracking.

A further aspect to consider was the principle of adopting contraction joints in an arch. If these were concreted before the concrete in the main blocks had been given adequate time to shrink, joints would continue to open up even after the contraction joints were concreted so that localized non-elastic movements could occur when the dam was loaded or unloaded. Concrete of the thickness

involved in this dam would have continued shrinking for a long time after construction as it was not cooled.

Less than 20 years after the dam was completed there was extensive cracking on the downstream face, reflecting the position of the reinforcement and extensive leakage along the contraction joints. There was also a prominent horizontal joint along the downstream face immediately below the level of the reinforcement which was more than 5 mm open. The present appearance of the dam was most unsatisfactory.

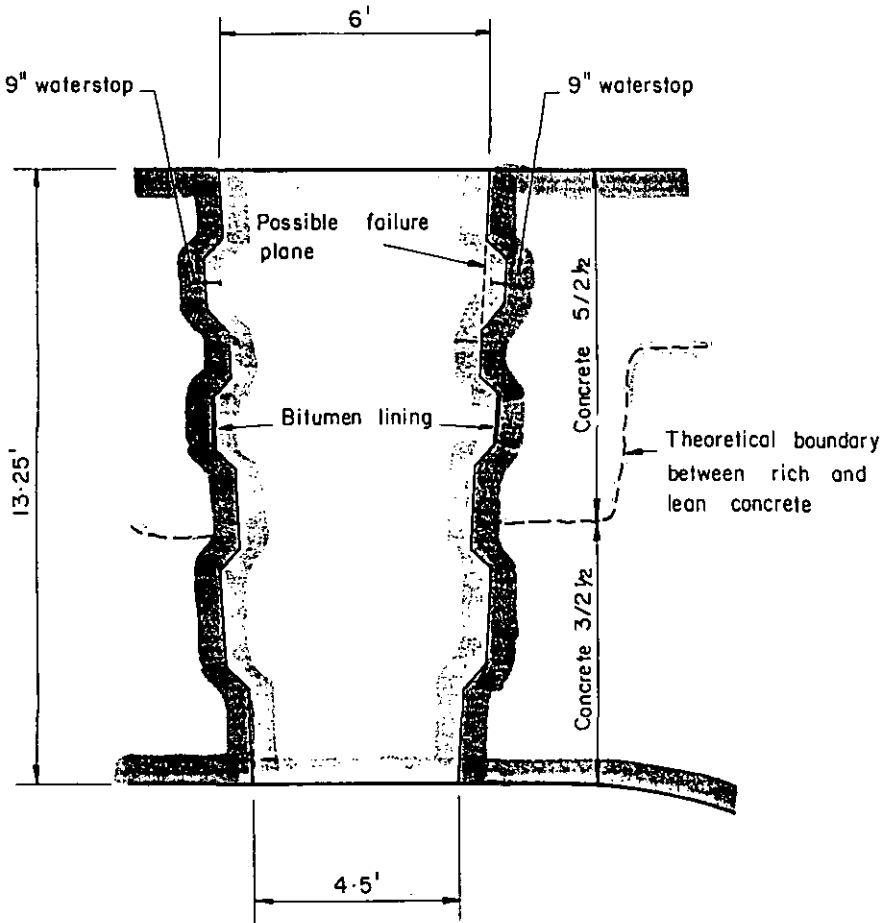
Fig. B.2. Closure detail in a buttress

A slide (not reproduced) showed a common form of closure detail, this time in a buttress (Fig. B.2).

The water stop was located in the keyway. When the concrete in the main buttress shrank, the wedge was prevented from moving downstream by the keys which therefore picked up the horizontal load. The key incorporating the waterstop was invariably weakened by the waterstop itself and tended to shear thereby rendering the waterstop entirely ineffective. The result was illustrated by a slide (not reproduced) showing extensive seepage discolouration along joints on the downstream face.

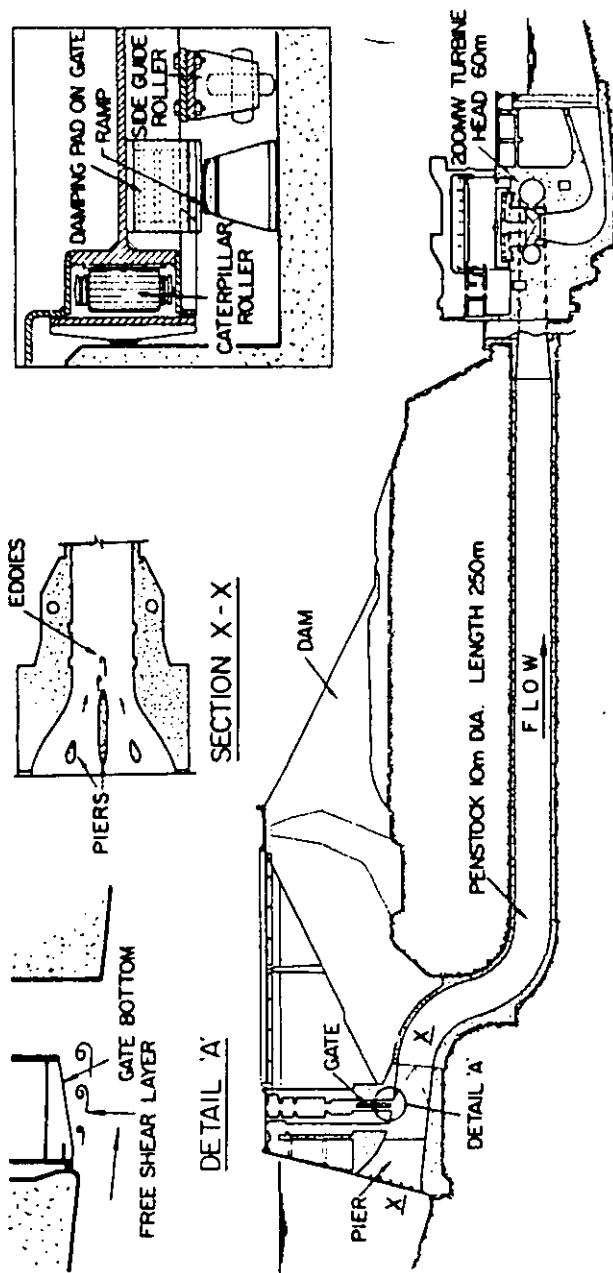
Fig. 2.2. Vertical section of intake, gate and penstock

The underside of the gate was subjected to eddies arising from the main vertical splitter and subsidiary horizontal screen supporting beams, which between them produced a wide range of frequencies for single and double eddies which included the gate vibration frequency. It was also possible to prove that the penstock downstream of the gate could have a frequency resonant with the gate frequency thereby amplifying the eddy forces acting on the underside of the gate. It should be appreciated that the range of the calculable frequencies was very large. Once the initiating mechanism had been identified, gate vibrations were eliminated completely by providing a low horizontal damping force on the very top of the gate (see Fig. 2.2).

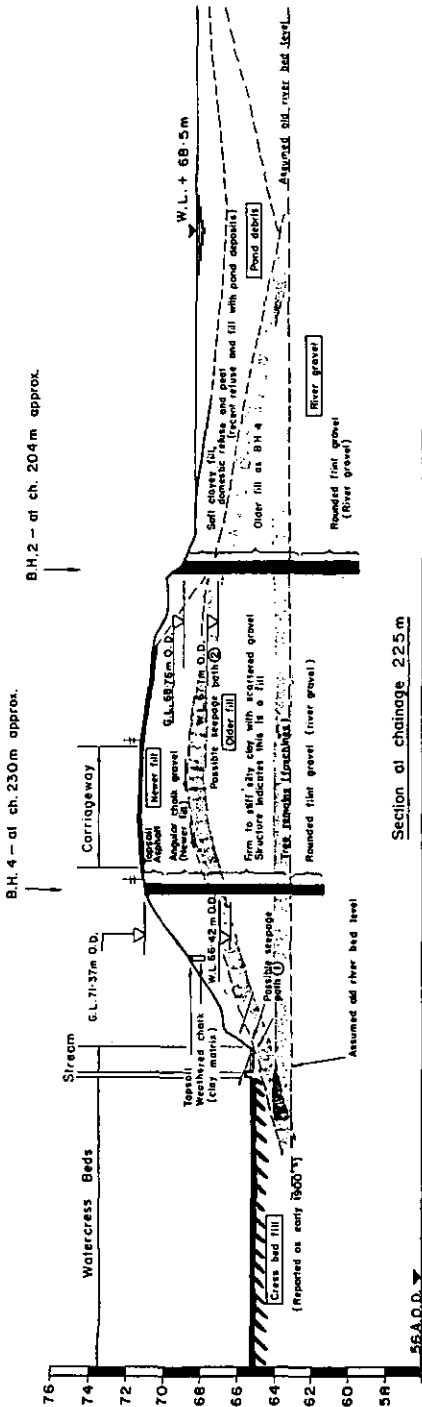
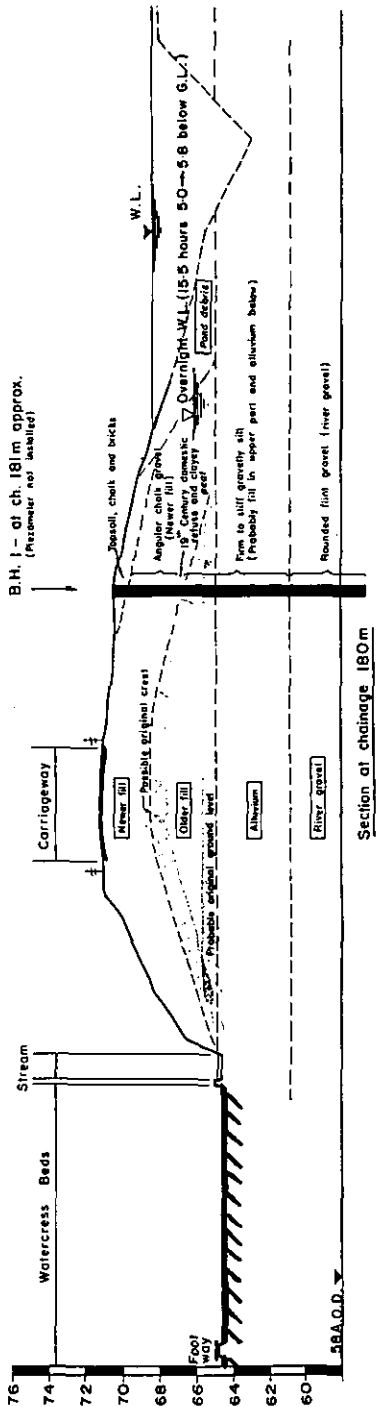
Fig. 3.1. Sections through dam

The original dam was completed to a level some 10 ft lower than at present over 700 years ago. The construction material was lumps of chalk which the villagers carried in reed baskets and placed in the marsh. The original dam profile was conservative and capable of some limited overtopping. The events described below then occurred apparently without any reference to the owner of the water who considered that he owned only the water and the upstream face of the dam.

1. At some time, probably in the last century, the dam was raised 10 ft to accommodate a public highway and thereby the downstream slope was considerably steepened.
2. At some time in the last century the watercress beds were widened and a drain constructed along the toe of the dam. In order to do this, the toe of the dam was removed and

thereby the dam itself was made even steeper. This inevitably caused localized slips which were repaired, presumably by the owner of the drain. These repairs contained 8 inch pipes at about 20 ft centres which carried appreciable volumes of seepage water. The water-cress beds themselves had artesian flow.

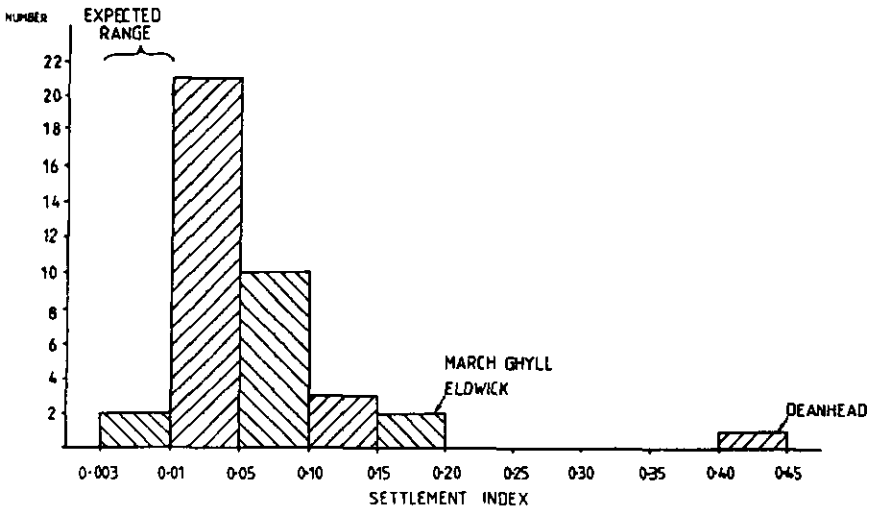
Fig. 5.1. Yorkshire Water, Western Division - crest settlement of central core dams

The distribution of settlement indices for this sample was shown in histogram form in Fig. 5.1. There were 39 dams in the sample. The oldest was built in 1825, the newest in 1970. Their heights ranged from 9 m to 54 m and the period of record used varied from 1 year to 7 years depending on the length of time for which accurate data were available.

Only two dams had settlement indices in the range predicted by Dr Charles. One of these was Scammonden, a rockfill dam with a rolled clay core; the other was a rockfill dam with a puddle clay core built in 1907.

All the other dams had higher settlement indices, the largest group of 21 being in the range 0.01 to 0.05. There was a skewed distribution with all the remainder, except one, lying below 0.20. Commenting on the three highest settlement indices:

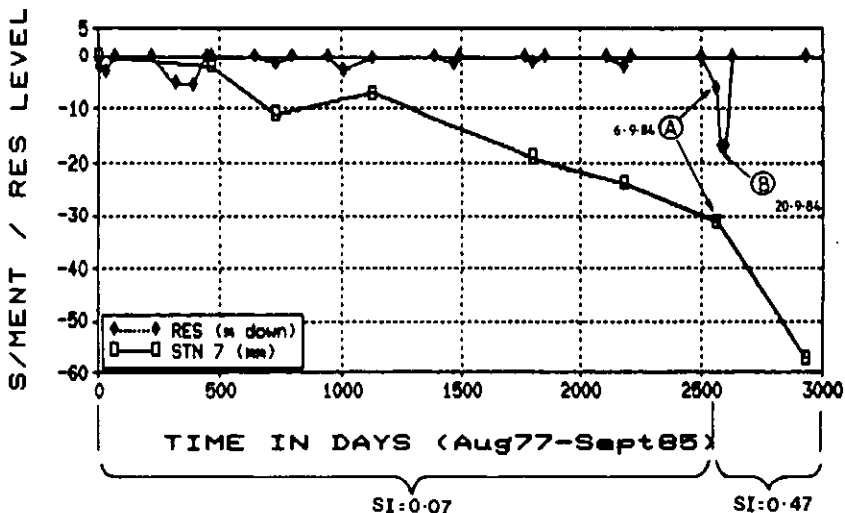
Fig. 5.2. Dean Head Dam - settlement 1977-1985

This was 19 metres high, built in 1840. The settlement record for the highest cross section for the period from 1977 to 1985 was shown in Fig. 5.2. This illustrated how the way in which reservoirs were operated influenced the settlement behaviour of dams. From August 1977 until August 1984 the reservoir was little used; however, in 1984, pipework connections enabled water to be taken to supply. It was drawn down by 5.9 m when the crest was levelled on 6th September 1984 (point A on Fig. 5.2). At this date the settlement rate was still linear with respect to time. The crest was not levelled again until September 1985, when 26 mm settlement was noted. In this period the reservoir had been completely emptied by 20th September 1984 (point B) and refilled again by 14th November 1984. Mr Claydon suggested that the rate of settlement was affected by the rate of drawdown, the extent of drawdown, and possibly also by the numbers of cycles of drawing down and refilling.

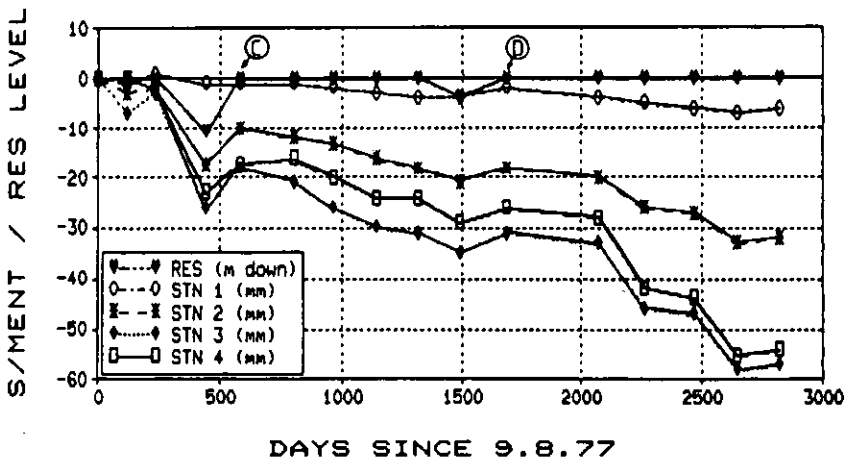
Fig. 5.3. Ramsden Dam - settlement 1977-1985

Figure 5.3 showed the settlement of four stations on the crest of Ramsden Dam, which was 22 m high and was built in 1892. These showed quite clearly that the crest not only fell on drawdown, but that it rose on refilling (points C and D). At this dam they had also recorded horizontal movement associated with reservoir draw-down, with the crest moving upstream on drawing down and moving a greater distance downstream on refilling.

He suggested that these data showed that the settlement pattern was affected by reservoir operation and that the subject needed further investigation.

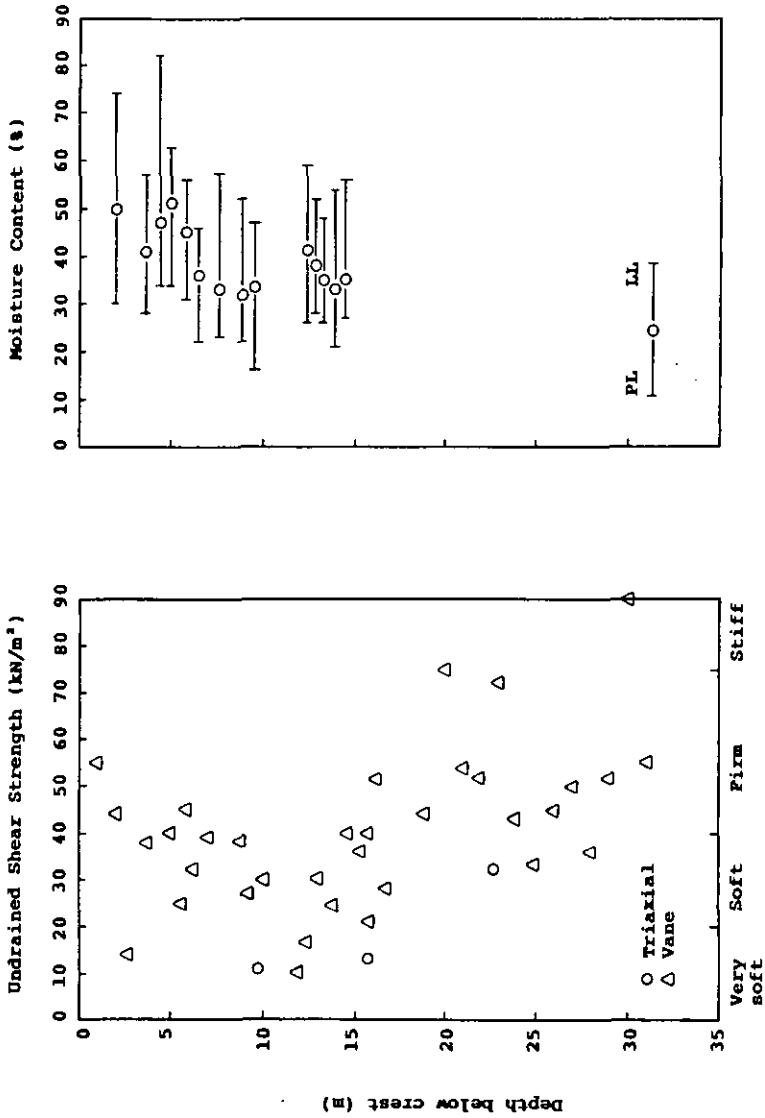
Fig. 6.1.1. Properties of puddle clay core at March Ghyll dam

There were other anomalous features on the embankment local to the area of maximum settlement which it was considered might be related. A recommendation was made that a site investigation of the puddle clay core and shoulder fill should be carried out using continuous sampling techniques in the puddle clay core. The site work had been completed but laboratory testing had not. The site vane test results for the continuous undisturbed samples from the borehole in the area of maximum settlement were shown in Fig. 6.1, and also the moisture contents, and plastic and liquid limits. The puddle clay plotted above the A-line on the plasticity chart, and above the original ground level, which was at a depth of about 17 m, it varied from very soft to soft but was generally firm below this level. A particularly weak area was indicated at between 9 and 14 m depth. A spade-shaped total pressure cell was installed in an adjacent borehole in the weak area, as at Walshaw Dean lower dam, to establish the minimum horizontal pressure in the longitudinal direction of the core and its susceptibility to hydraulic fracture. However, results were not yet available.
