The embankment dam

Proceedings of the sixth conference of the
British Dam Society held in Nottingham on
12-15 September 1990

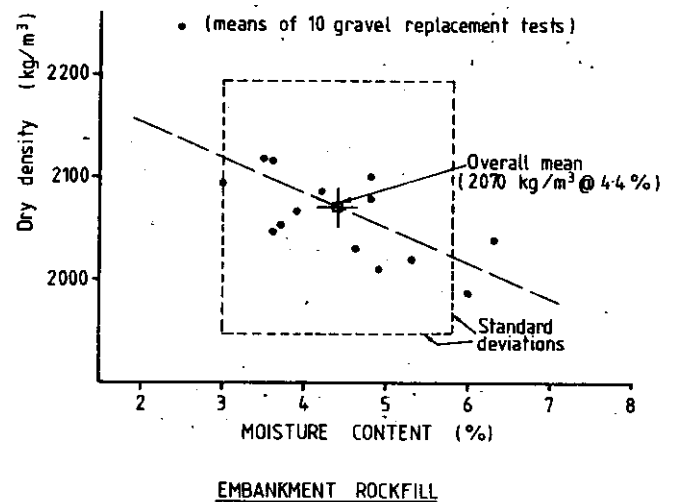
Fig 3 Dry density/moisture content relationship

37. There were 149 test holes excavated, giving a rate of one hole per 6650m³ of fill. The mean bulk density was 2159 kg/m³ with a range between 2675 and 1820 kg/m³ giving a dry density of 2070 kg/m³ at an average moisture content of 4.4%. Contrary to what might have been expected it was found that the higher densities occurred with lower moisture content as is illustrated in Figure 3.

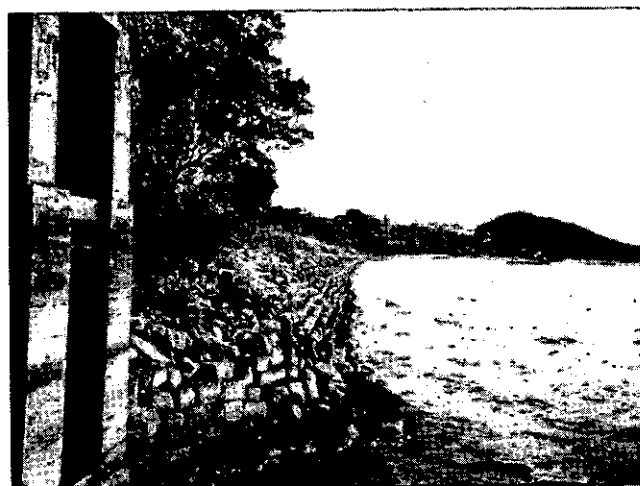
Fig. 4. Typical ancient Sri Lankan embankment dam

19. Safety assessment of embankment dams in Sri Lanka presents a number of unique problems. There are some 300 or so major reservoirs (those supplying 80 or more hectares of irrigation) and tens of thousands of smaller ones. These are all impounded by low earth dams or bunds designed to serve the commercial needs of the country's densely populated rural areas. Many of the reservoirs (referred to as 'tanks' in Sri Lanka) have been in existence since the last century and records show that some of them have been in almost continuous use since first constructed by Sri Lanka's ancient kings (Fig.4), some over 1600 years ago. The tanks form an integral part of the rural environment and the communities depend on them for much more than just their irrigation needs. They are part of the social fabric of the population so that their safety is taken as a matter of course. The failure of the Kantalai Tank bund in April 1986 (ref. 1) with the loss of 127 lives therefore came as a devastating shock to the Sri Lankan people.
