**SAFETY OF
EMBANKMENT
DAMS**

**Reservoir
Safety and the
Environment**

**1994 BDS CONFERENCE
DISCUSSION**

THE BRITISH DAM SOCIETY

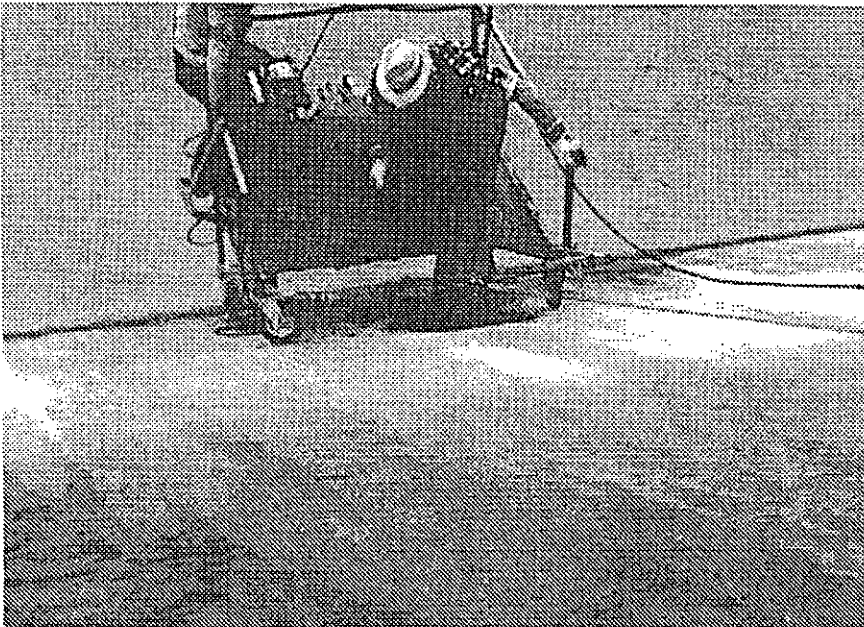
Figure 2 : Repair of a burst blister

Repairs are necessary (Figure 2), causing a lot of labour and cost. In an actual case with a continuously increasing number of such blisters, we were asked to investigate the conditions of development of these deficiencies and to try to make a prognosis as to the number of blisters to be expected in the future.

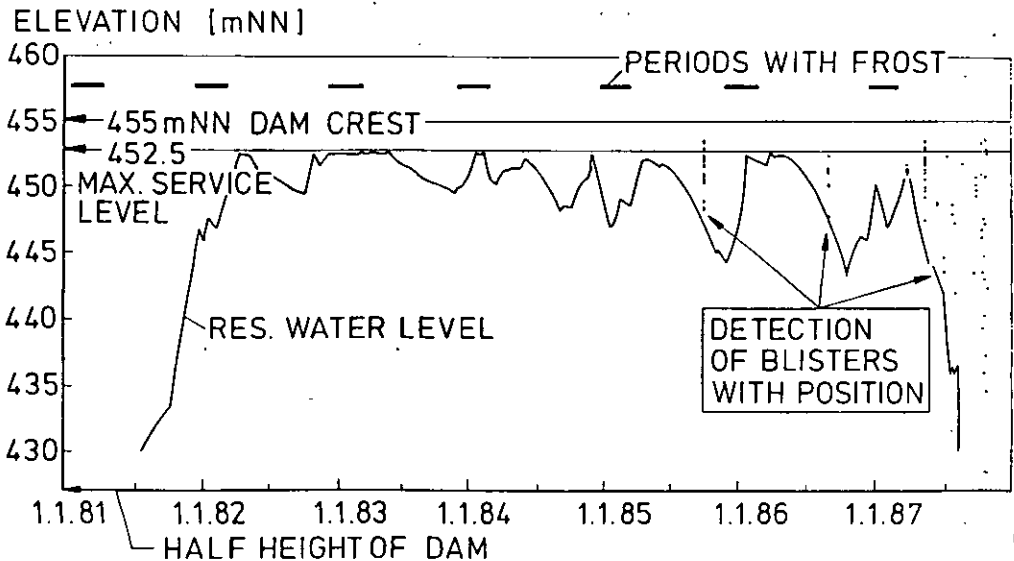
Figure 6 : Development with time of reservoir water level and of blisters in asphalt membrane

An interesting question was: where and when do blisters appear? As can be seen from the diagram in Figure 6, blisters do not appear under water. On the other hand, in the case in question, the blisters also required a certain time to develop; we concluded from some statistics that the number of frost periods plays a certain role in the development of blisters. The largest number of blisters appeared in areas where 4 to 7 cold winters affected the membrane under the absence of a water cover.

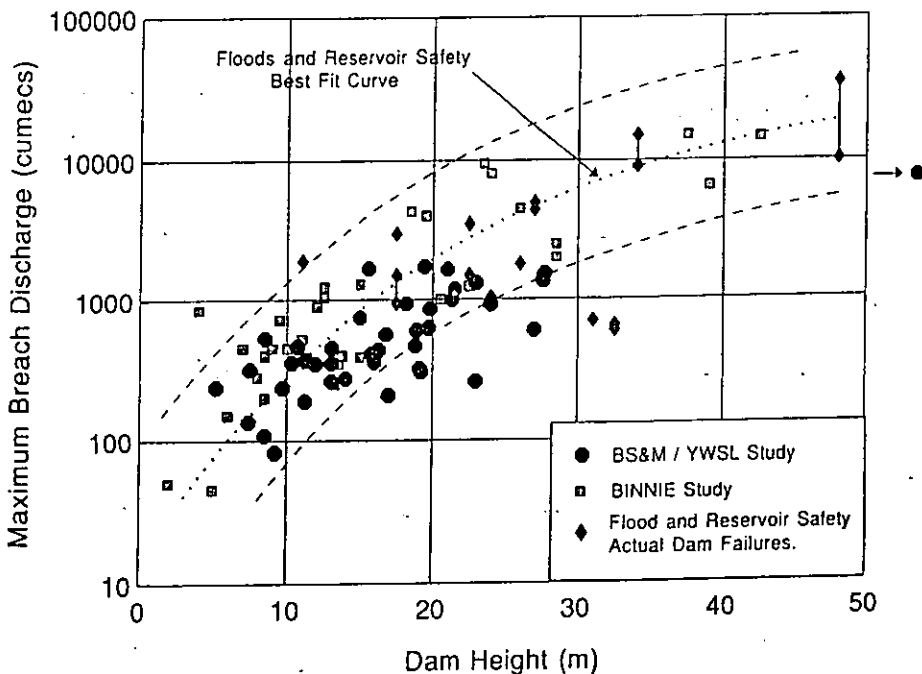
Figure 1 from Tarrant et al with additional data

The paper by Tarrant et al (Proceedings pp 282-291) contains a number of graphs showing the comparison of various parameters obtained from the results of 35 dam failure studies by Binnie using DAMBRK.UK. Babbie, Shaw & Morton have studied over 30 dams owned by Yorkshire Water Services and the results of these studies have been incorporated onto figures 1, 2 and 7 of the paper by Tarrant et al to both extend the number of records and compare results. These comparisons show that the relationships of maximum breach discharge with dam height and reservoir capacity are very good even though all the YWS/BSM studies are based on overtopping failures whereas the Binnie studies in the paper are a combination of overtopping and piping failures together with actual dam failures in the case of Figure 1. The length of structural damage compared with dam height also agree well as shown in Figure 7.

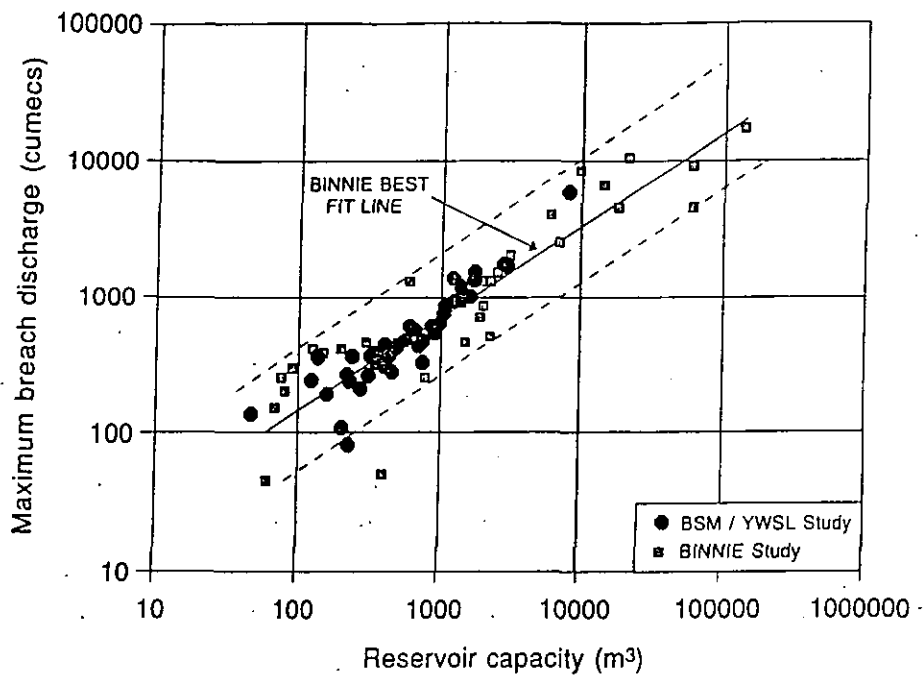
Figure 2 from Tarrant et al with additional data

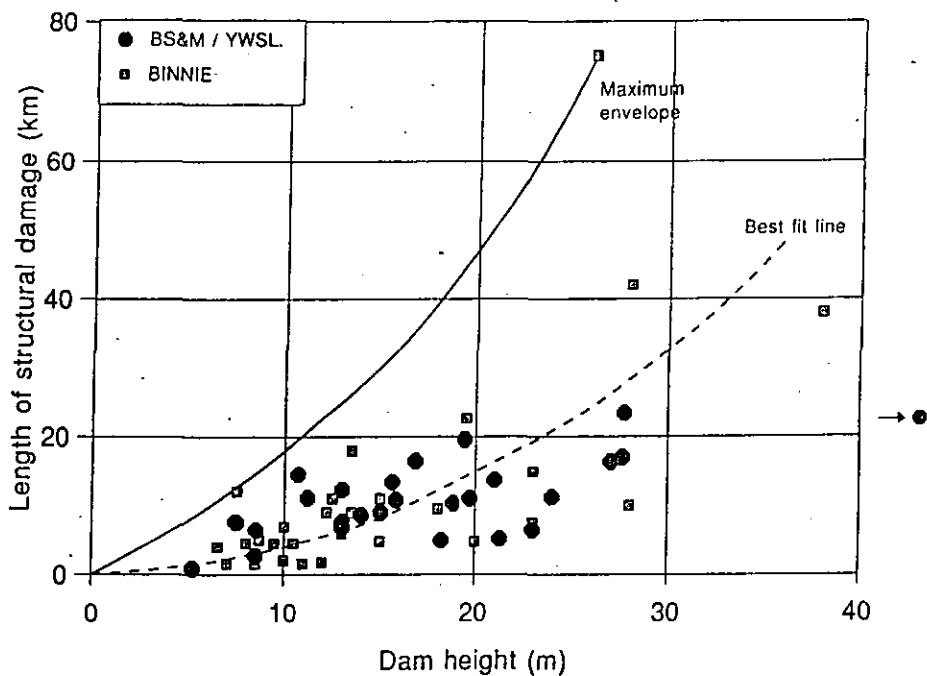
Figure 7 from Tarrant et al with additional data
